**CITY OF HOLLYWOOD, FLORIDA  
DEPARTMENT OF DEVELOPMENT SERVICES  
PLANNING DIVISION**

**SUBJECT:** Vacation Homes Invest, LLC requests a Certificate of Appropriateness for Demolition of one single-family home and a Certificate of Appropriateness for Design for three single-family homes located at 958 Jefferson Street within the Lakes Area Historic Multiple Resource Listing District.

# *Home Inspection Report*

*958 Jefferson Street, Hollywood Fl. 33019*

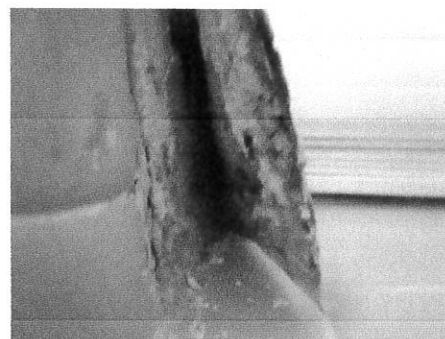
**Photo #18** SUSPECT MOLD.

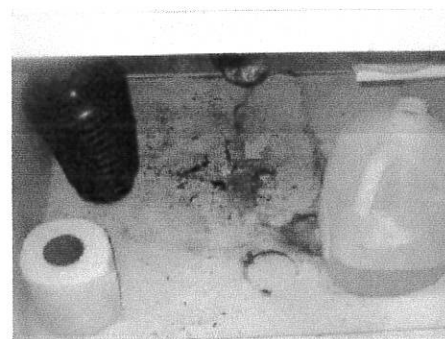
**Photo #19** DAMAGED VANITY DUE TO DRAIN LEAK.

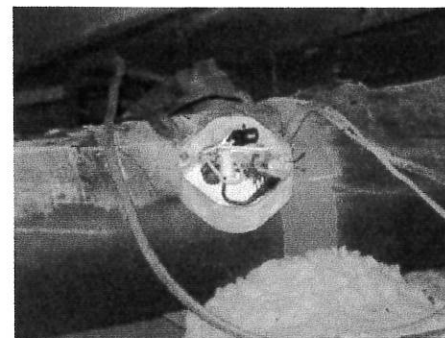
**Photo #20** SPLICES IN ATTIC.
