ATTACHMENT B
Unsafe Structure Determination
Letter and Report

RE: Block 40, Great Southern Hotel
1830 Young Circle, Hollywood, Florida 33020

REPORT OF FINDINGS

GREAT SOUTHERN HOTEL
1830 YOUNG CIRCLE
HOLLYWOOD, FLORIDA
FOLIO NO.: 5142-15-01-7810

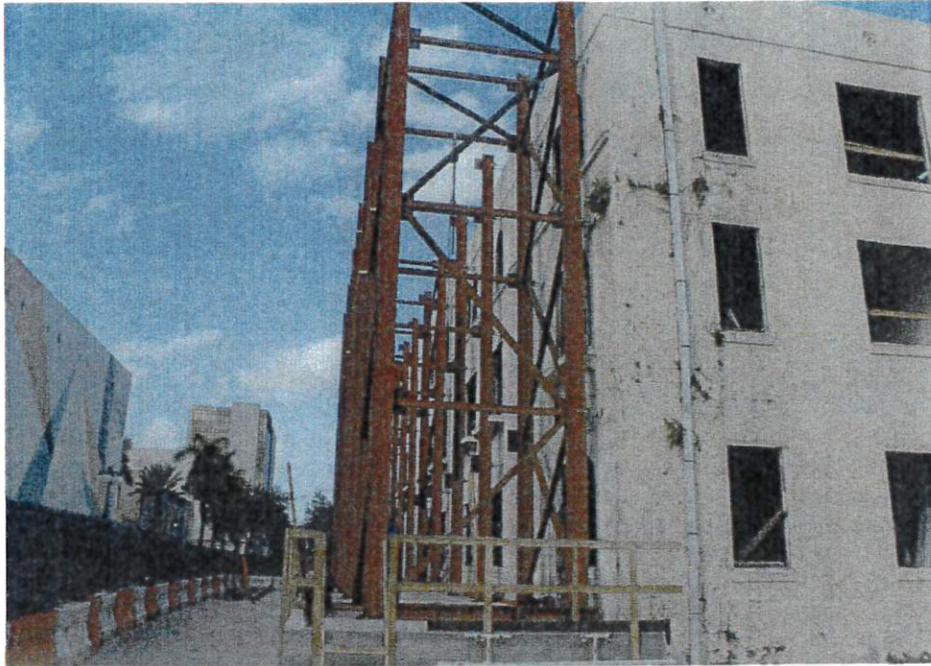
1. View of the southwest area of the subject structure; facing north.

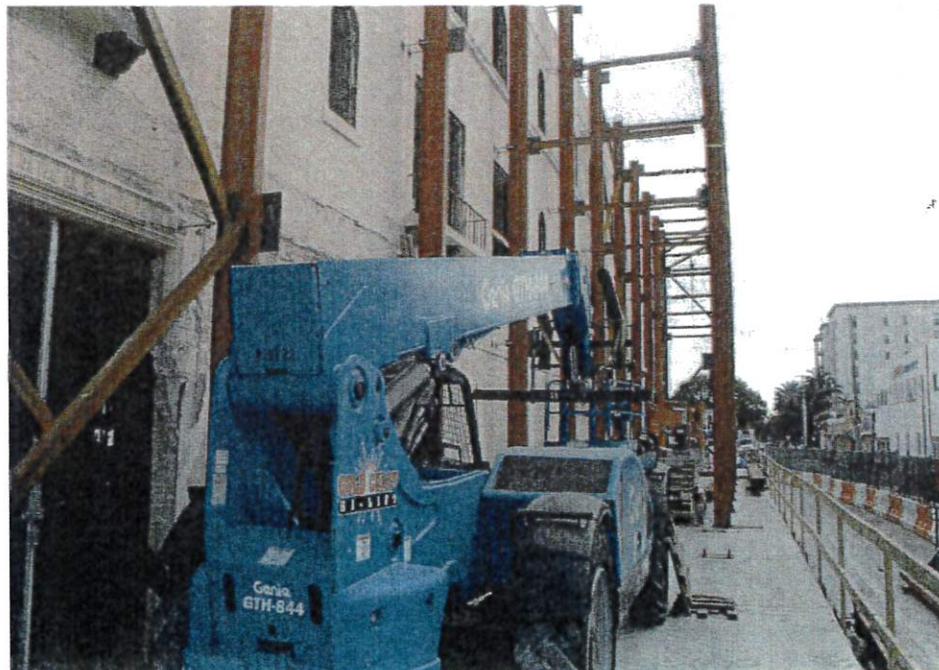
2. View of the northwest area of the subject structure; facing south.

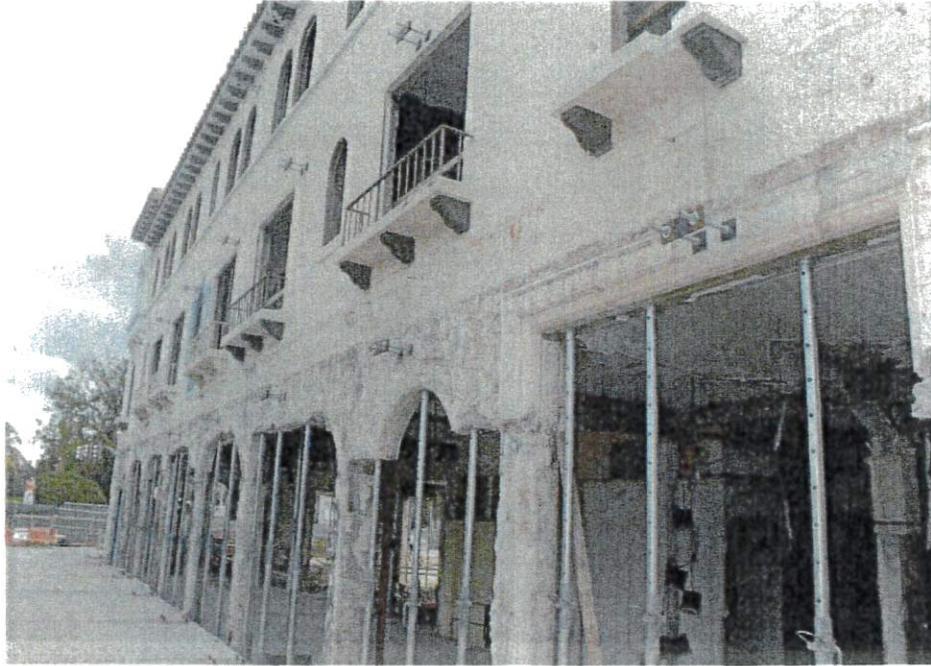
- The foundations and several of the through bolts were installed/constructed for the proposed historic preservation of the west, north and east walls (See photographs 3 to 5).

3. View of the northwest area of the subject property: looking east.

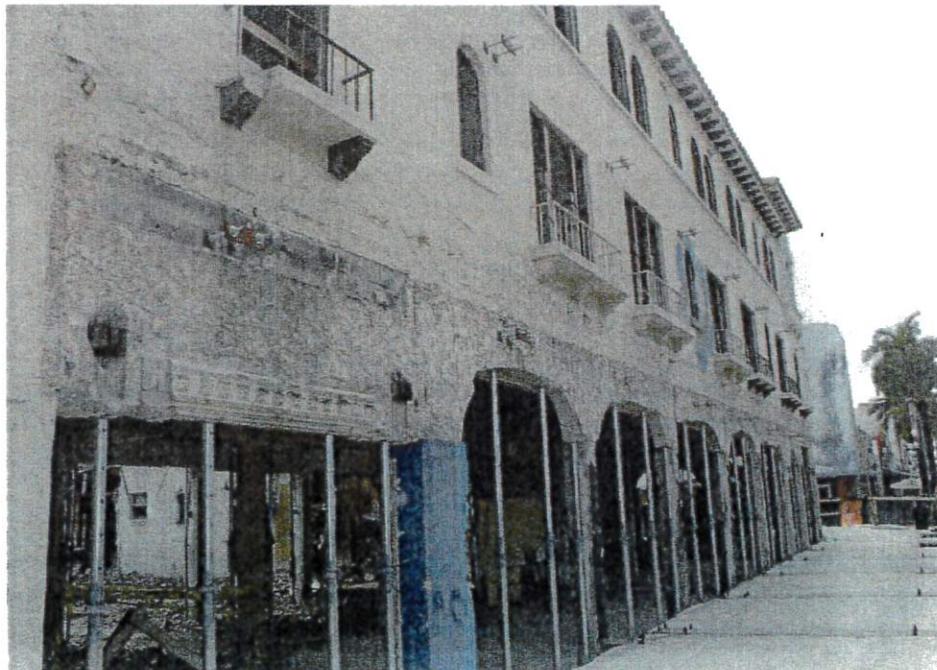
4. View of the northeast area of the subject property: looking west.

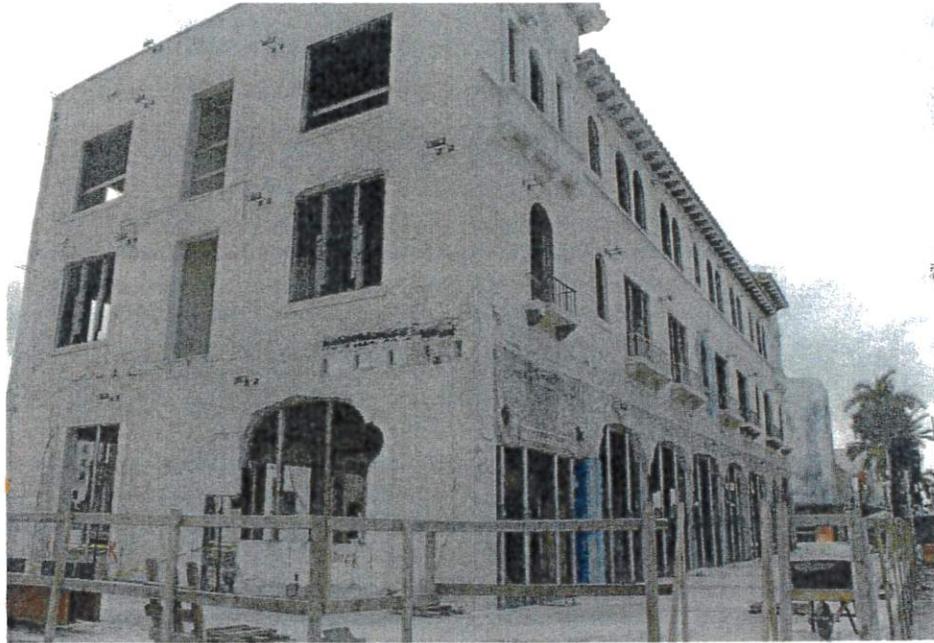
5. View of the northeast area of the subject property: looking southwest.

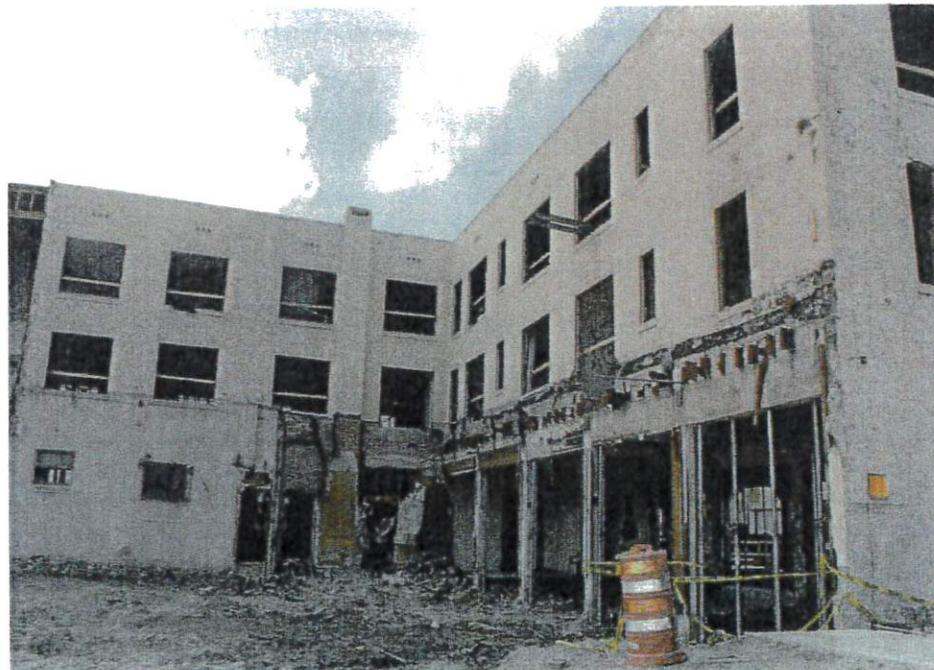
6. View of the southeast area of the subject structure: looking west.

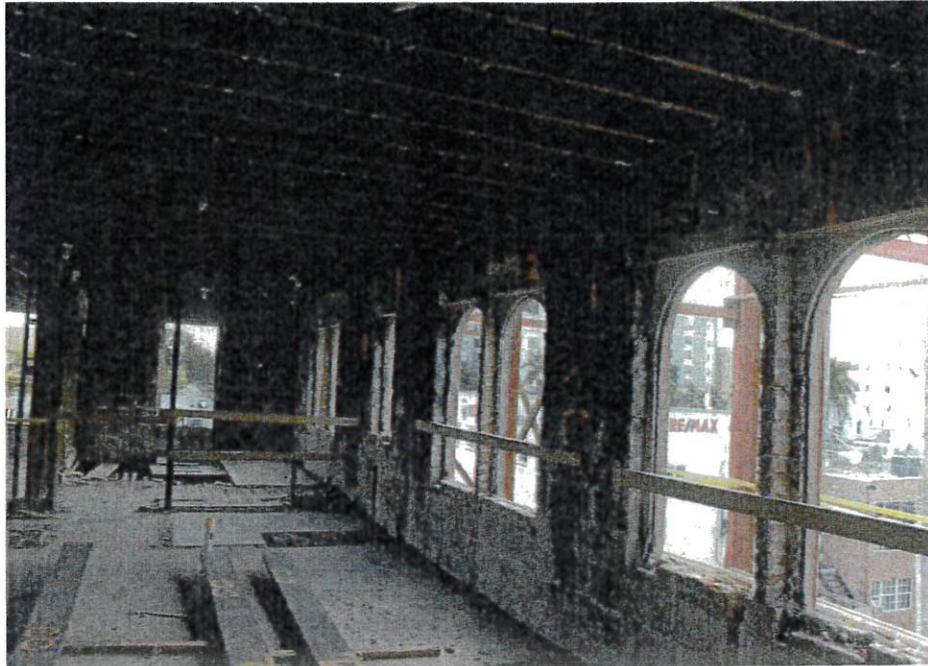
- Charred CMU walls, deteriorated wood floors and wood truss in the southwest area of the structure, third floor level (See photograph 7).
- The third level tie beam with cracked and spalled concrete and exposed corroded reinforcement at the various areas of the structure (See photograph 8).

7. Interior view of the charred CMU walls, deteriorated wood floors and wood truss in the southwest area of the structure, third floor level.

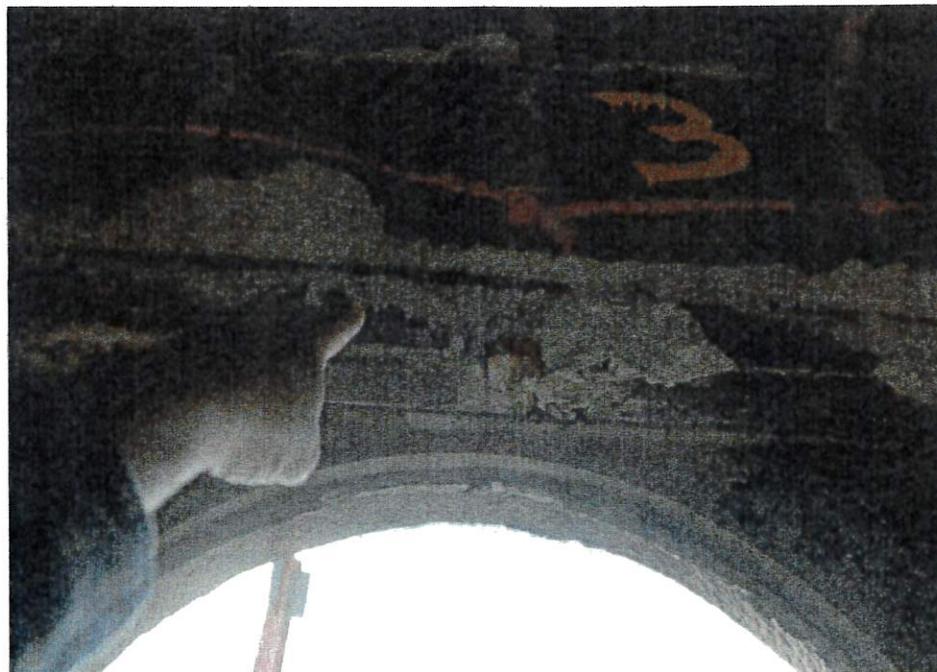
8. Typical view of the third level tie beam with cracked and spalled concrete and exposed corroded reinforcement at the southwest area of the structure.

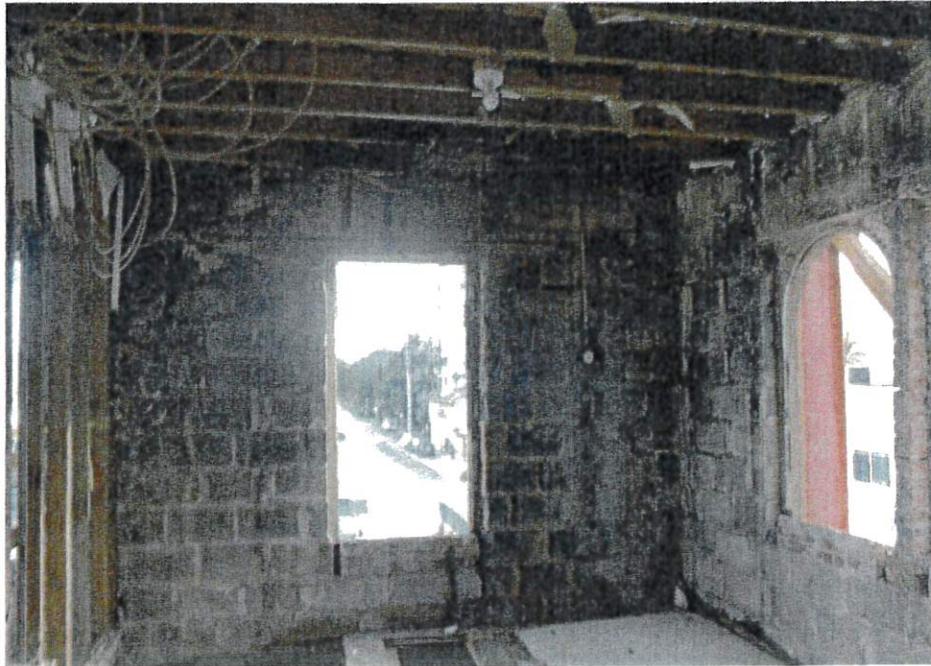
- Charred CMU walls, deteriorated wood floors and wood truss in the southwest corner of the structure, third floor level (See photograph 9).
- Deteriorated CMU parapet wall above tie beam in the southwest area of the structure, third floor level (See photograph 10).

9. Interior view of the charred CMU walls, deteriorated wood floors and wood truss in the southwest corner of the structure, third floor level.

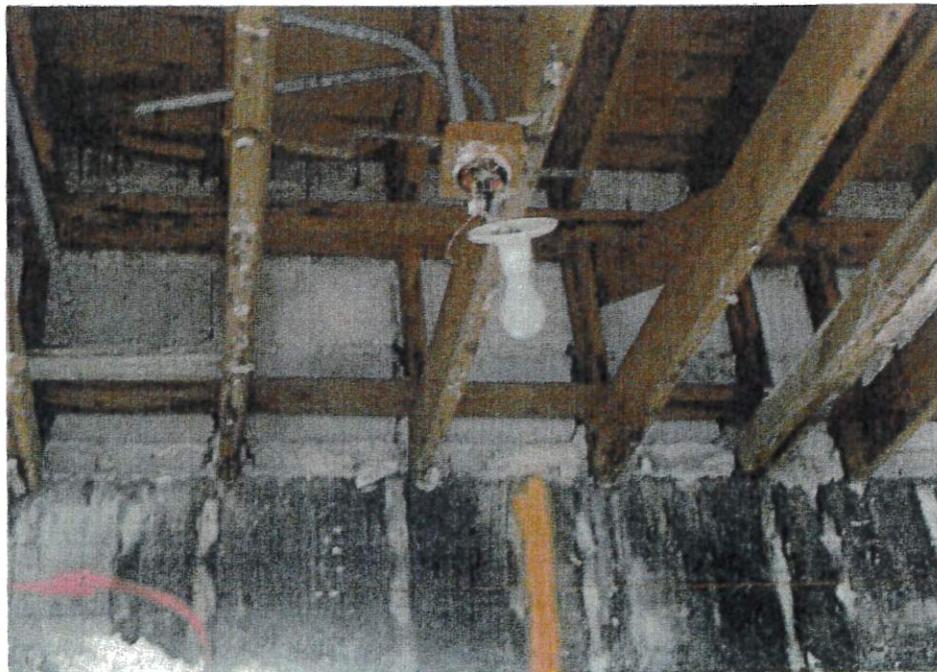
10. Interior view of deteriorated CMU parapet wall above tie beam in the southwest area of the structure, third floor level.

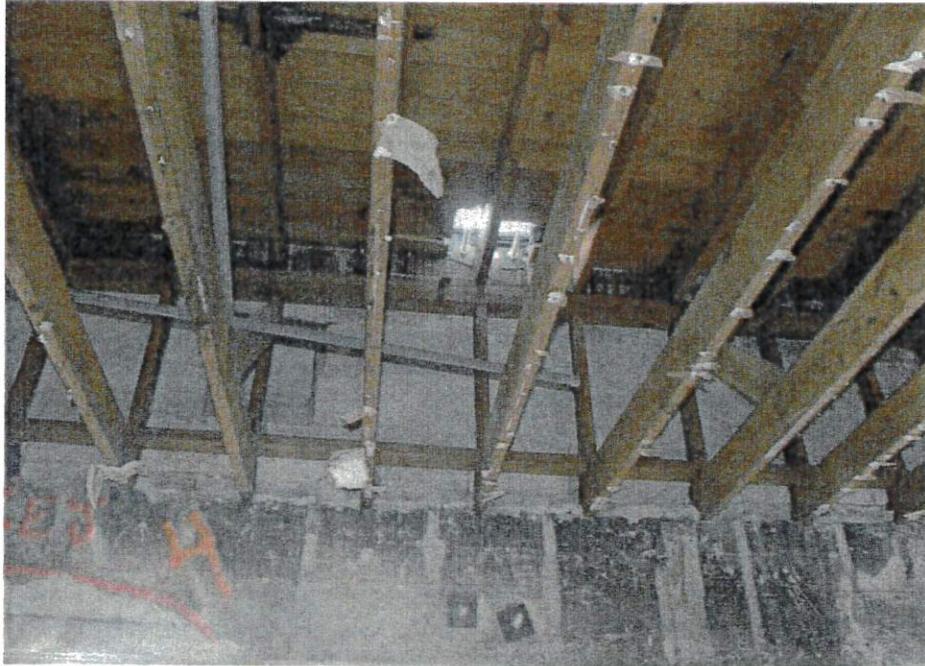
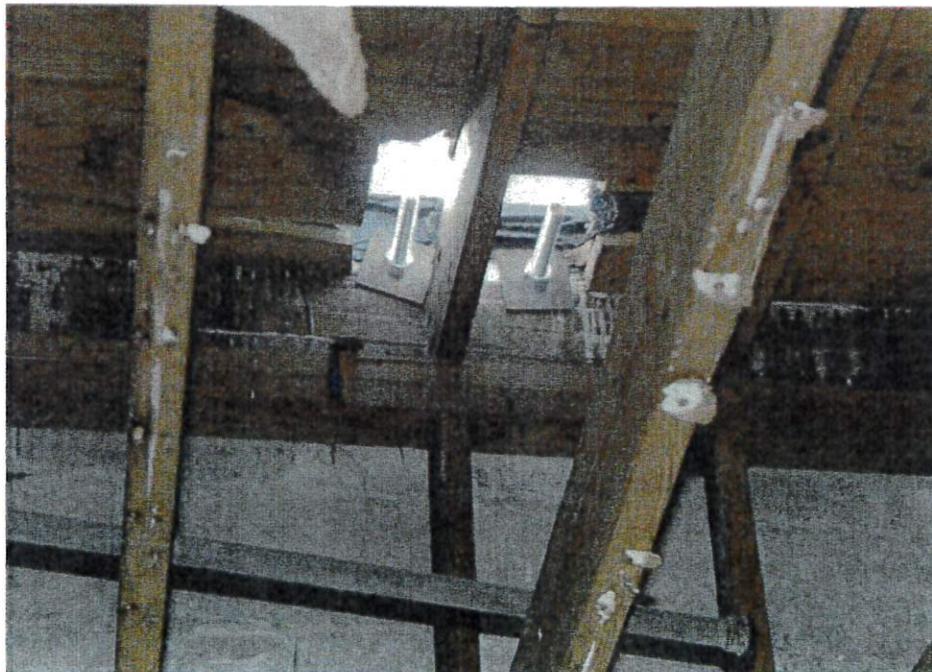
- Deteriorated CMU parapet wall above tie beam in the west central area of the structure, third floor level; with rods in the tie beam and parapet wall above (See photograph 11 & 12).

11. Interior view of deteriorated CMU parapet wall above tie beam in the west central area of the structure, third floor level; with rods in the tie beam and parapet wall above.

12. Close-up view of CMU parapet wall above tie beam in the west central area of the structure, third floor level; with rods in the parapet wall above.

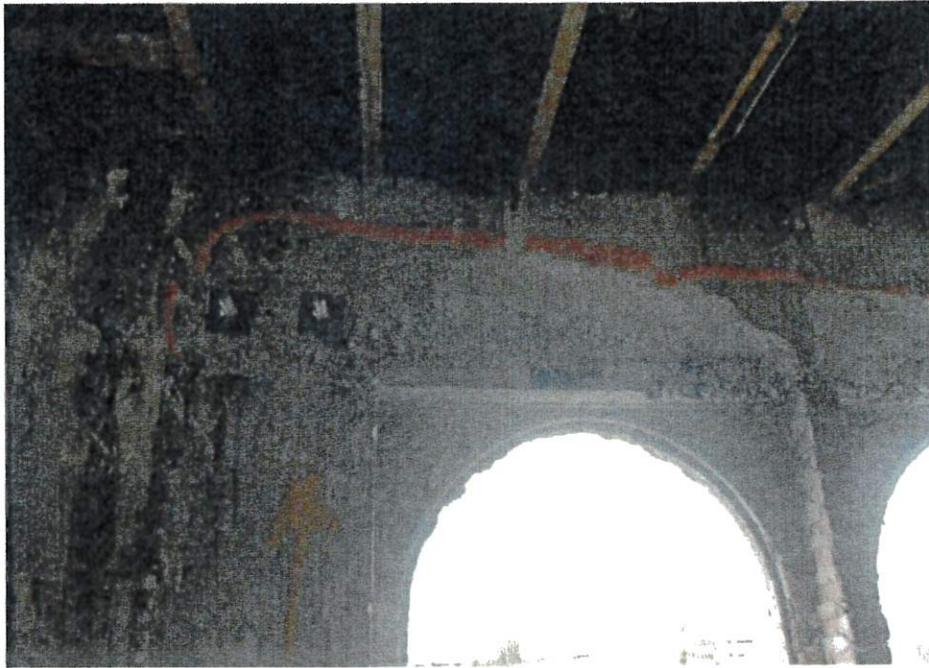
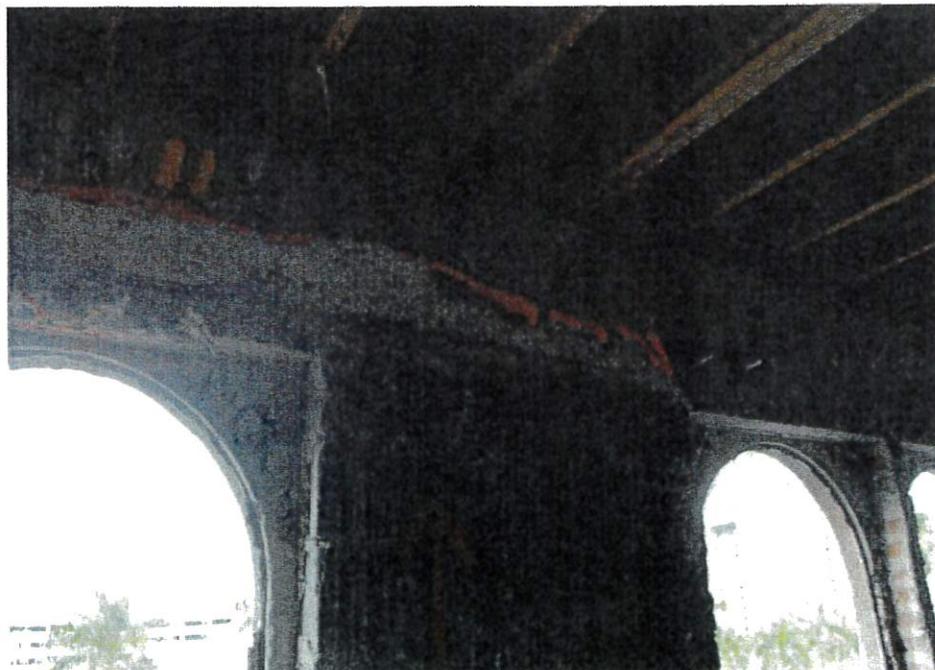
- Third level tie beam with cracked, spalled and honeycombed concrete and exposed corroded reinforcement at the north area of the structure (See photograph 13 & 14).

13. Typical view of the third level tie beam with cracked, spalled and honeycombed concrete and exposed corroded reinforcement at the north area of the structure.

14. Typical view of the third level tie beam with cracked, spalled and honeycombed concrete and exposed corroded reinforcement at the north area of the structure.

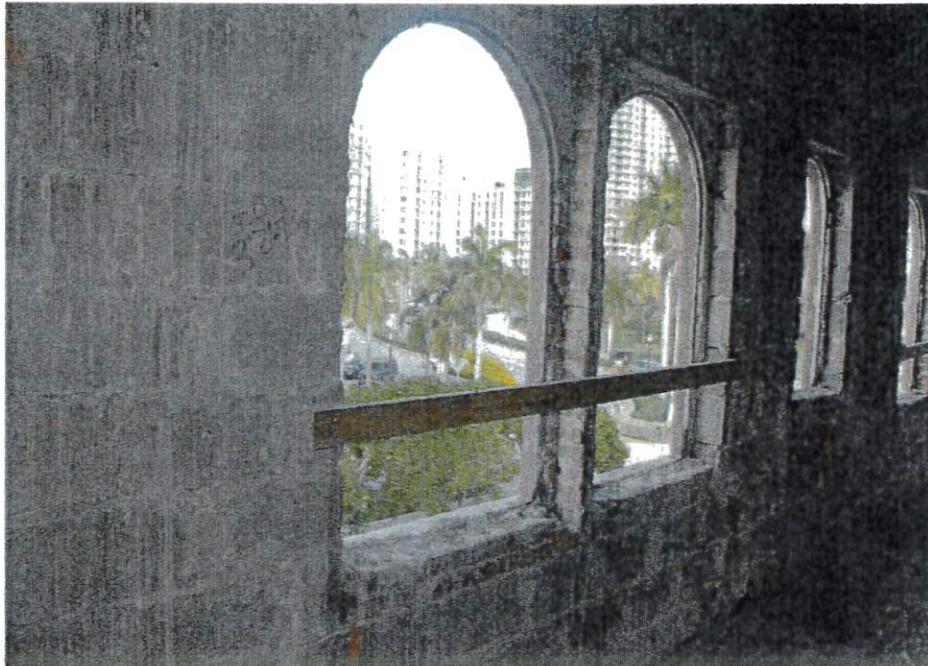
- North wall with composite brick and CMU wall section on the third floor level of the structure (See photograph 15).
- Tie-beam with cracks and corroded reinforcement with connecting rods for the restoration; north and west areas of the second floor level (See photograph 16, 18 & 19).
- Termite damaged deteriorated wood flooring with noticeable sloping and wall to floor separation in the corridor at the northwest area of the structure; second floor level (See photograph 17).
- Connecting rods for restoration placed in spalled concrete areas with cracks and corroded reinforcement on the second floor of the structure (See photograph 20)
- Columns with cracked and spalled concrete sections and corroded reinforcement on the ground floor of the structure (See photograph 21).
- Column to footing connection on the ground floor at the southeast area of the structure (See photograph 22).

15. View of north wall with composite brick and CMU wall section on the third floor level of the structure,

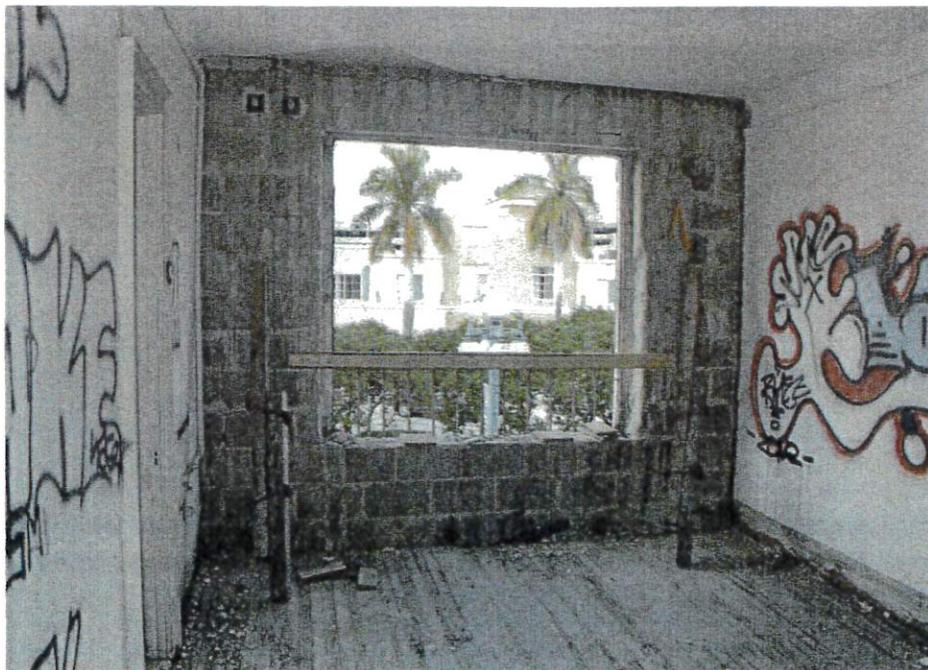
16. View of tie-beam with cracks and corroded reinforcement with connecting rods for the restoration; north area of the second floor level.

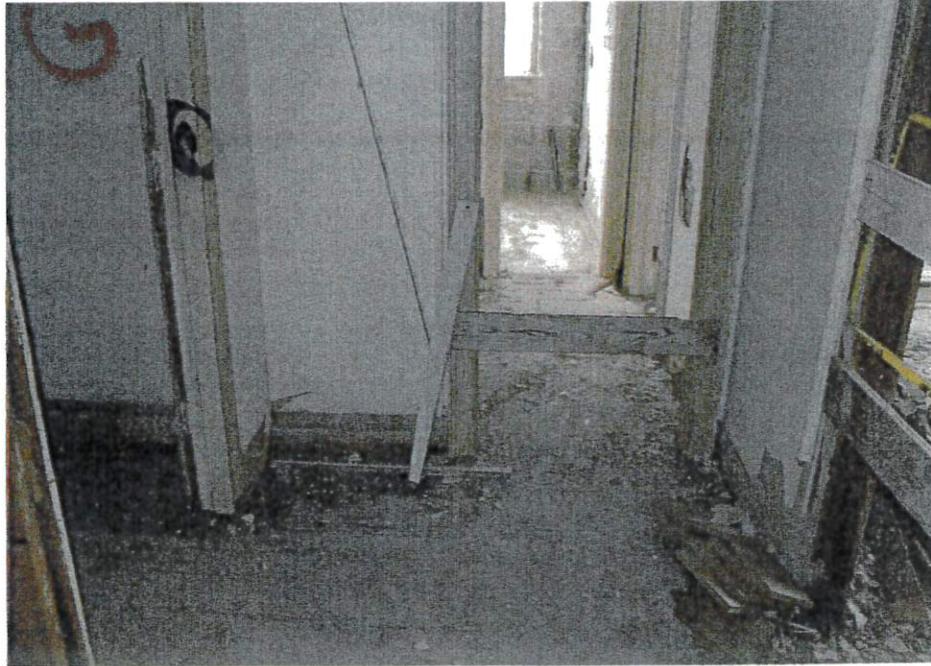
17. View of termite damaged deteriorated wood flooring with noticeable sloping and wall to floor separation in the corridor at the northwest area of the structure; second floor level.

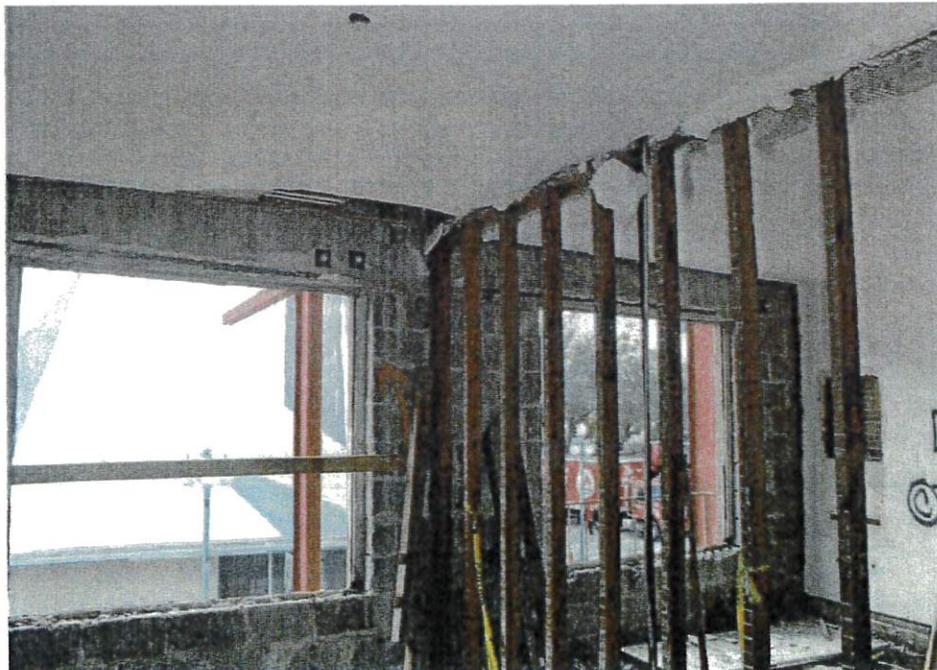
18. View of tie-beam with cracks and corroded reinforcement with connecting rods for the restoration; west area of the second floor level.

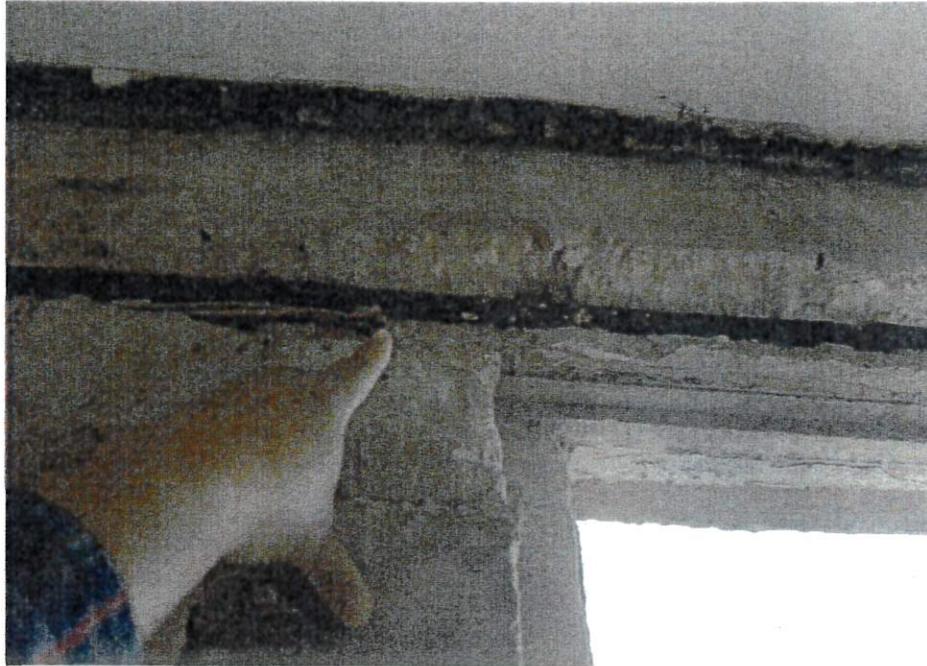
19. Close-up view of tie-beam with cracks and corroded reinforcement; west area of the second floor level.

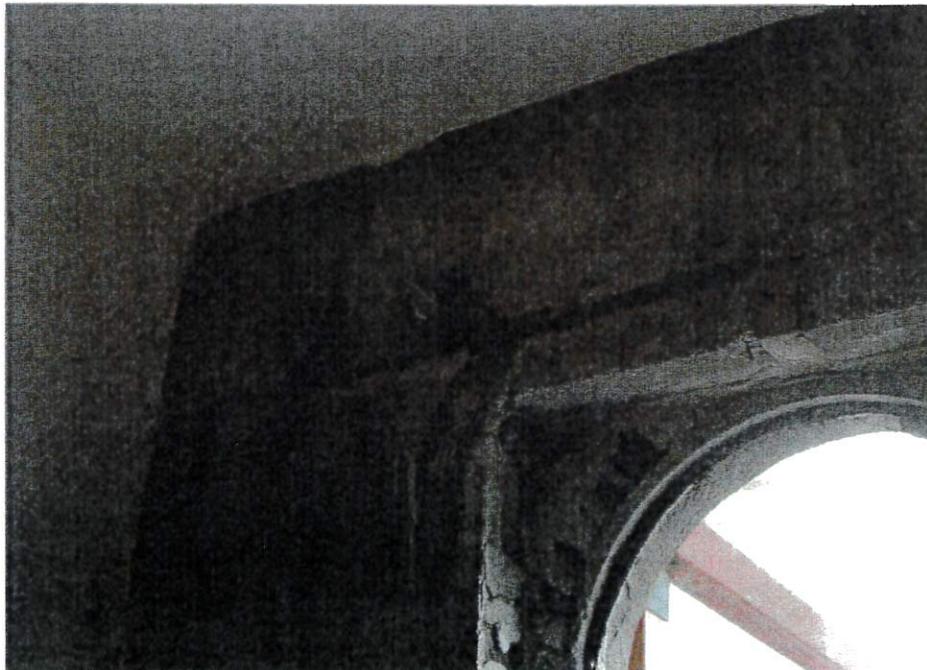
of some connecting rods for restoration in spalled concrete areas with cracks and corroded reinforcement on the second floor of the structure. There was also columns with cracked and spalled concrete sections and corroded reinforcement on the ground floor of the structure with some column to footing connection on the southeast area of the structure showing signs of excessive displacement and differential movement.

20. View of connecting rods for restoration placed in spalled concrete area with cracks and corroded reinforcement on the second floor of the structure.

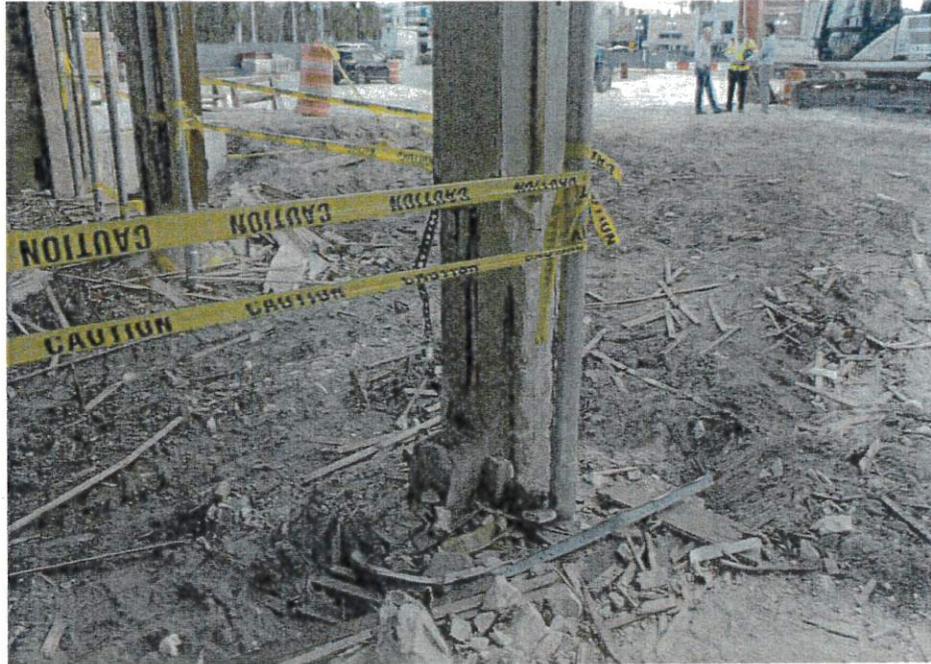
21. Typical view of column with cracked and spalled concrete sections and corroded reinforcement on the ground floor of the structure.

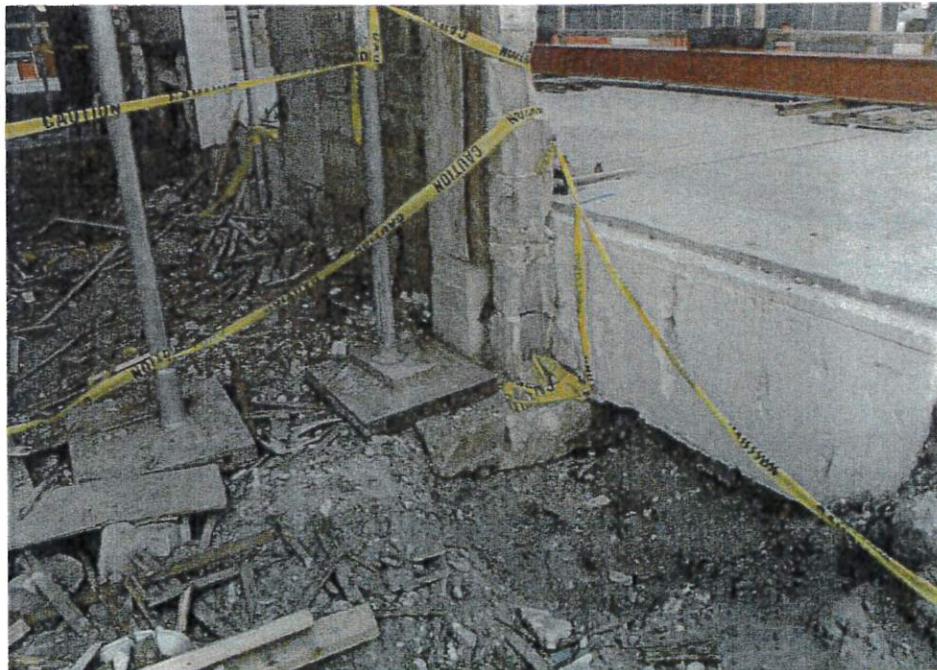
22. View of column to footing connection on the ground floor at the southeast area of the structure.

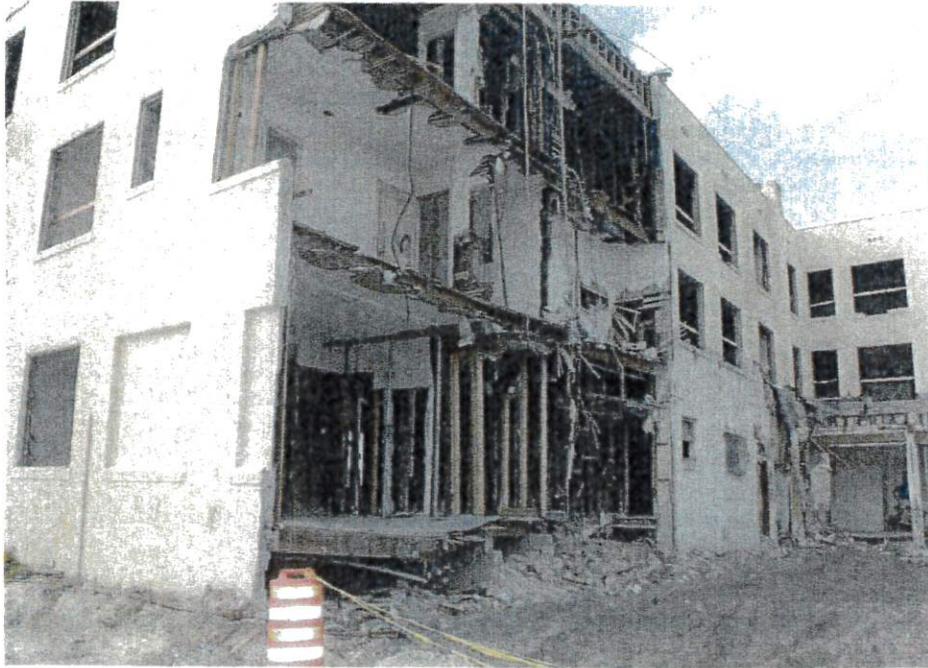
23. View of removed wall with exposed wood flooring, partition walls, stem wall and crawl space the ground floor level at the southeast area of the structure.

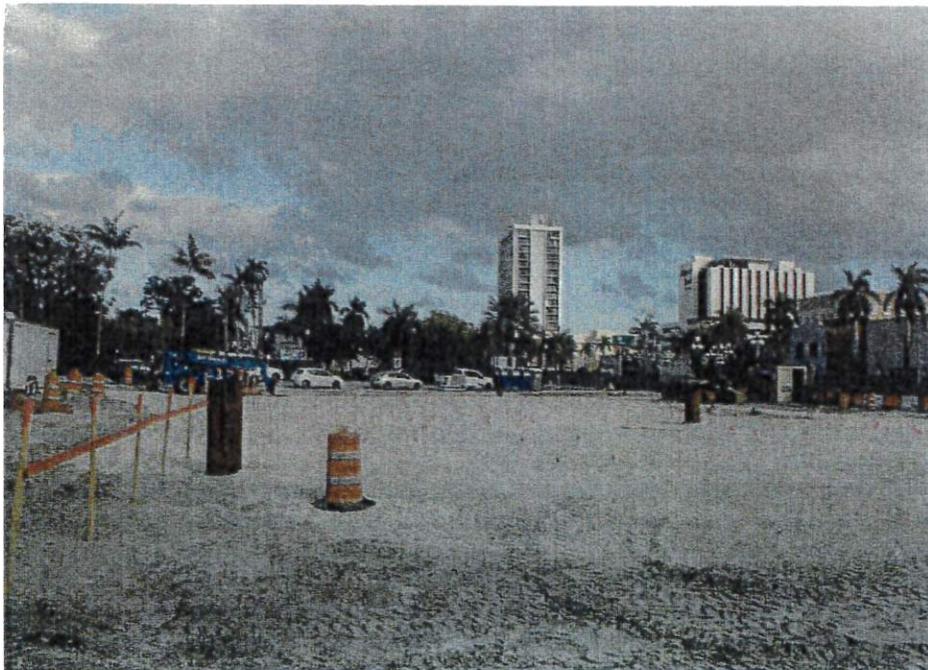
24. View of the south area of the property with survey markings for pile installation for the proposed 20 plus story tower.

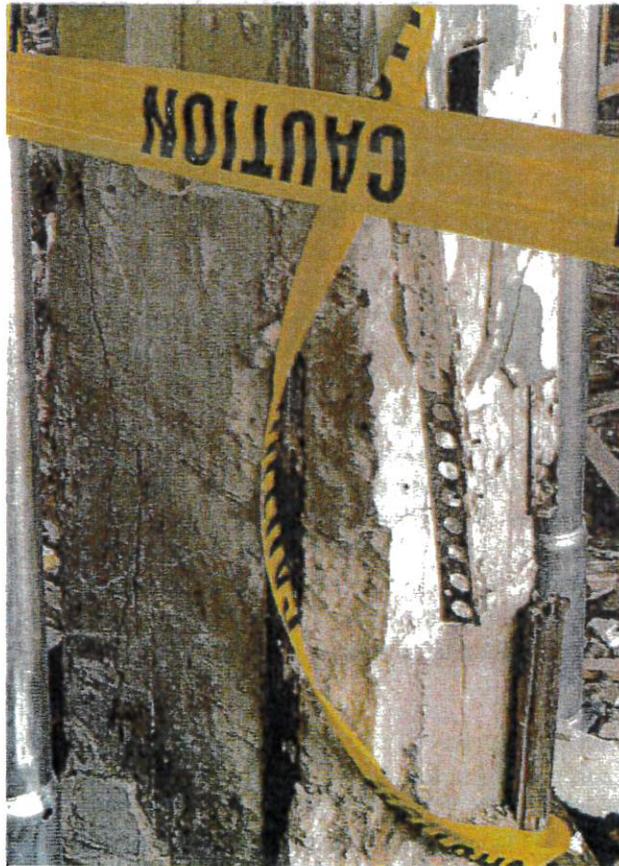
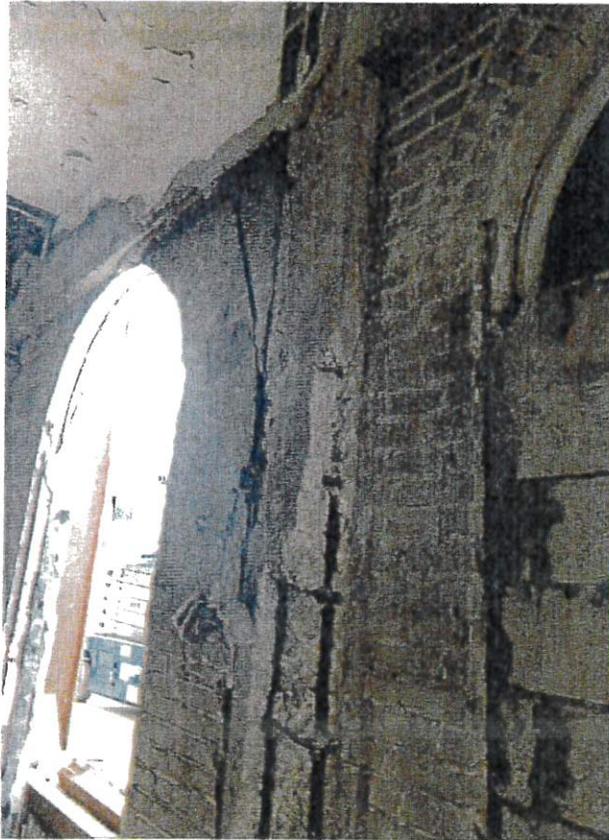
The structural concrete columns all exhibit substantial spalling and delamination. Various parts of the vertical reinforcement are exposed with over 50% loss of section in most exposed areas. For this reason, all structural concrete beams and columns are currently being 100% re-shored. We are giving verbal directive in the field as items are exposed and will be creating a plan to document the location of the shoring.

Our bracing drawings were designed under the assumption that the structure would be self-supporting of its own weight. The newly exposed areas have led us to believe that this is not possible (steel post shores have been added for safety). In order for the bracing system to work as designed, the building structure must be repaired first. In order for repair work to begin on the building, the building must be deemed safe to work within. **At this time we can not verify that the building is safe to work in, and there-fore all work needs to stop within the foot print of the building.**

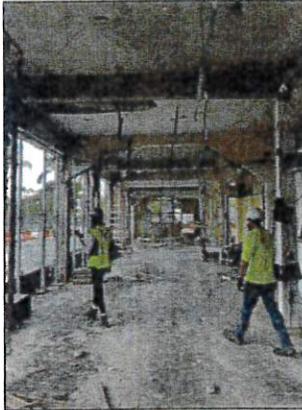
North portion of building, ceiling still in place

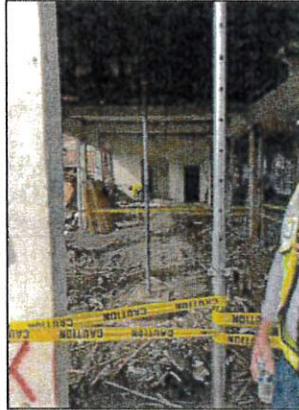
Sagged decorative beam (shored), wood joists to be shored (north portion)

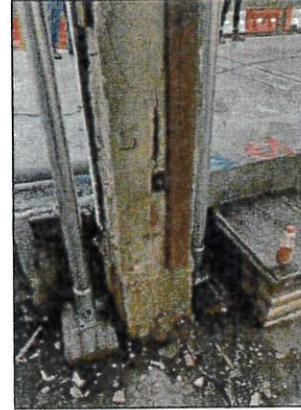
Column at south façade, with crack & spall at base

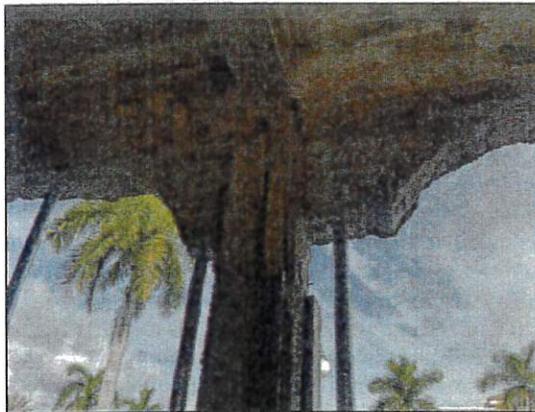
Top portion of same column – existing block infill supported by shoring

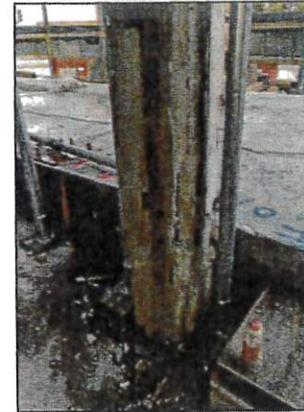
Column at south façade, other view. Observe Spalling and cracking at the base

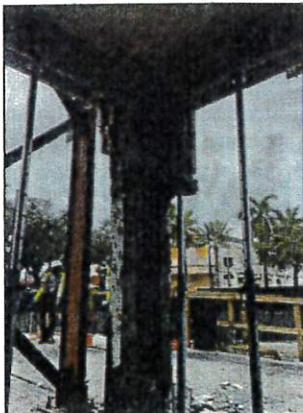
Column at Northwest corner, still covered with damaged wood blocking and masonry

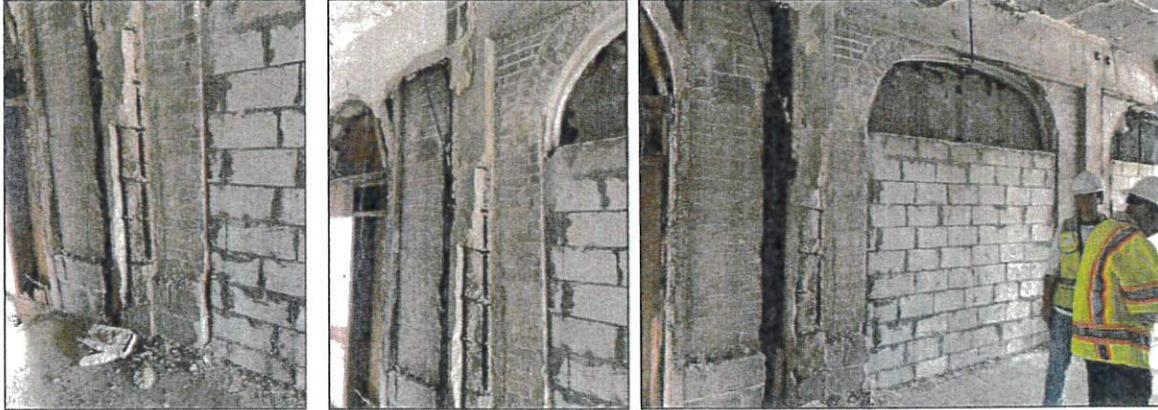
Column w/excessive spalling (W façade) and wall infill (not the original construction). The exposed rebars seen in the picture will require complete replacement. The beam above the opening shows a longitudinal crack running for the extension of the span.

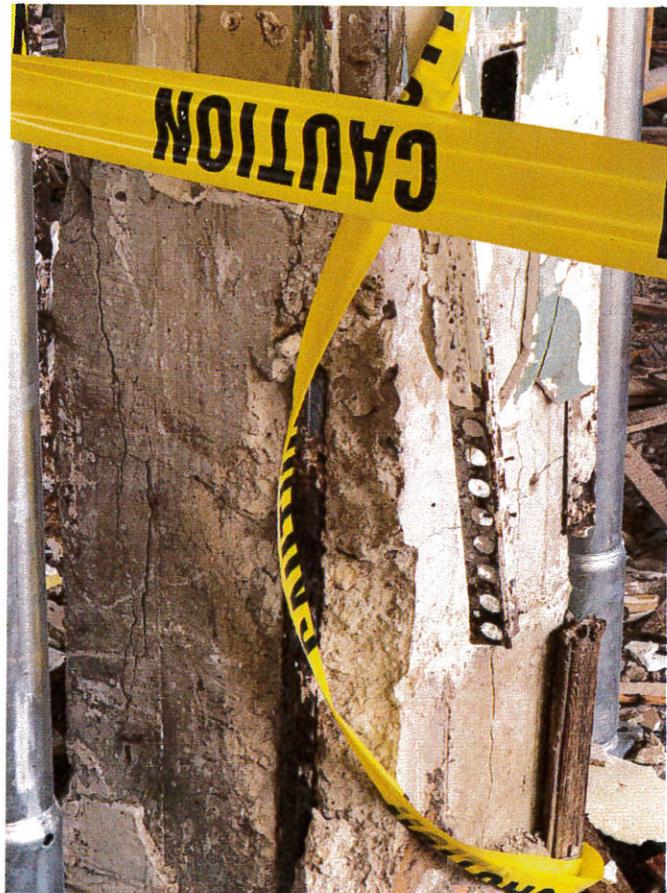
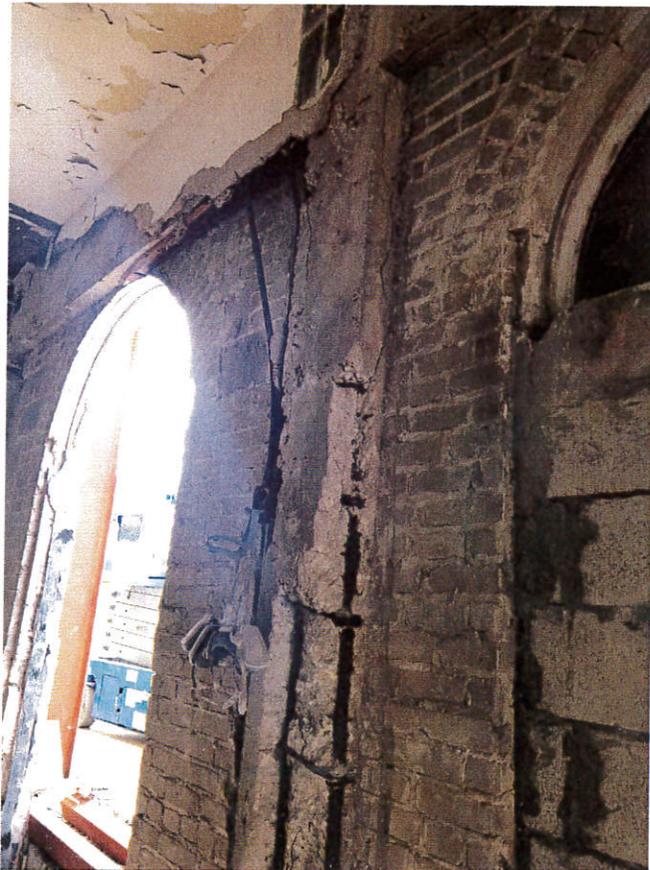
The structural concrete columns all exhibit substantial spalling and delamination. Various parts of the vertical reinforcement are exposed with over 50% loss of section in most exposed areas. For this reason, all structural concrete beams and columns are currently being 100% re-shored. We are giving verbal directive in the field as items are exposed and will be creating a plan to document the location of the shoring.

Our bracing drawings were designed under the assumption that the structure would be self-supporting of its own weight. The newly exposed areas have led us to believe that this is not possible (steel post shores have been added for safety). In order for the bracing system to work as designed, the building structure must be repaired first. In order for repair work to begin on the building, the building must be deemed safe to work within. **At this time we can not verify that the building is safe to work with in, and there-fore all work needs to stop within the foot print of the building.**

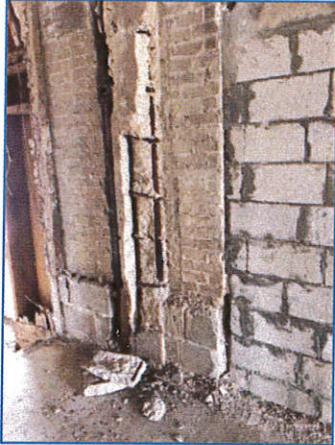
Column w/excessive spalling (W façade)

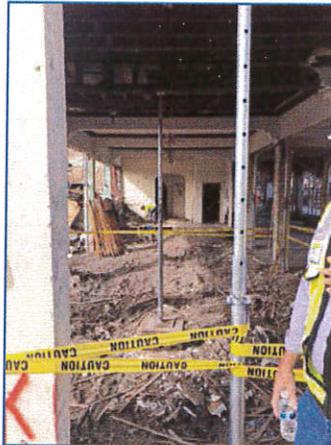
Sagged decorative beam (shored),
wood joists to be shored (north portion)

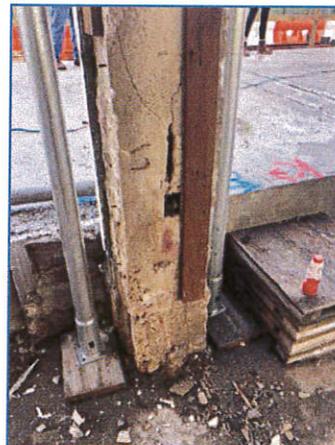
Column at south façade, with crack & spall at base

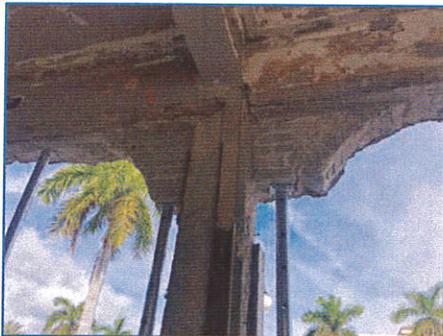
Top portion of same column.
