Project: CITY OF HOLLYWOOD FIRE STATION 74

FS 74 – HVAC Renovation

PRE-EXISTING CONDITIONS

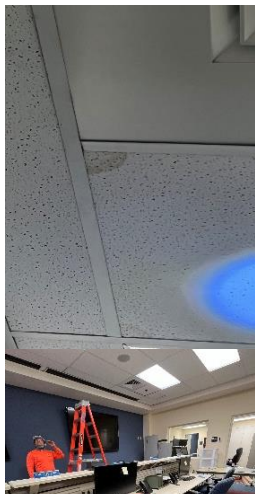
In some areas where work will be conducted to install new VAV units, the ceiling tiles show signs of moisture.

The entire area in the third-floor data room must be replaced at the time the VAV is replaced.

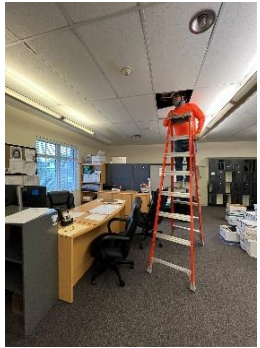
Corridor area on the entrance side of the room 218 where one CH-1 are located: Ceiling tiles must be removed and reinstalled; light fixtures must be disconnected; and the carpeted area adjacent to the area must

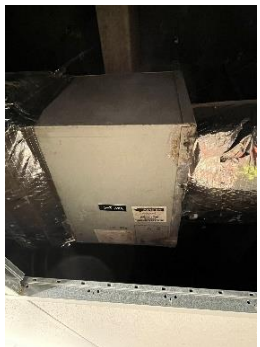
Work on the VAV unit in the backup room will involve removing ceiling tiles and installing new ones; provisions must also be made to temporarily isolate a fire sprinkler head. The carpeted area must be protected, and furniture must be moved.

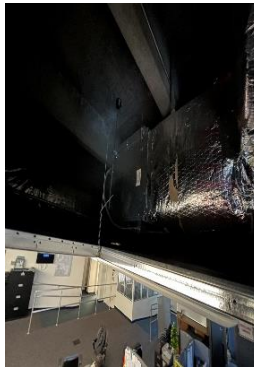
In the Internal Affairs area, located in the southern section of the building, consideration must be given to the removal and subsequent installation of the acoustical ceiling, as well as the protection of the area with carpeting. Additionally, furniture must be removed and subsequently reinstalled.

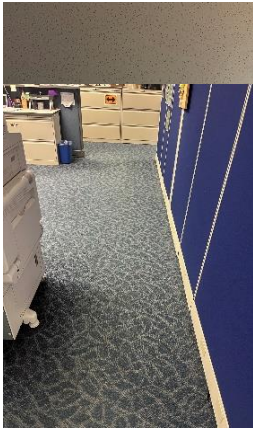
The floor area on the north side of the building must be protected; ceiling tiles and light fixtures must be removed and reinstalled, and office furniture must be covered.
