**Envirowaste Services  
Group, Inc.  
Broward Region  
City of Hollywood CRA  
A1A Storm Water Basin Inspection**

## Clean & CCTV Storm Water Basins along A1A

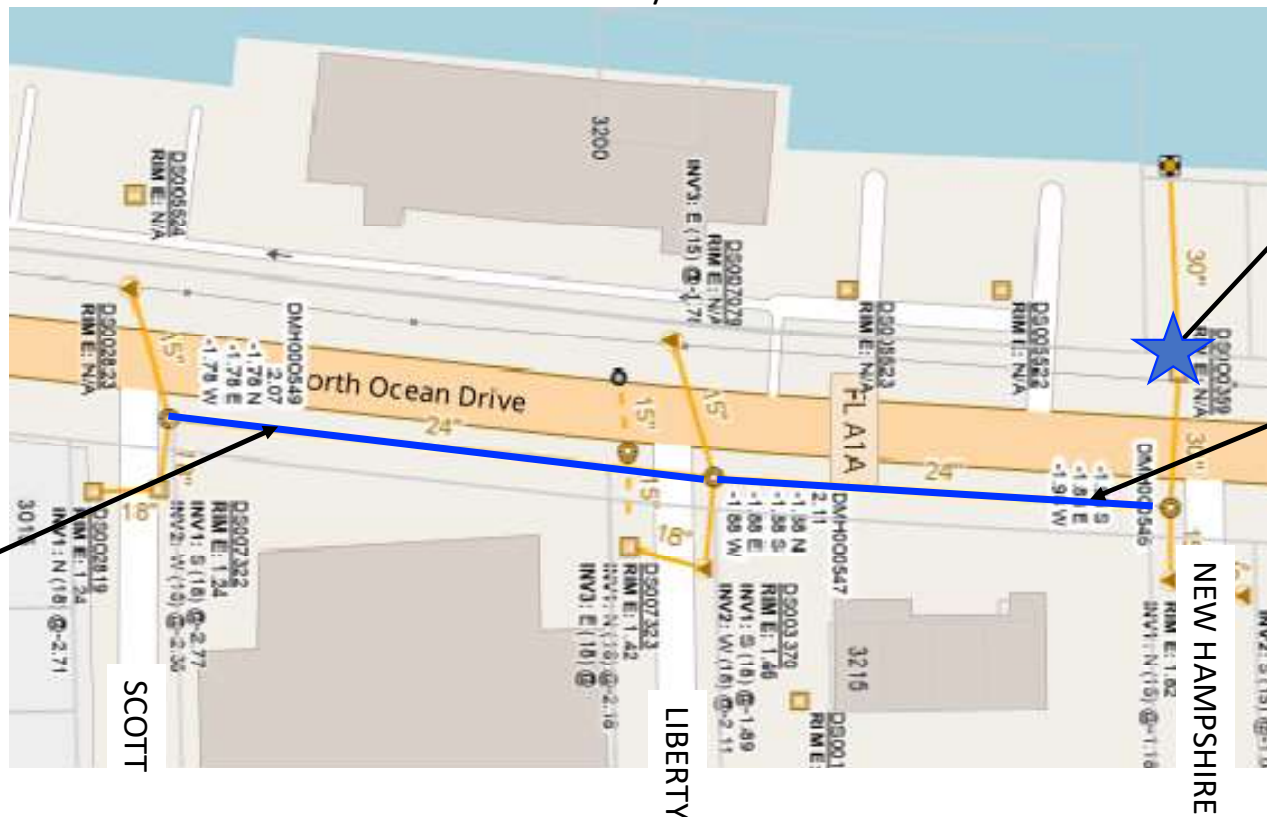
## NEW HAMPSHIRE/LIBERTY BASIN

Utility Bore  
Remove Utility  
conduit?  
Sectional Liner

Check Mate Valve

Utility Bore  
Remove Utility  
Sectional Liner

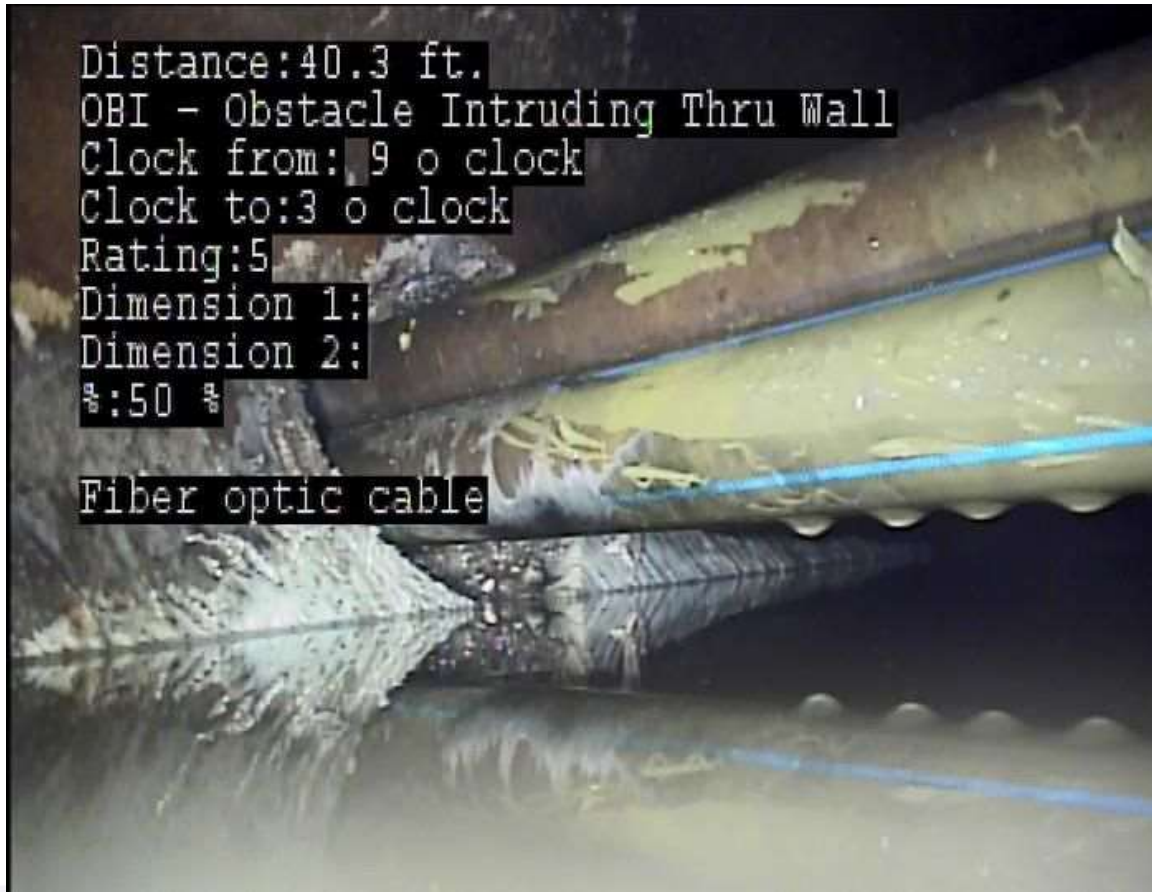
**Utility bore remove utility install sectional liner**

40.3	OBI	Obstacles Intruding Thru Wall, 50% of cross sectional area from 9 o'clock to 3 o'clock / Fiber optic cable	00:02:21	City of Hollywood	M5
40.6	MSA	Survey Abandoned / Camera blocked by cable	00:04:53	24-0052B-

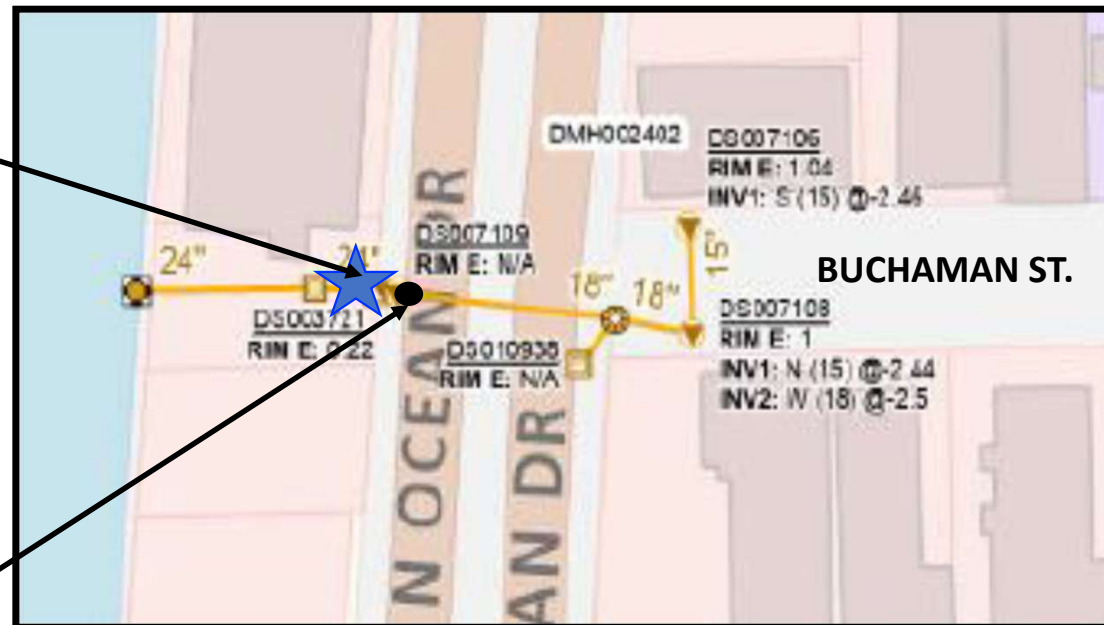
### BUCHAMAN STREET BASIN

Checkmate Valve/  
Is leaking at seal.  
Install New Valve

Heavy cleaning,  
structure DS007109  
has several  
infiltrations coming  
out of the wall. /  
Disposed before  
jobsite.

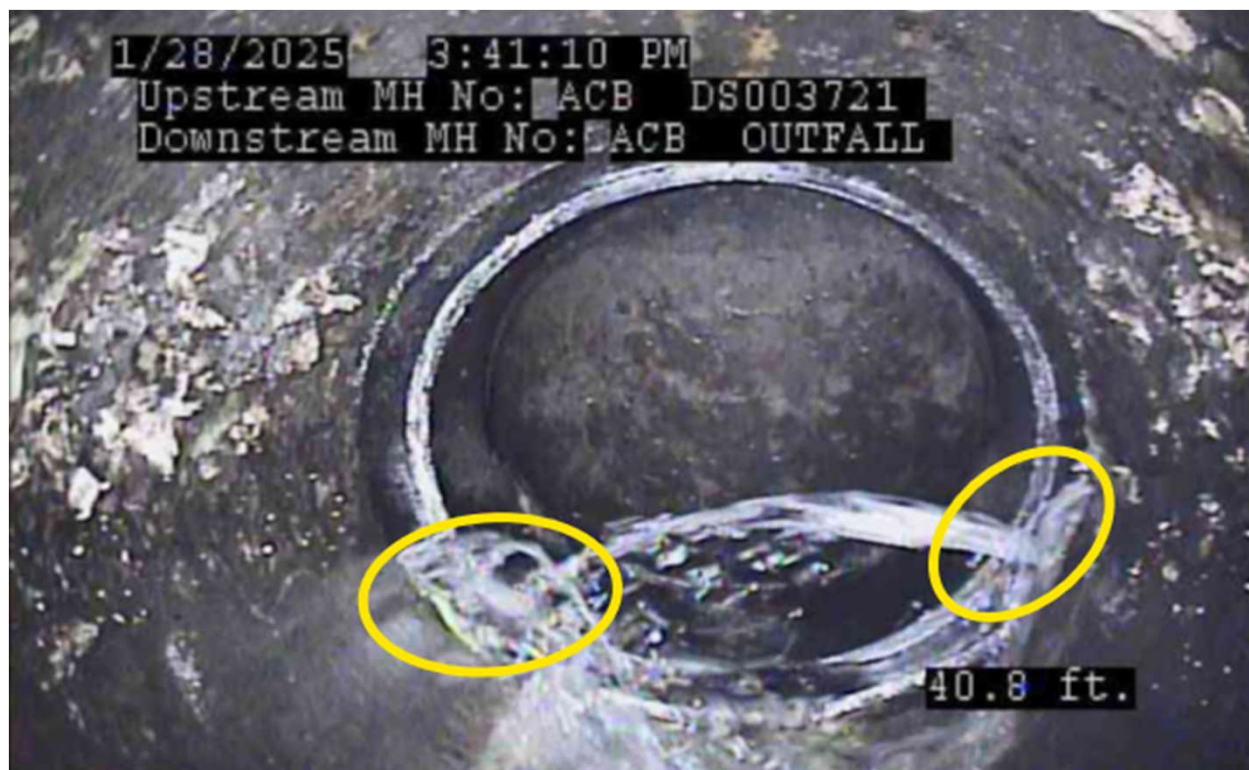
**BFP is leaking around seal**

44.2 IG Infiltration Gusher from 4 o'clock to 8 o'clock 00:02:37 City of Hollywood M5  
44.5 ACB Catch Basin / Outfall Valve 00:03:47 24-0052B-

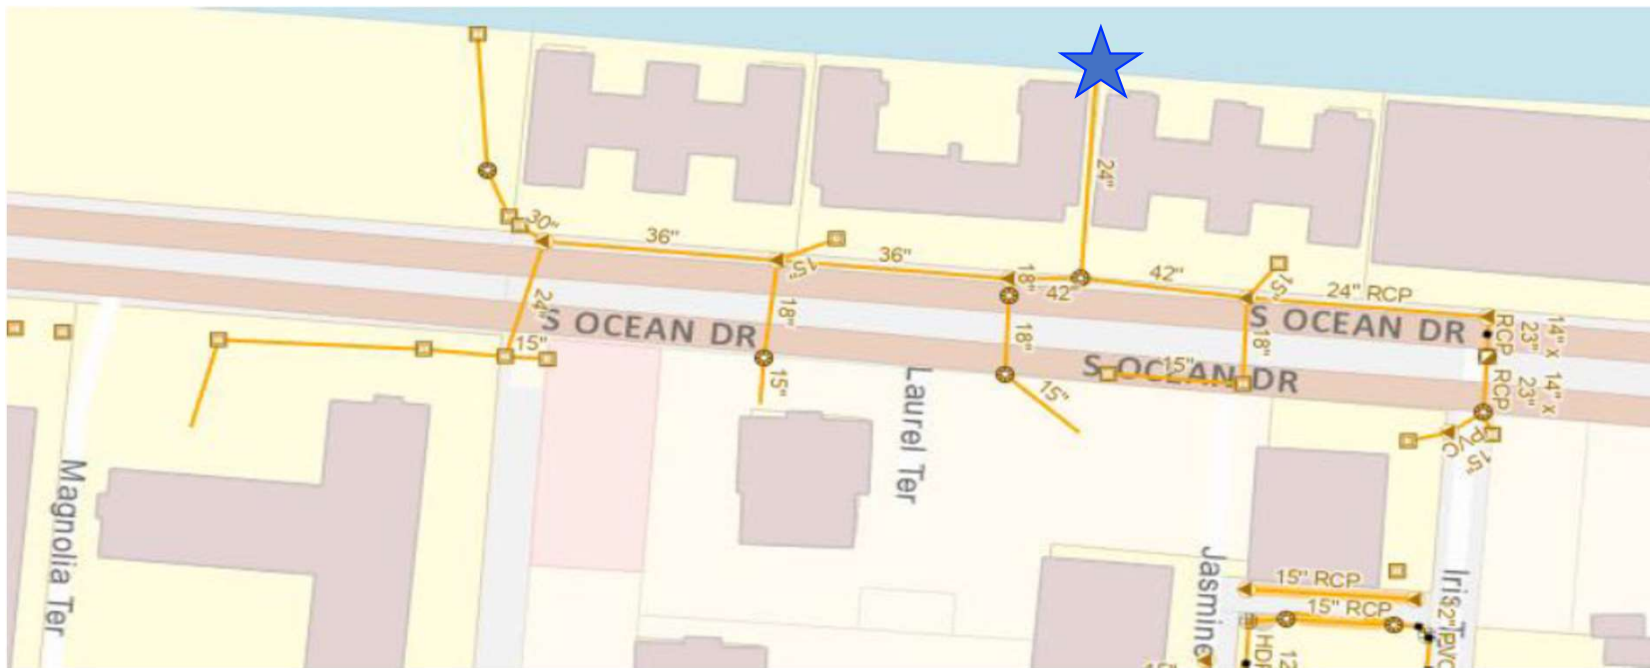
## IRIS AND MAGNOLIA STREET TERRACE BASIN

Wapro valve

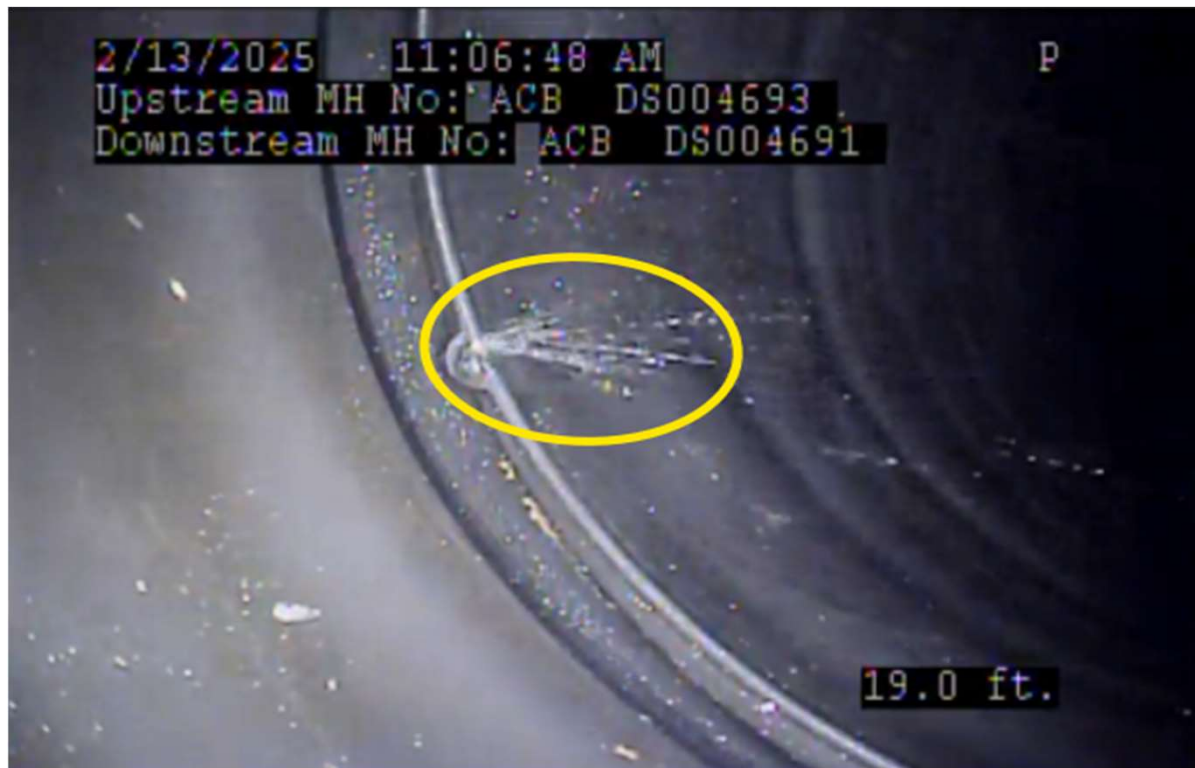
1:856	Distance	Code	Observation	Counter	Photo	Grade
<b>DS004693</b>						
	0.0	ACB	Catch Basin / DS004693			
	0.0	MWL	Water Level, 5% of the vertical dimension			
	18.9	IR	Infiltration Runner at 9 o'clock	00:02:19		M4

83.5	IR	Infiltration Runner at 8 o'clock	00:03:45		M4
	108.1	IR	Infiltration Runner at 3 o'clock	00:06:01	City of Hollywood 24-0052B-	M4
	108.1	IR	Infiltration Runner at 7 o'clock	00:06:34		M4
	113.4	ACB	Catch Basin / DS004691	00:07:19

18" Polyethylene Pipe

Infiltration throughout the pipe at 19 ft, 83.5 ft and 108.1 ft.

**Sectional Liner Repair**
