ATTACHMENT B

Additional Documents

Hollywood Houses – The Work of Architect Charles Reed, Jr.

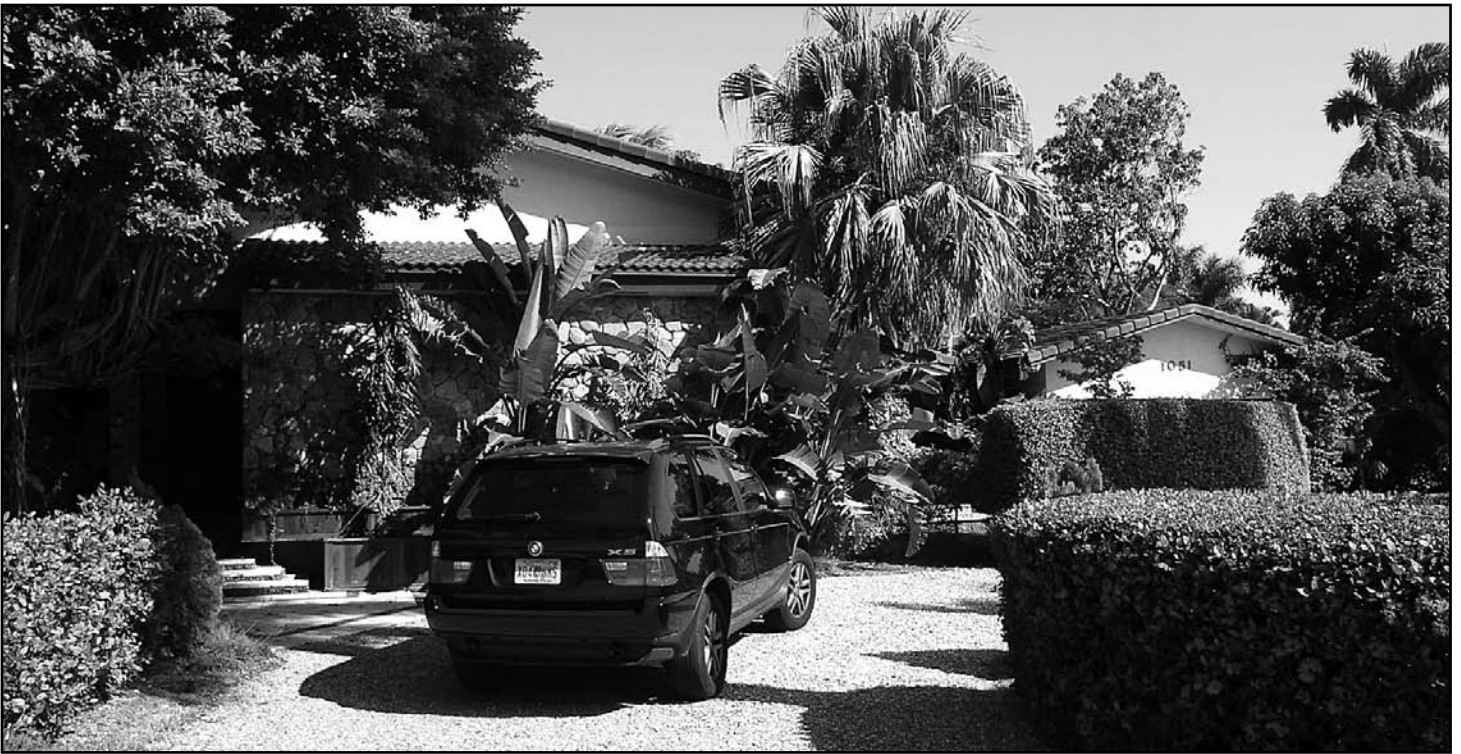
Fig. 22b – Current photo of Ritchie House showing modification inappropriate for the architectural style of the Ritchie House [photo by Louis Friend, 2006]

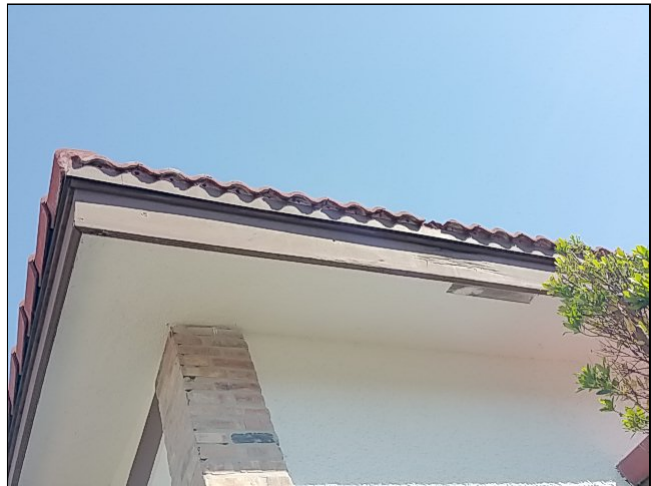
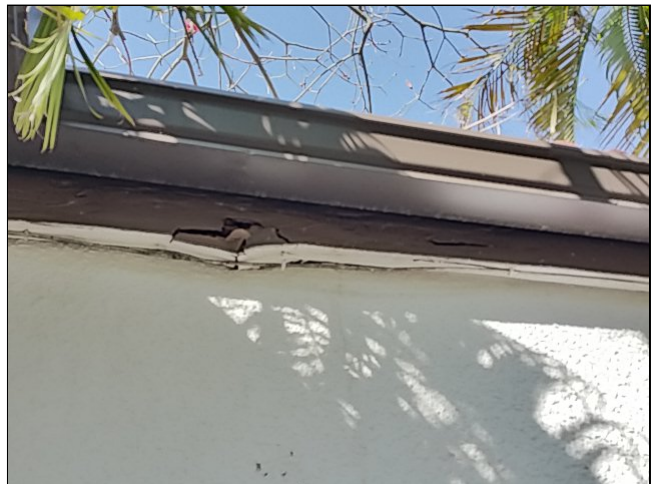
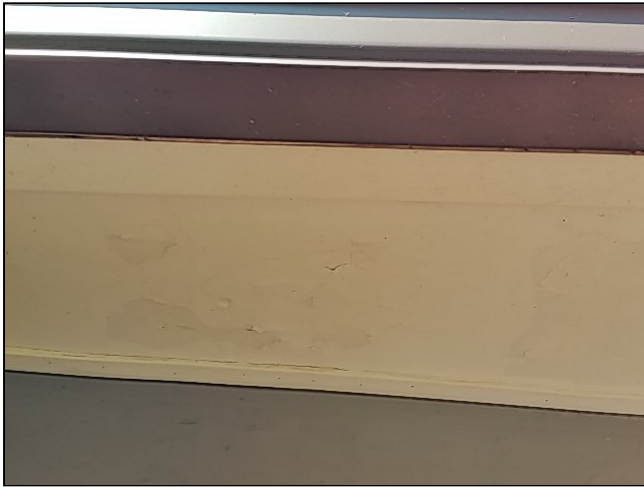
(1) Fascia has termite and wood rot damage in various areas.

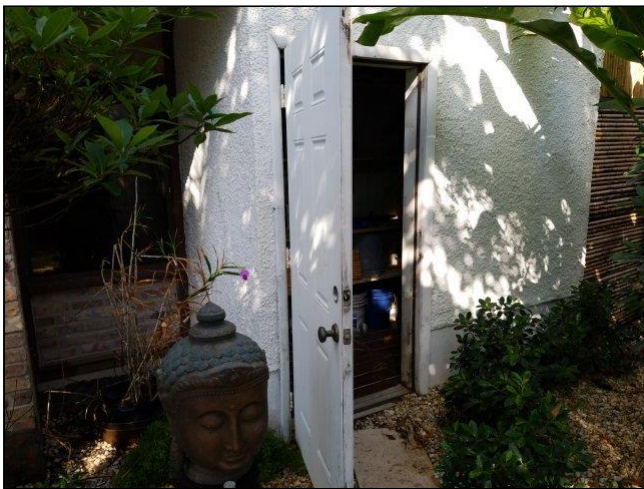
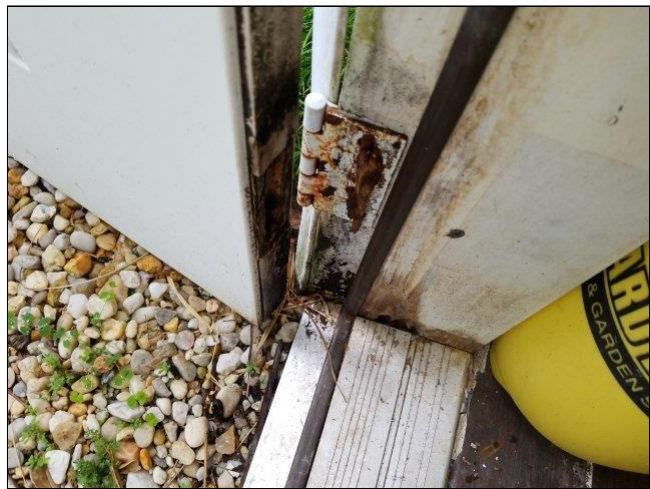
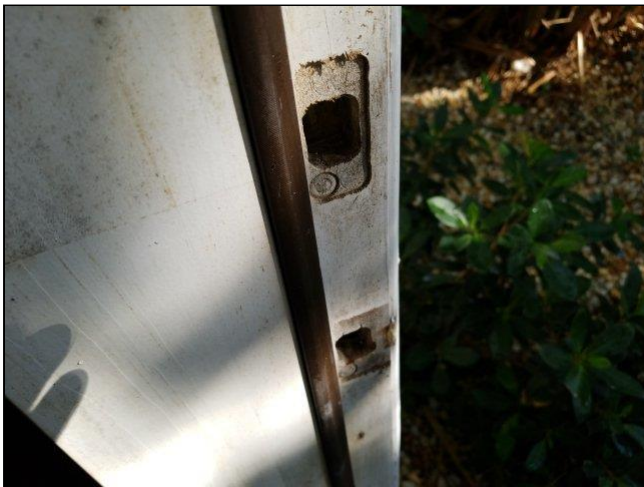
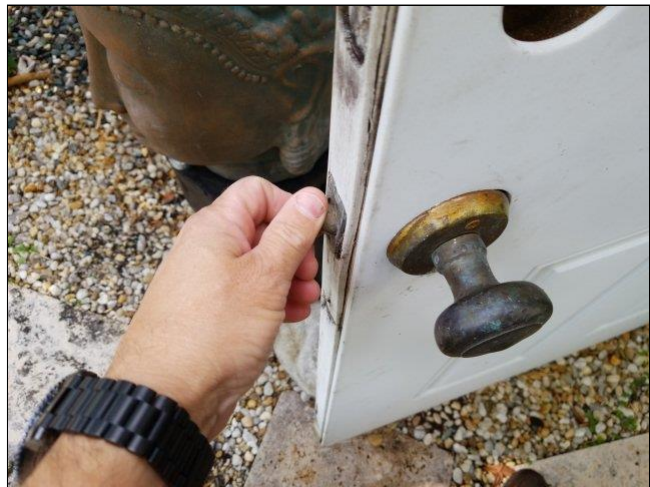
(2) Storage door has water damage, door knob assembly is inoperative and door frame is missing latch plates. Recommend replacing door and frame. \$300 to \$400

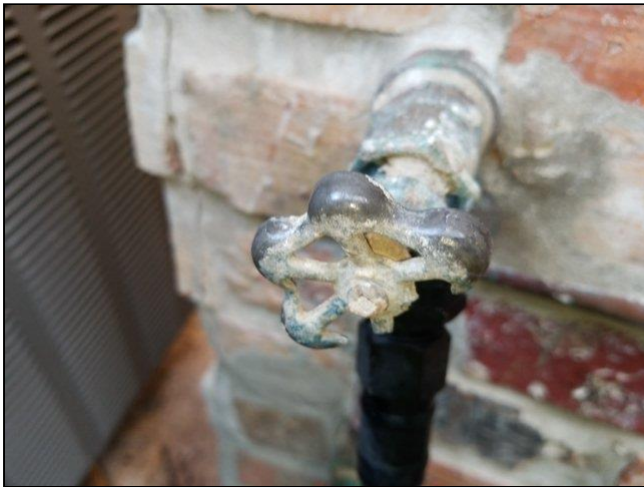
(3) Hose bib knob is damaged. Recommend replacing knob. \$5

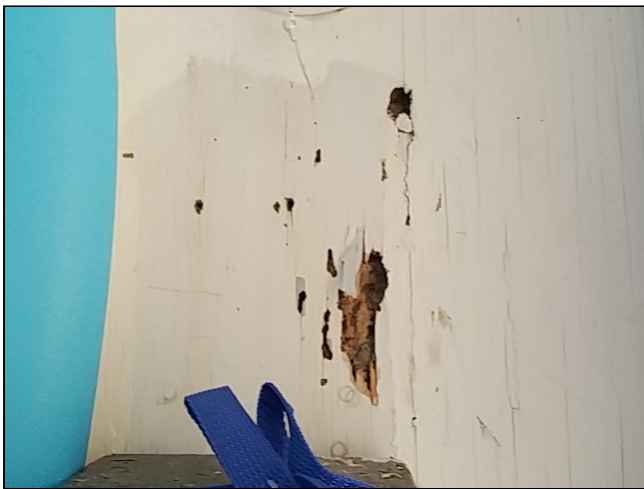
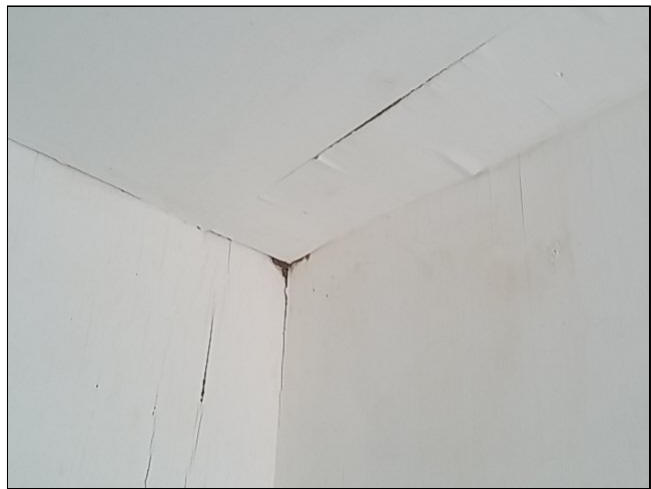
(4) Pool equipment room has mud tubes, evidence of subterranean termites. \$Unknown

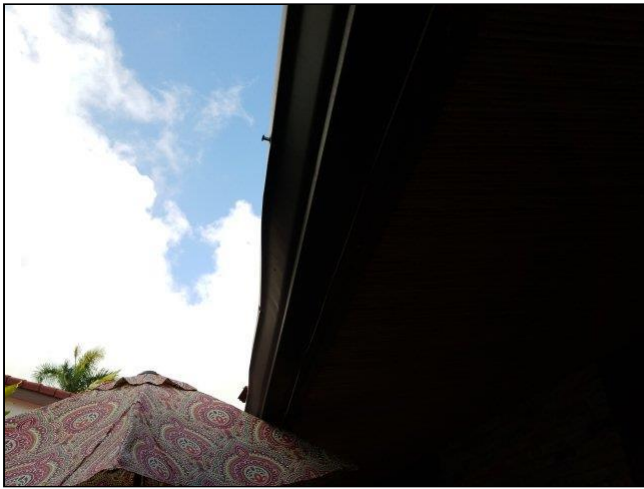
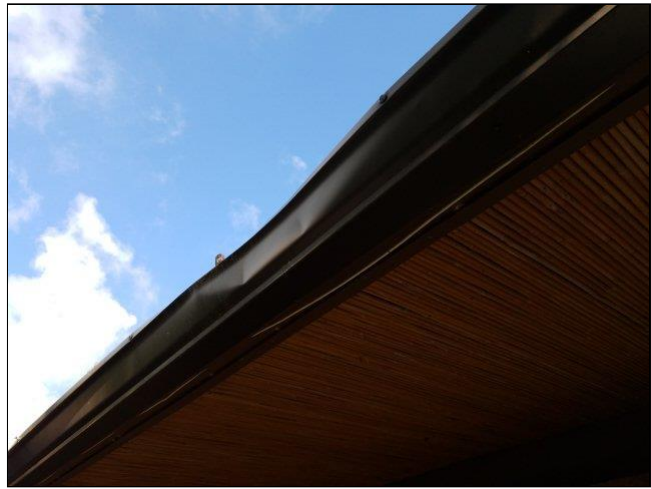
(6) Patio gutter is damaged and loose from fascia board. Recommend repairing gutter. \$200 to \$300

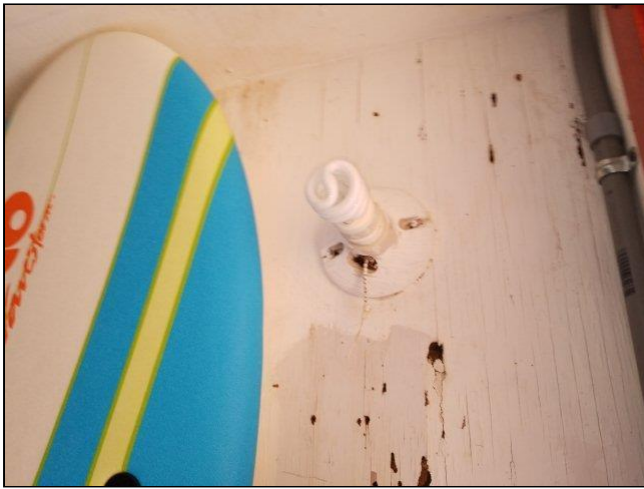
(7) Pool pump shed light fixture is inoperative. Recommend replacing fixture. \$30 to \$50

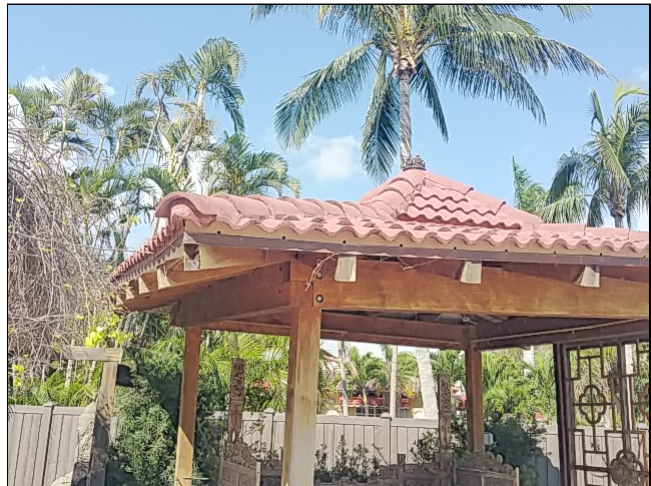
(8) West cabana roof is tilted down, possible subterranean damage. \$Unknown

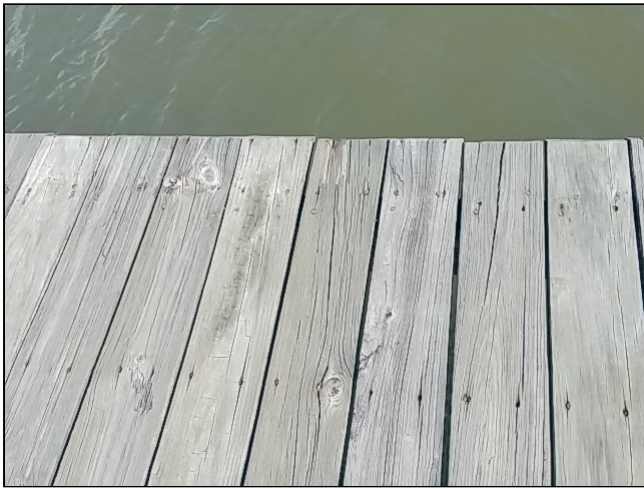
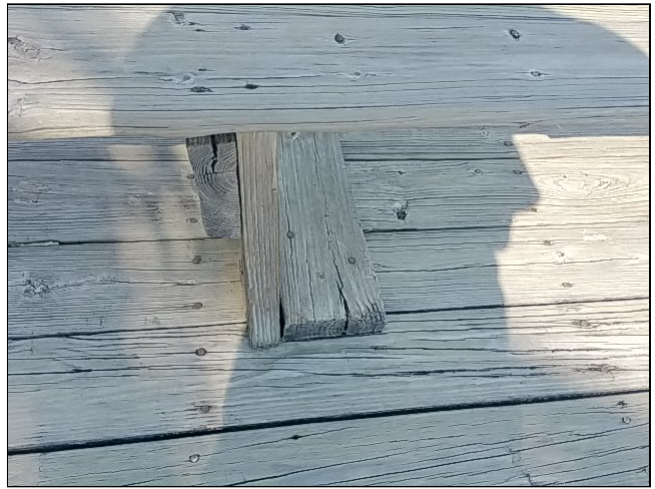
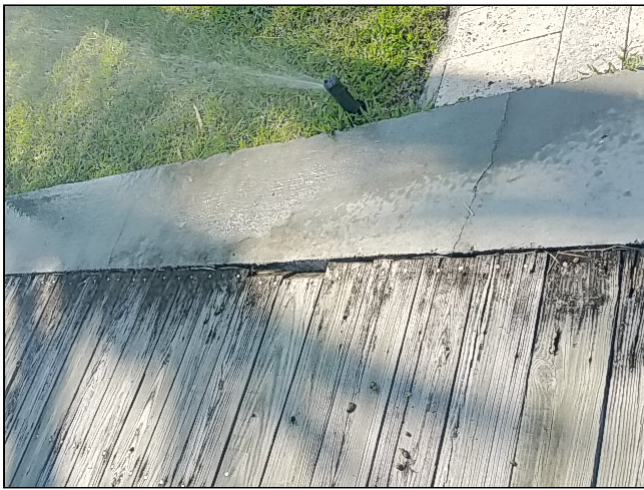
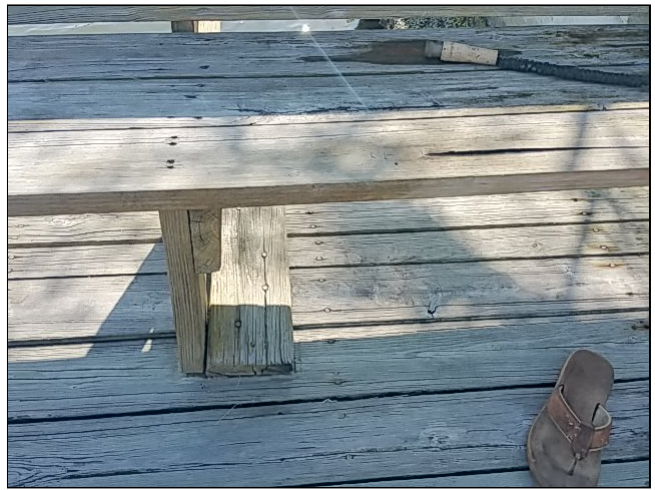
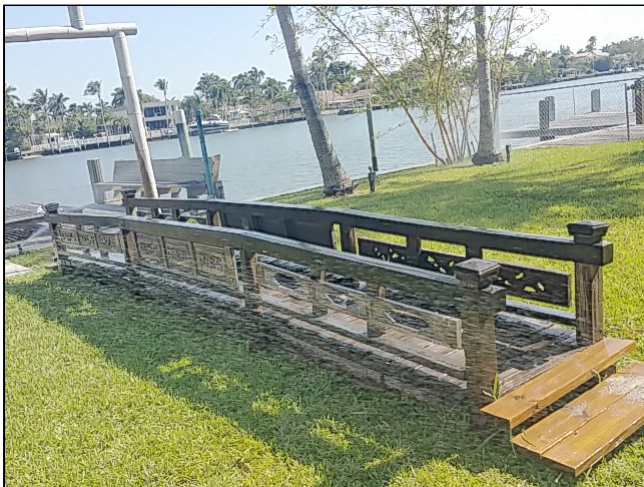
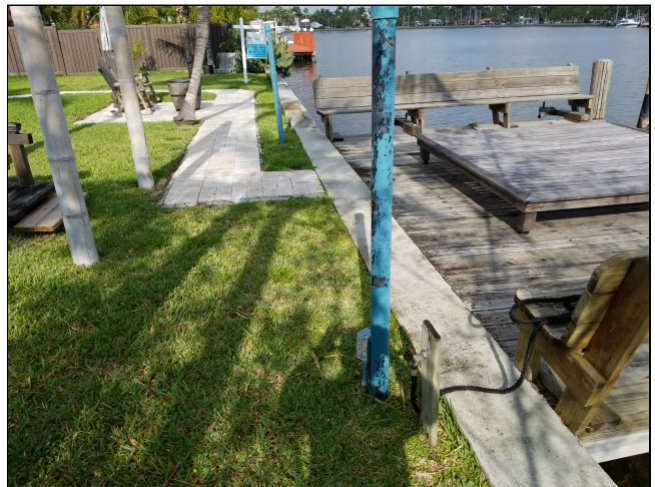
(9) Wood walkway is rotted in various areas. Dock boards are rotted in various area

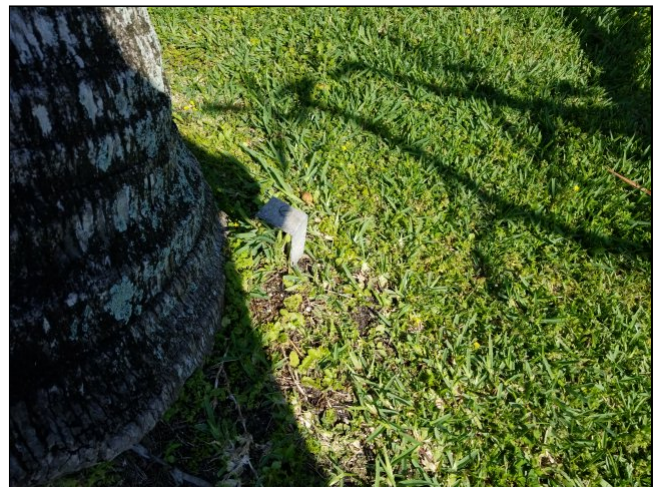
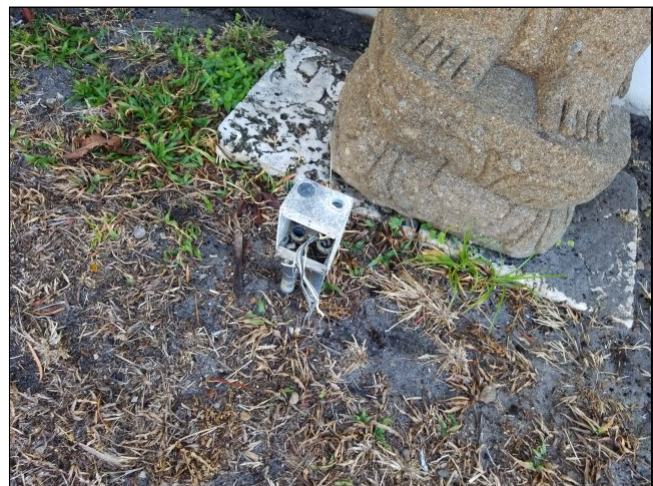
(11) Various electrical junction box throughout property are open with exposed wiring. Recommend a licensed electrician inspect further and repair. \$Unknown

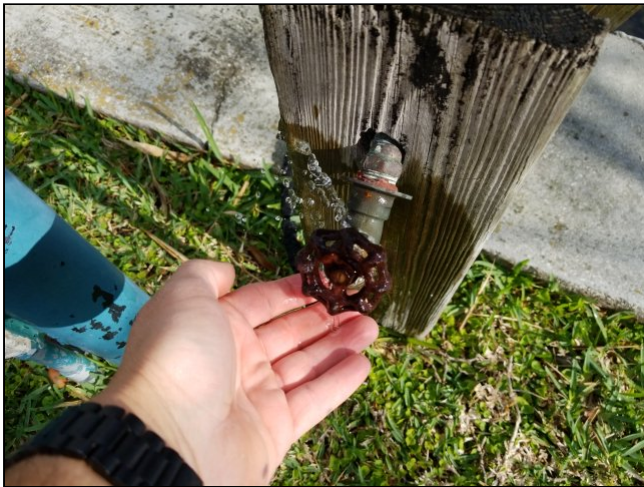
(12) Hose bib leaks when valve is open. Recommend a licensed plumber repair. \$100 to \$120

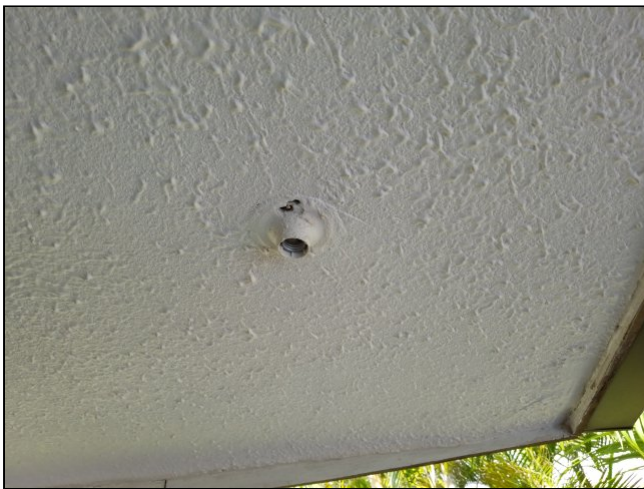
(13) Soffit light fixture is missing bulb. Recommend adding bulb. \$10

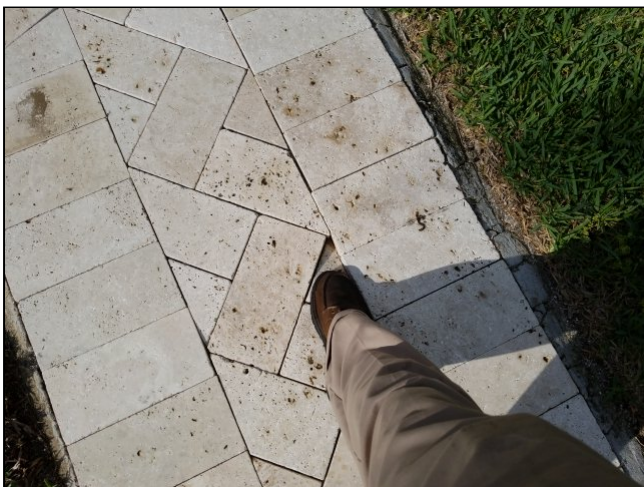
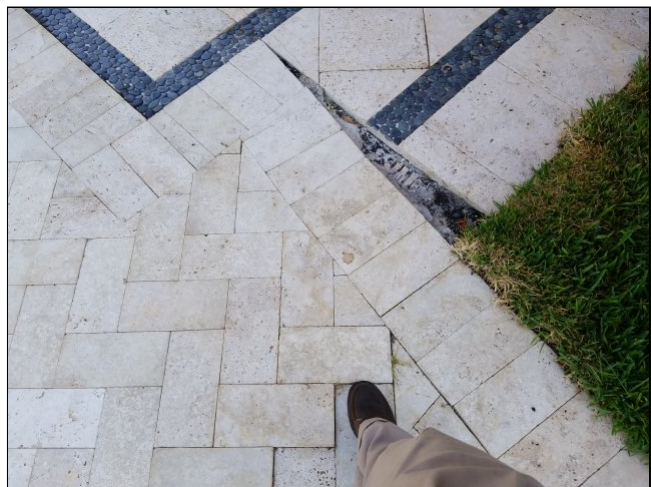
(14) Walkway pavers at different areas throughout home or uneven and is a trip hazard. Recommend leveling off papers. \$200 to \$300

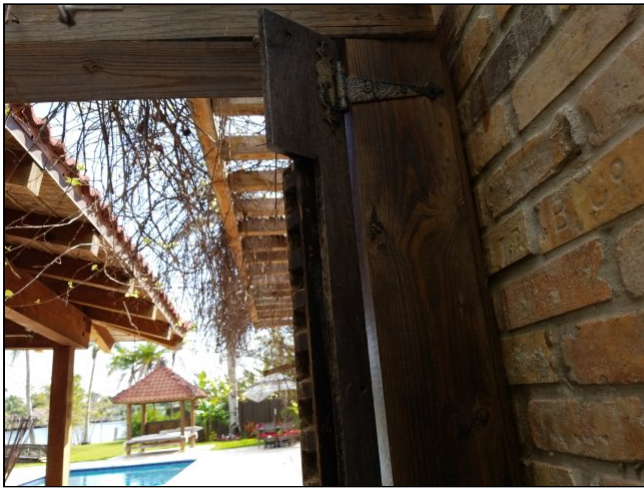
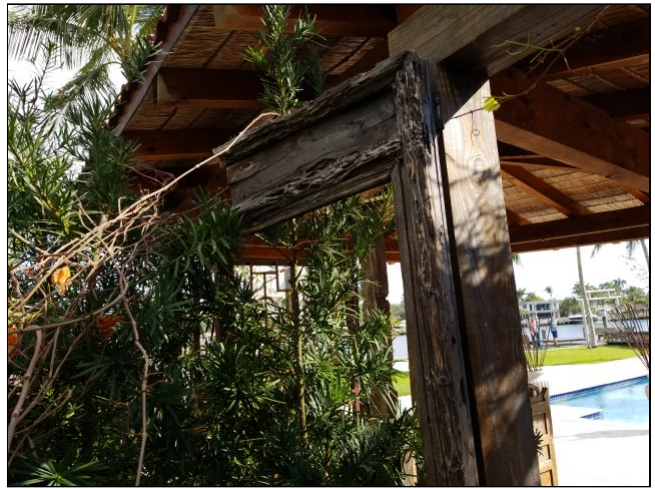
(15) Decorative wood door by jacuzzi are damage and no longer operational. Recommend replacing doors. \$Unknown

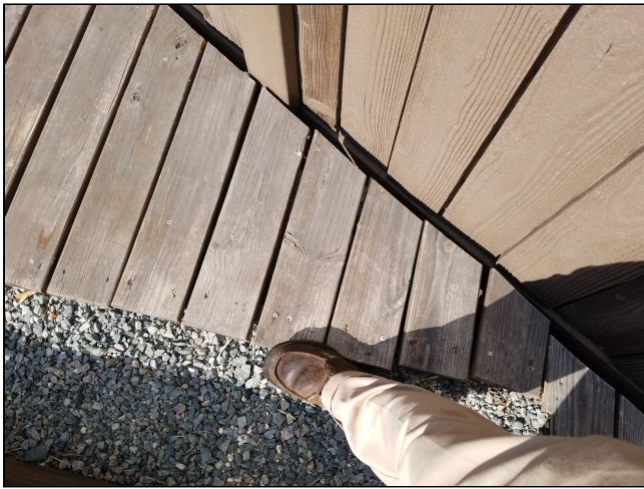
(16) Wood deck by jacuzzi has various loose boards. Recommend securing boards.

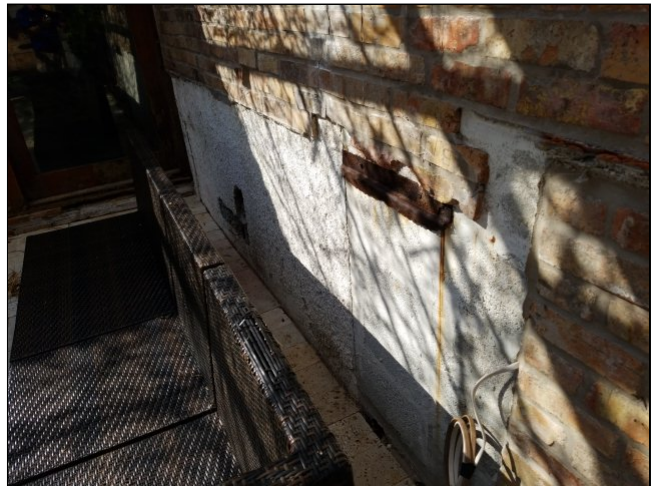
(17) Parapet wall has a settlement crack. Recommended license contractor inspect further. \$Unknown

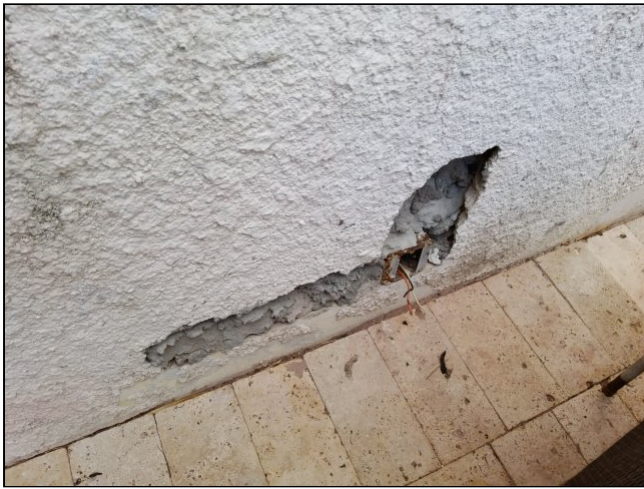
(18) Open junction box with exposed wiring and wall is unfinished.

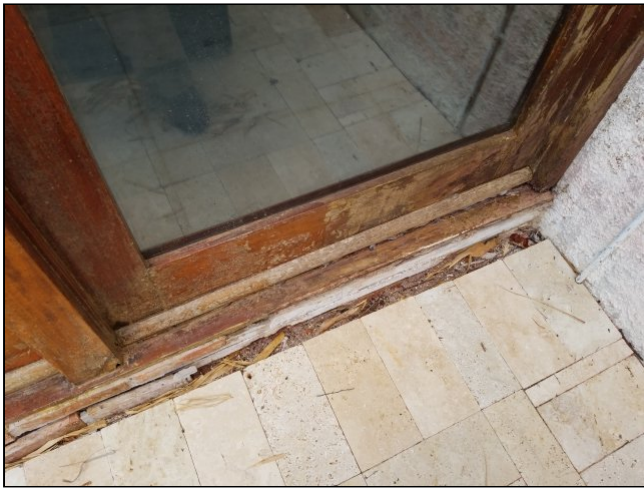
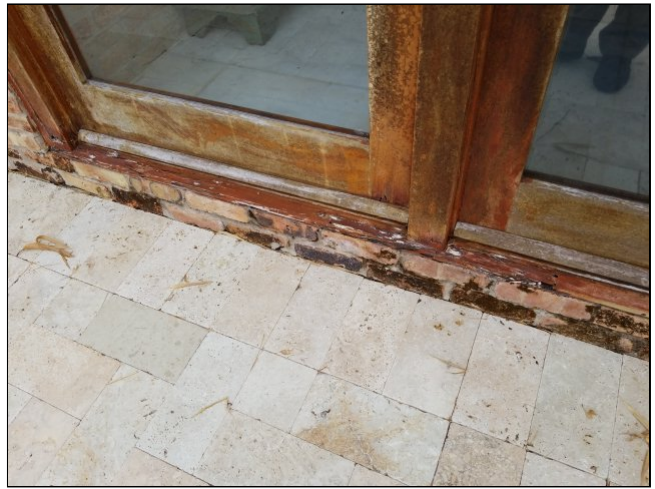
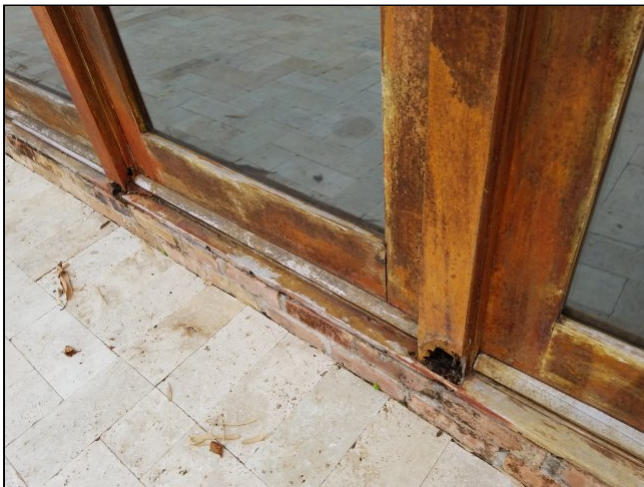
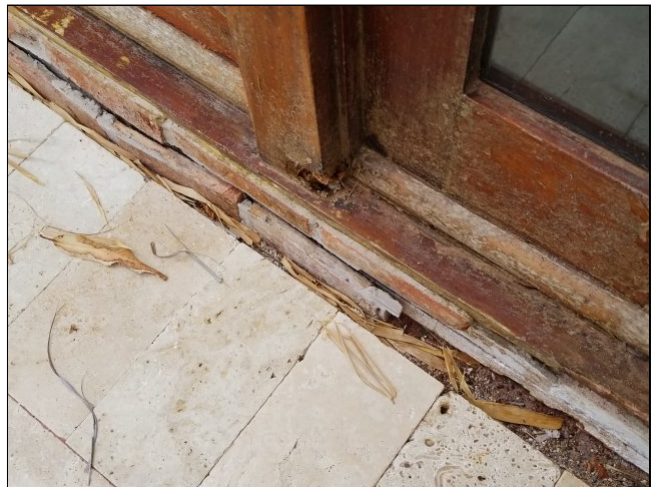
(19) Patio rear door frames has water damage. Recommend replacing bank of doors. \$Unknown

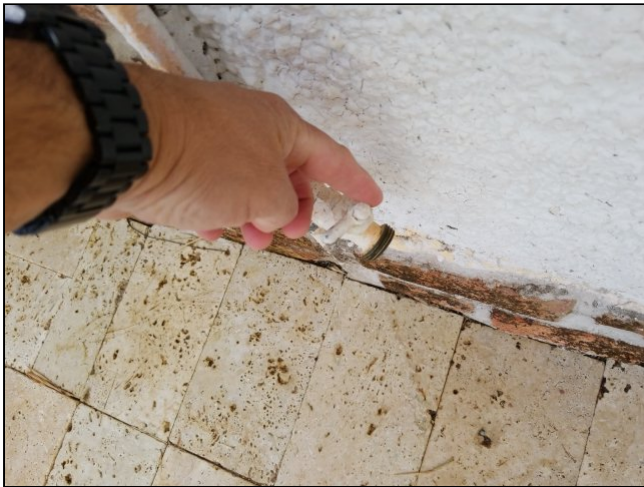
(20) Hose bib has a damaged knob. Recommend replacing knob.

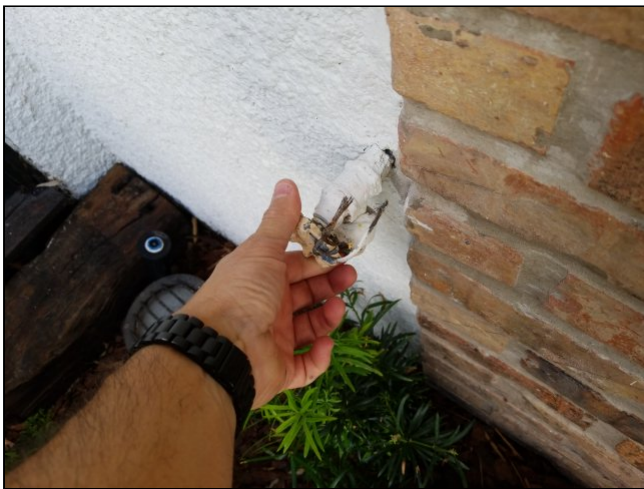
(21) Hose bib by front door has no water pressure. Recommend a license plumber repair. \$120 to \$Unknown

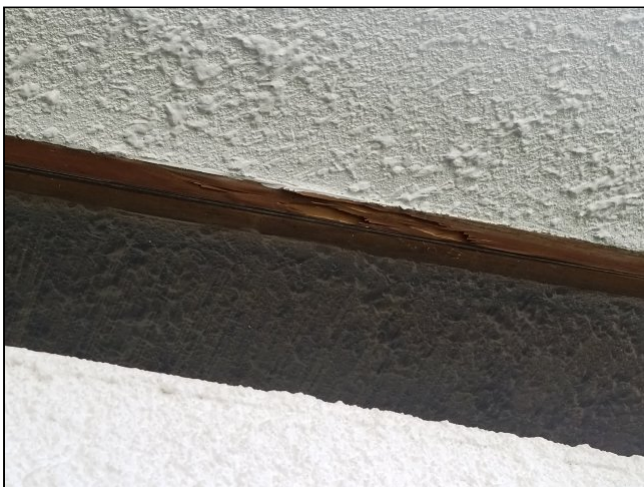
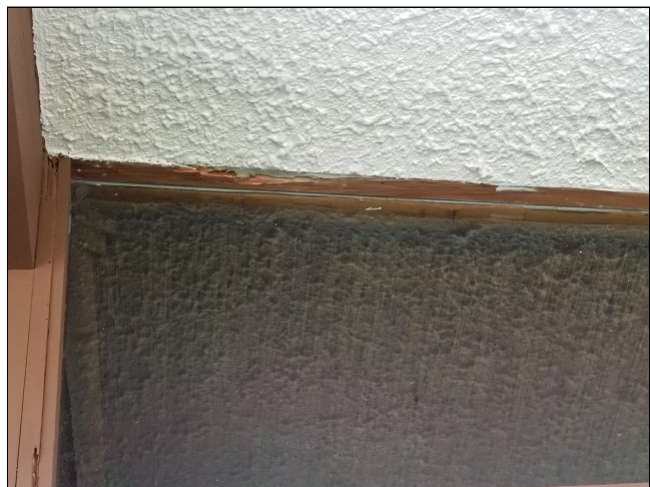
(22) Custom made wood window frames have termite damage at various areas. Recommend fumigation for drywood termite if home is not under a current warranty. Estimate cost to fumigate \$3200 to \$3600

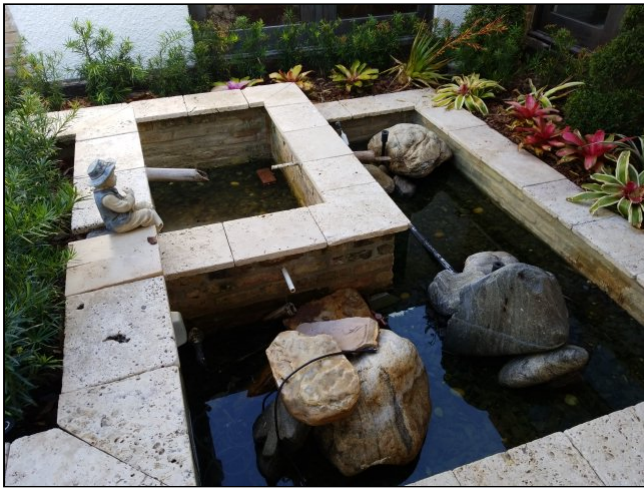
(23) Front door fountain is inoperative at time of inspection. \$Unknown

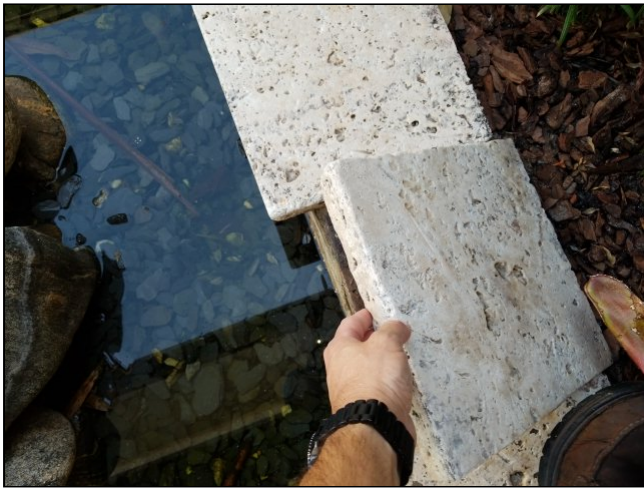
(24) Various loose fountain coping tiles. Recommend securing tiles. \$200 to \$300

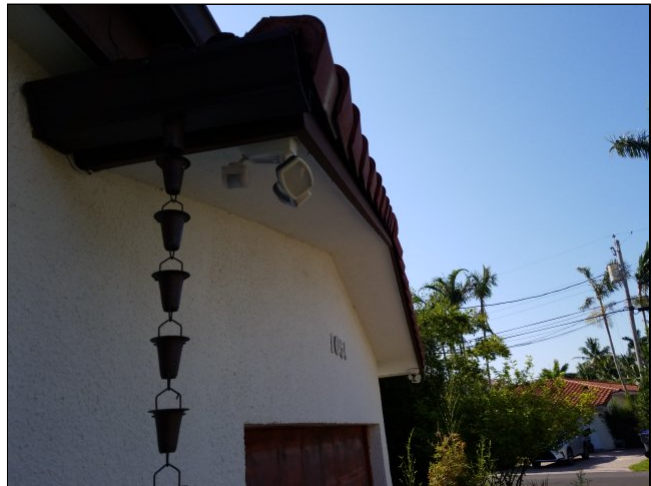
(25) Flood light fixtures are inoperative at time of inspection. Fixtures are on motion/light sensors.

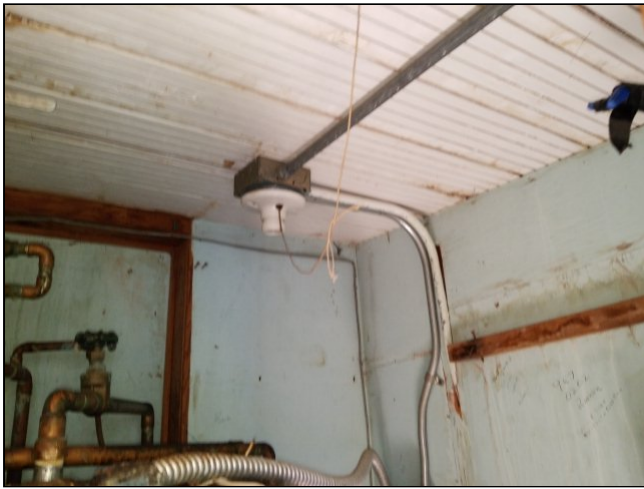
(26) Water heater closet light fixture is missing bulb

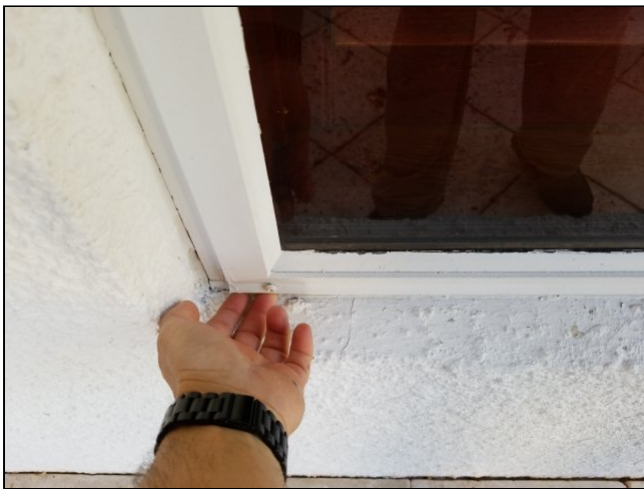
(27) Various awning windows are screw down and can not be opened.

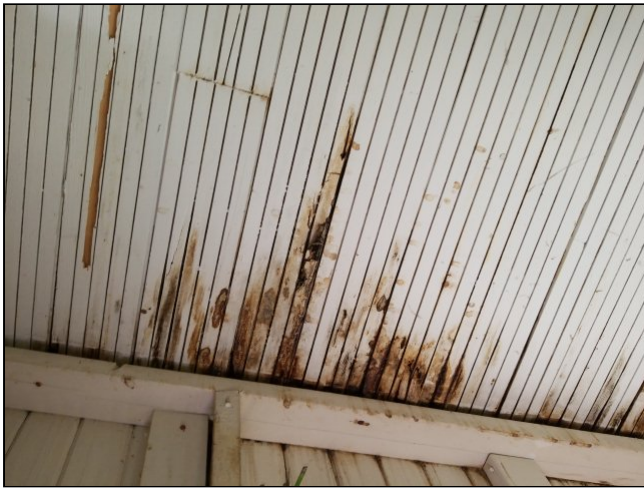
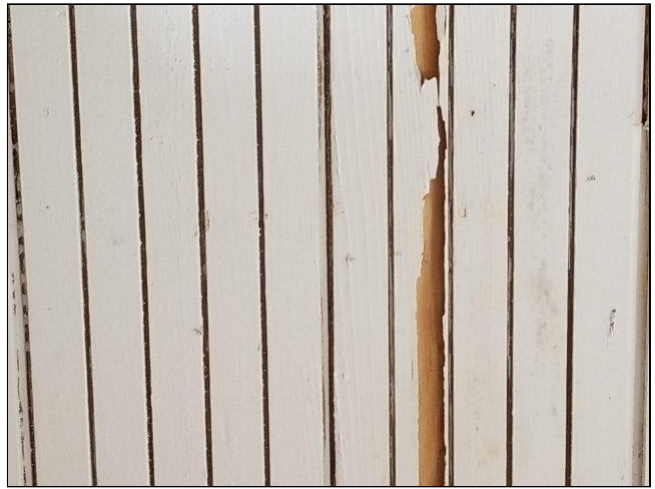
(29) Storage closet wood ceiling has water stains and termite damage.

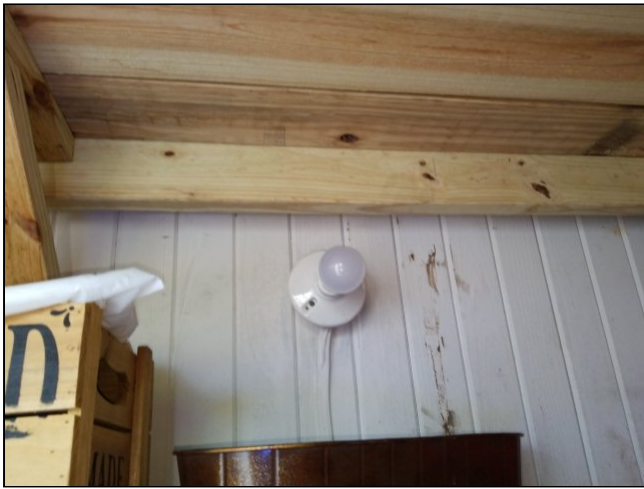
(30) Storage wall fixtures is inoperative. \$5

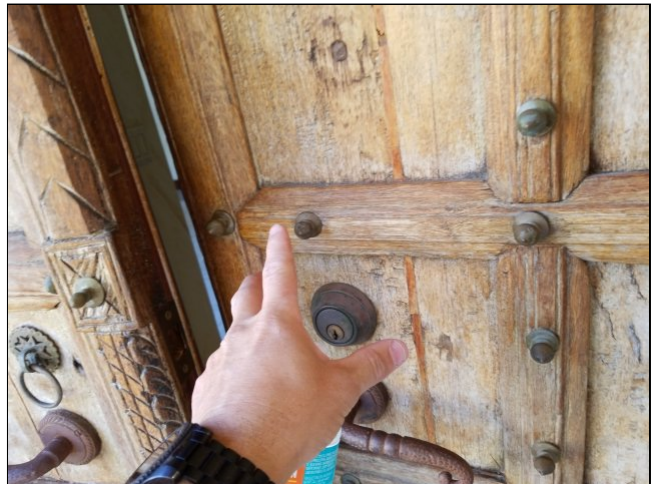
(34) Front door rubs against tile flooring and door does not remain open.

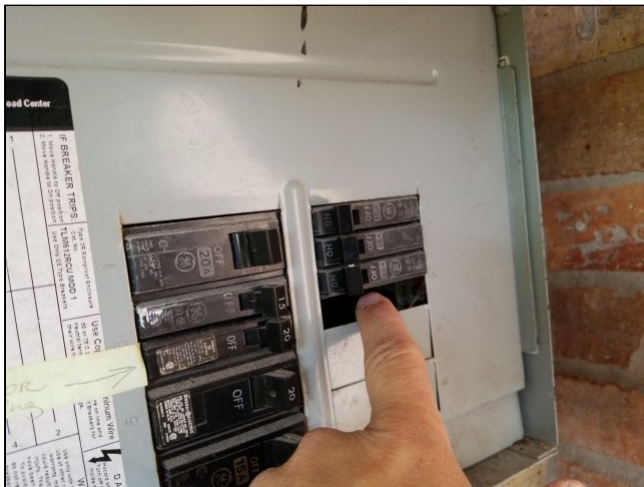
Open breaker slot. Recommend adding cover

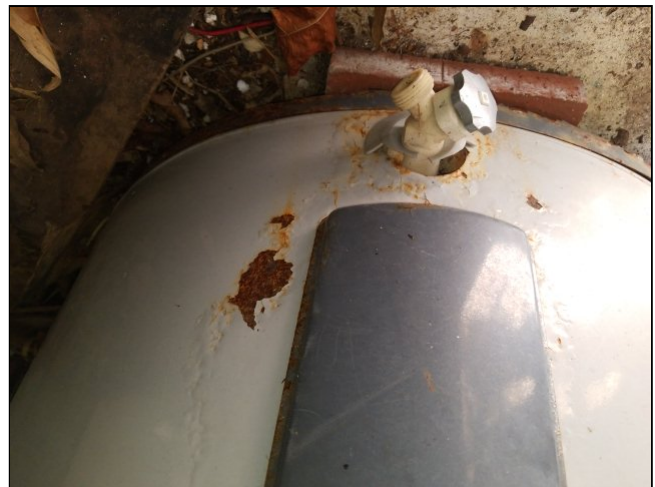
Water heater housing is rusted. No evidence of moisture at time of inspection.

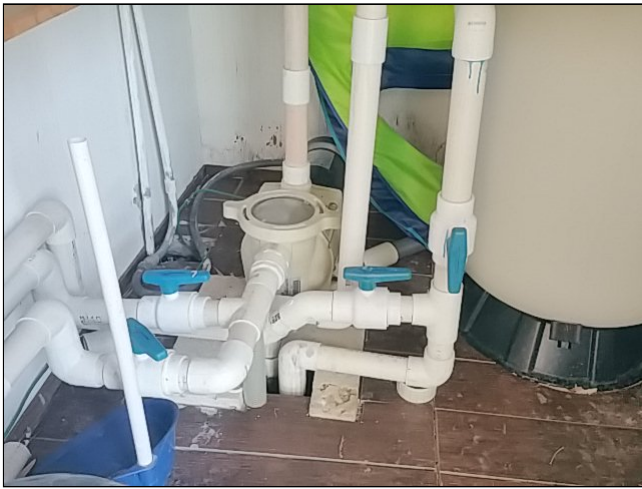
Pool equipment room floor tile is blocking all pipes into ground if they were in need of repair.

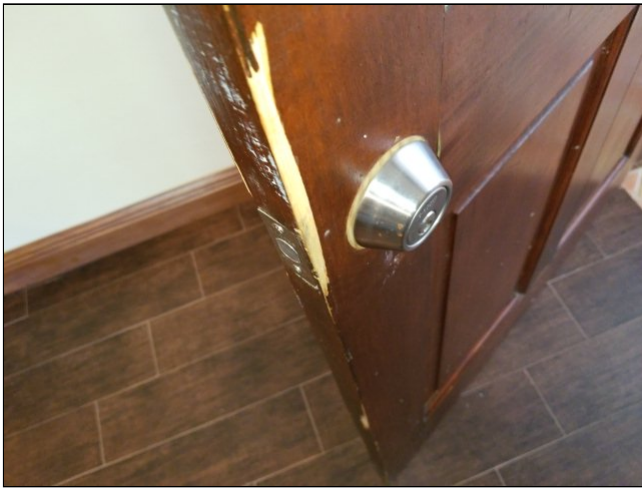
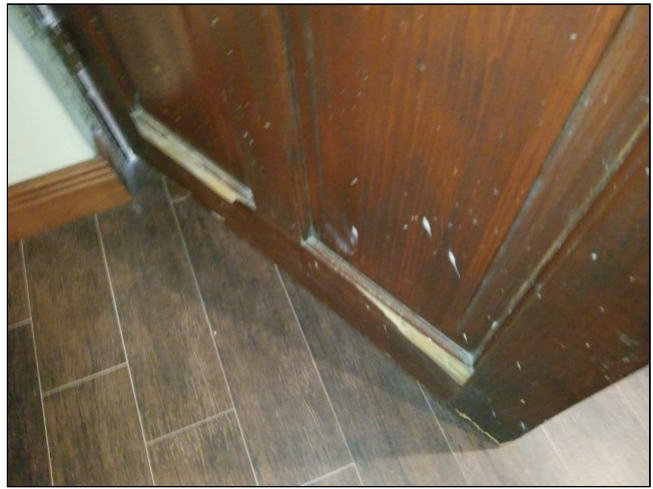
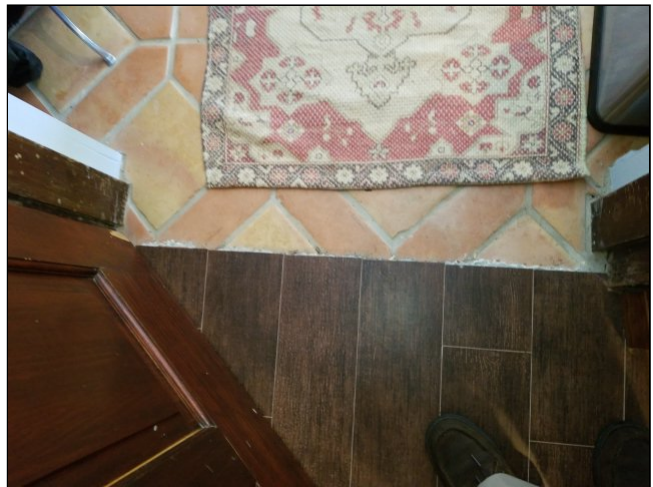
(1) Door to garage wood veneer is peeling.

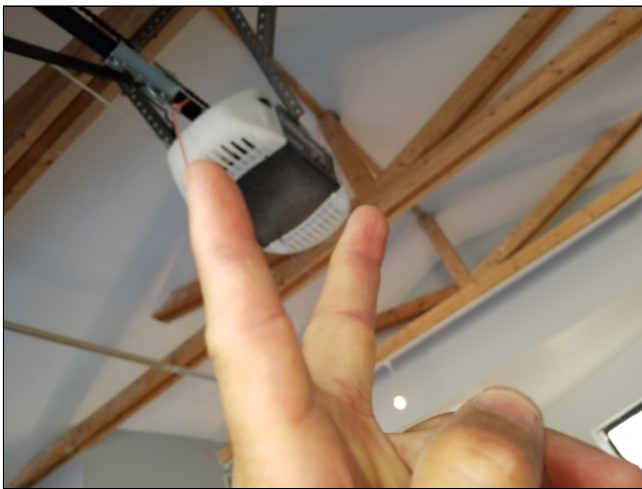
(4) Overhead garage door opener has 2 inoperative bulbs.
