**CITY OF HOLLYWOOD, FLORIDA  
DEPARTMENT OF DEVELOPMENT SERVICES  
PLANNING DIVISION**

**SUBJECT:** Vacation Homes Invest, LLC requests a Certificate of Appropriateness for Demolition of one single-family home and a Certificate of Appropriateness for Design for three single-family homes located at 958 Jefferson Street within the Lakes Area Historic Multiple Resource Listing District.

# *Home Inspection Report*

*958 Jefferson Street, Hollywood Fl. 33019*

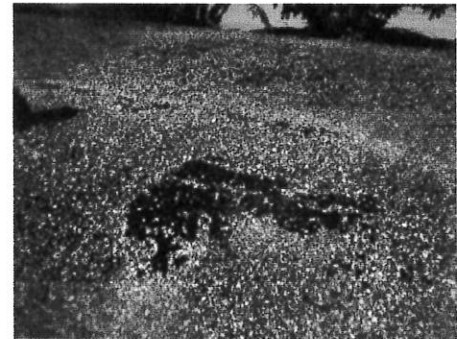
1. Various areas of the tar and gravel roof is missing slurry. Correct as necessary.
2. The roof is improperly flashed at various vent stacks Properly flash the roof.
3. The roof is leaking at the patio east beam end area.(10 foot long leak)Recommend repairs by a licensed roofing contractor.

**Photo # 1**      MISSING ROOF GRAVEL(SLURRY)

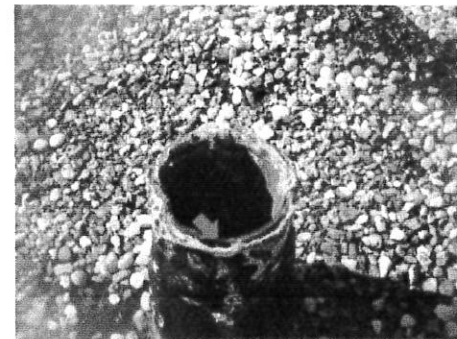
**Photo # 2**      IMPROPERLY FLASHED ROOF.

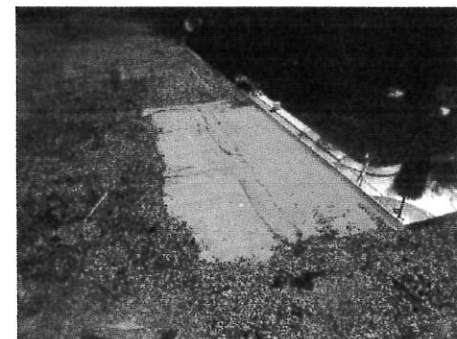
**Photo # 3**      FLAT ROOF REPAIR.

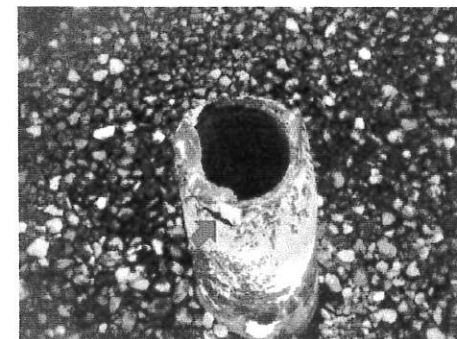
**Photo # 4**      IMPROPERLY FLASHED ROOF.

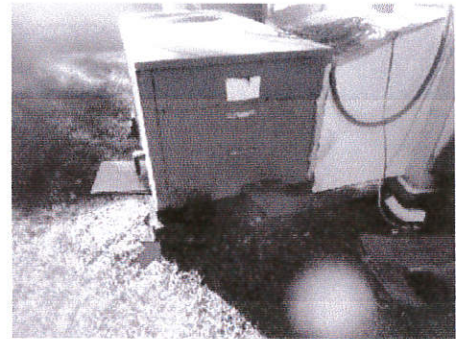
**Photo # 5**                      IMPROPERLY SUPPORTED AC SYSTEM.

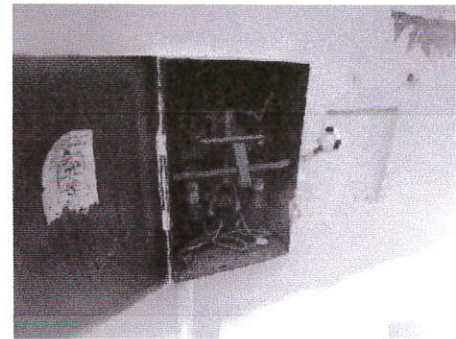
**Photo # 6**                      FUSE SUB PANEL.

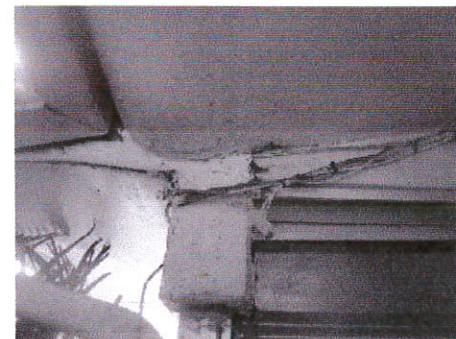
**Photo #7**                      EVIDENCE OF ROOF LEAK.

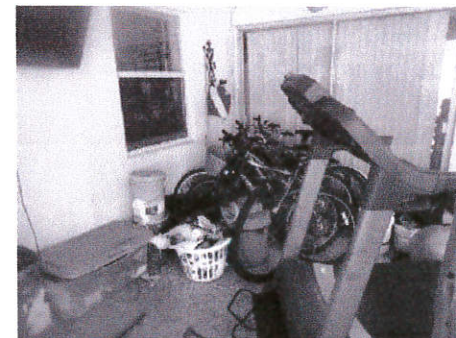
**Photo #8**                      OBSTRUCTIONS WERE PRESENT  
THROUGHOUT.

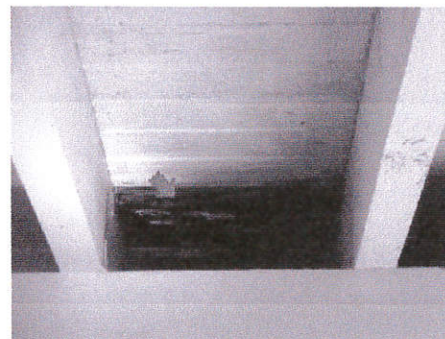
The roof sheathing is deteriorated at the rear flat roof leak(as per Wood Destroying Organisms Report). Recommend repairing or replacing the affected areas.

**Photo #9** DETERIORATED SHEATHING AT ROOF LEAK.

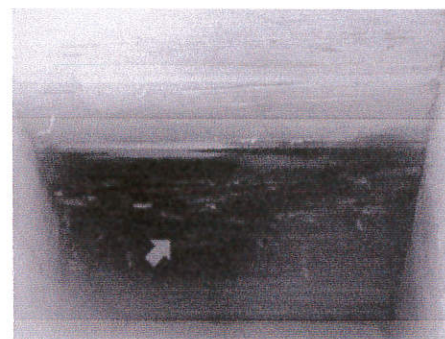
**Photo #10** DETERIORATED SHEATHING AT ROOF LEAK.

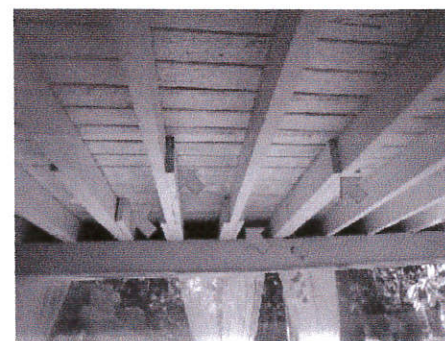
**Photo #11** REPAIRS TO ROOF RAFTERS.

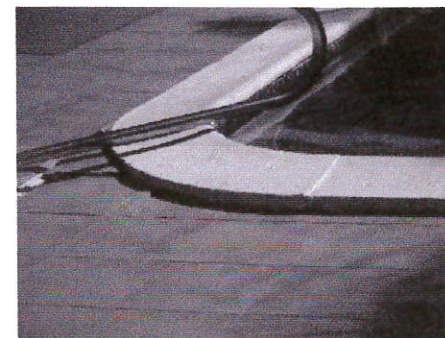
**Photo #12** SETTLEMENT AT POOL DECK.

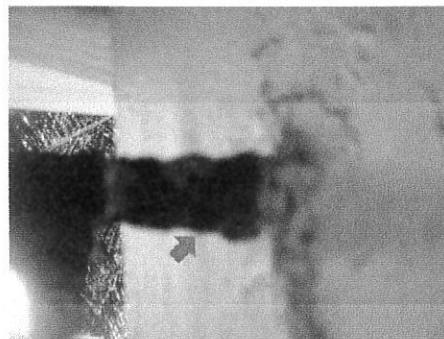
**Photo #13** DETERIORATED WATER SUPPLY LINES.

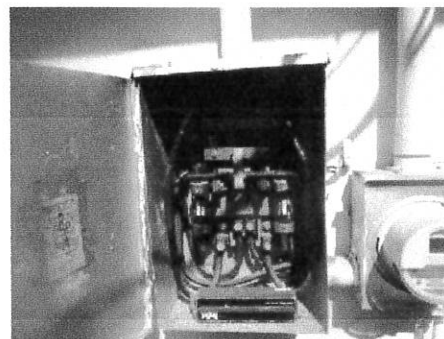
**Photo #14** VIEW OF MAIN PANEL.

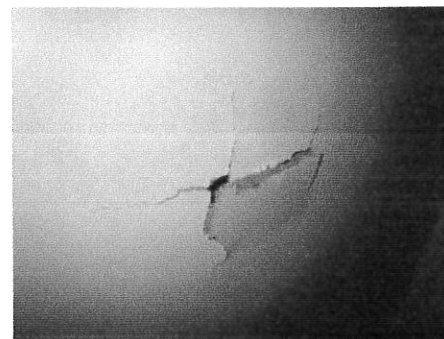
**Photo #15** DAMAGED DOOR.

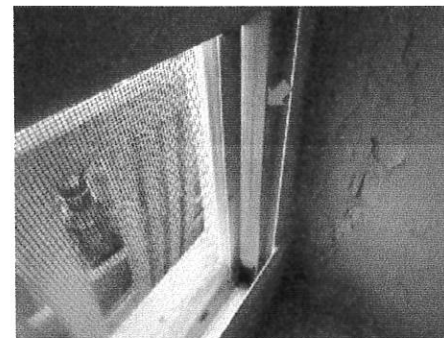
**Photo #16** BROKEN BALANCE ROD.

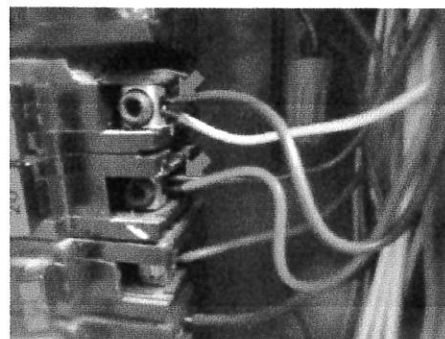
**Photo #17**      DOUBLE TAPPED BREAKERS.

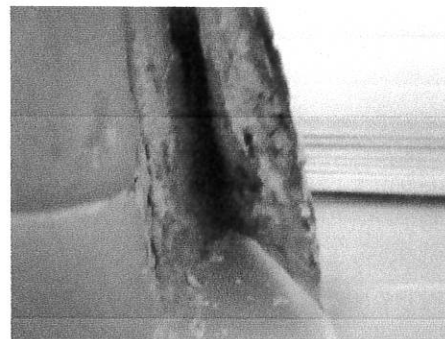
**Photo #18**      SUSPECT MOLD.

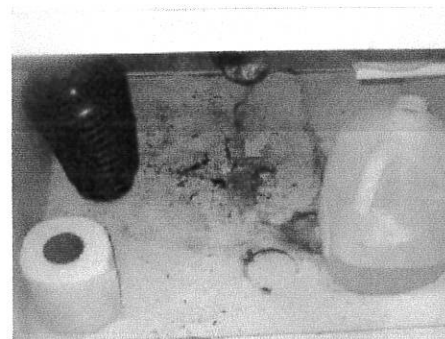
**Photo #19**      DAMAGED VANITY DUE TO DRAIN LEAK.

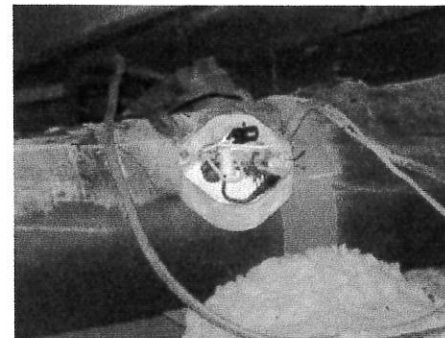
**Photo #20**      SPLICES IN ATTIC.

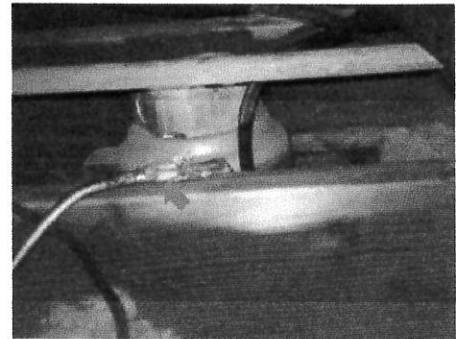
10. Worn cloth insulation was present at the attic wiring. Replace the affected areas.

**Photo #21**      WORN CLOTH WIRING INSULATION.

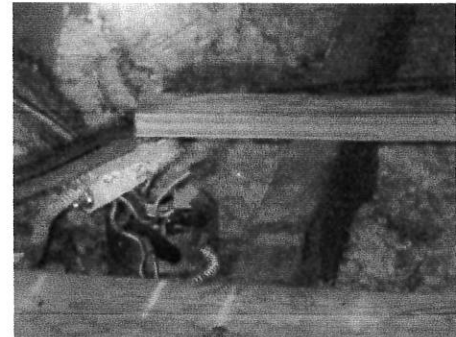
**Photo #22**      SPLICES IN ATTIC.
