**CITY OF HOLLYWOOD, FLORIDA  
DEPARTMENT OF DEVELOPMENT SERVICES  
PLANNING DIVISION**

**SUBJECT:** Vacation Homes Invest, LLC requests a Certificate of Appropriateness for Demolition of one single-family home and a Certificate of Appropriateness for Design for three single-family homes located at 958 Jefferson Street within the Lakes Area Historic Multiple Resource Listing District.

# *Home Inspection Report*

*958 Jefferson Street, Hollywood Fl. 33019*

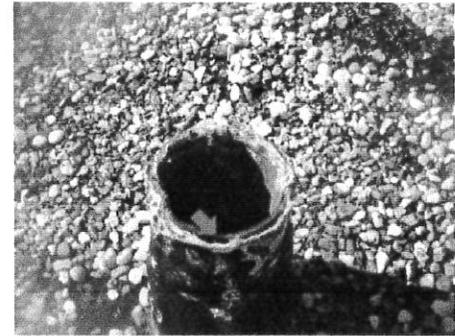
**Photo # 2**            IMPROPERLY FLASHED ROOF.

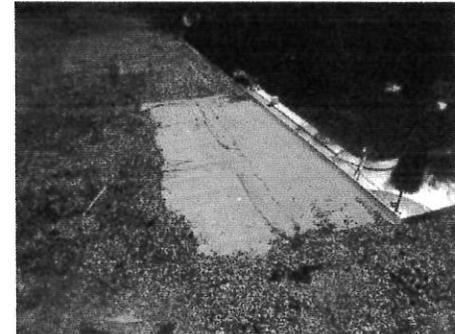
**Photo # 3**            FLAT ROOF REPAIR.

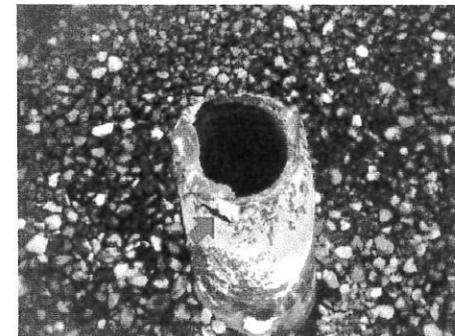
**Photo # 4**            IMPROPERLY FLASHED ROOF.

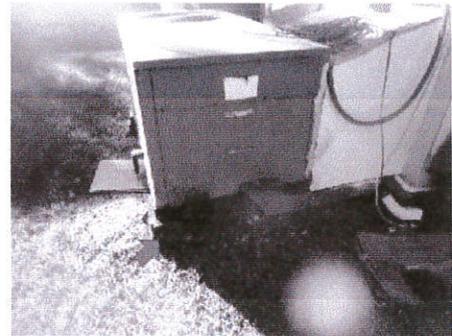
**Photo # 5** IMPROPERLY SUPPORTED AC SYSTEM.

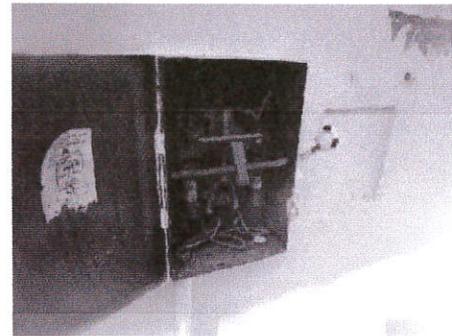
**Photo # 6** FUSE SUB PANEL.

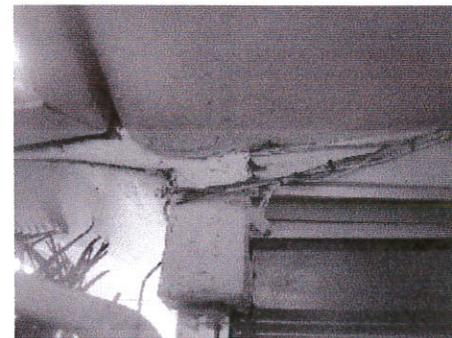
**Photo #7** EVIDENCE OF ROOF LEAK.

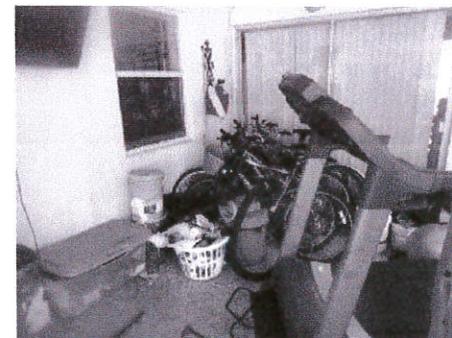
**Photo #8** OBSTRUCTIONS WERE PRESENT THROUGHOUT.

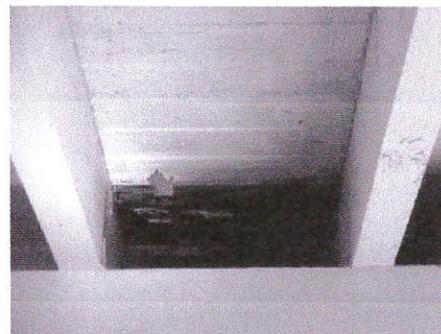
**Photo #9** DETERIORATED SHEATHING AT ROOF LEAK.

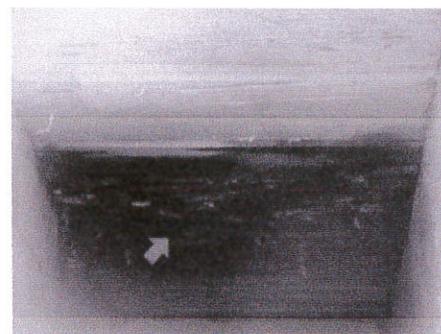
**Photo #10** DETERIORATED SHEATHING AT ROOF LEAK.

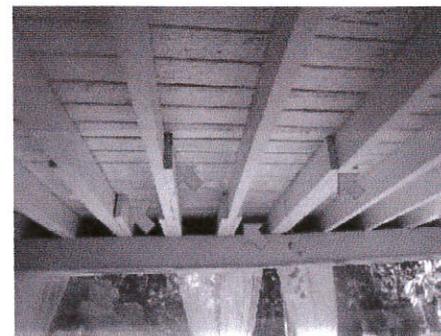
**Photo #11** REPAIRS TO ROOF RAFTERS.

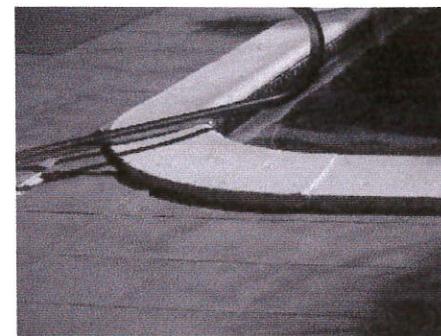
**Photo #12** SETTLEMENT AT POOL DECK.

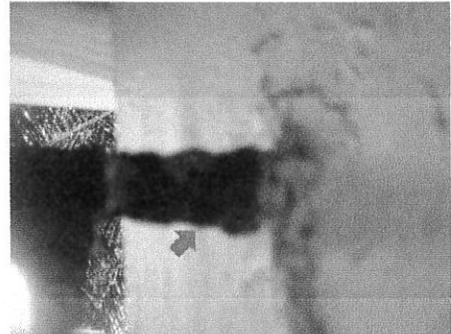
**Photo #13** DETERIORATED WATER SUPPLY LINES.

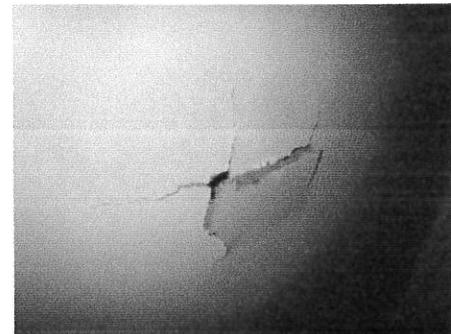
**Photo #15** DAMAGED DOOR.

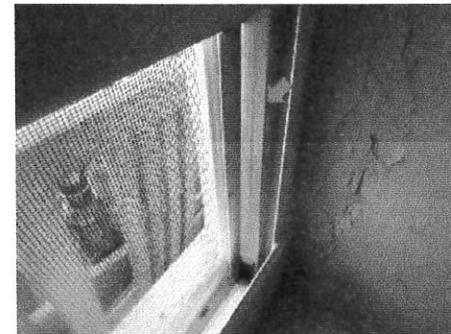
**Photo #16** BROKEN BALANCE ROD.

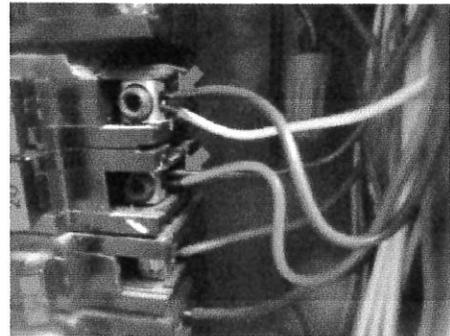
**Photo #17**      DOUBLE TAPPED BREAKERS.

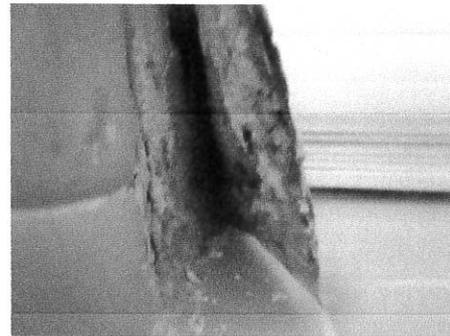
**Photo #18**      SUSPECT MOLD.

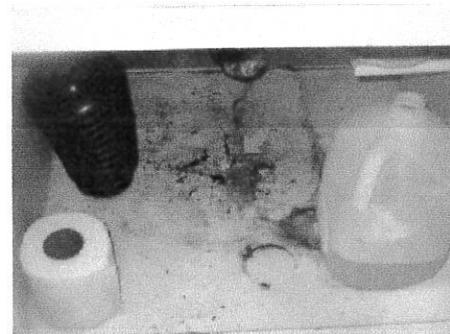
**Photo #19**      DAMAGED VANITY DUE TO DRAIN LEAK.

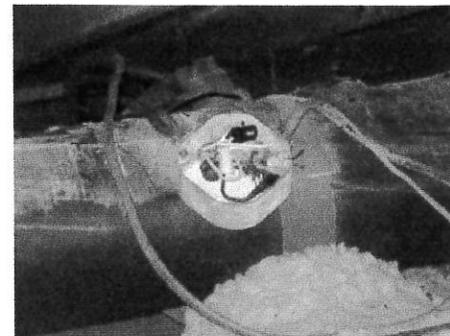
**Photo #20**      SPLICES IN ATTIC.

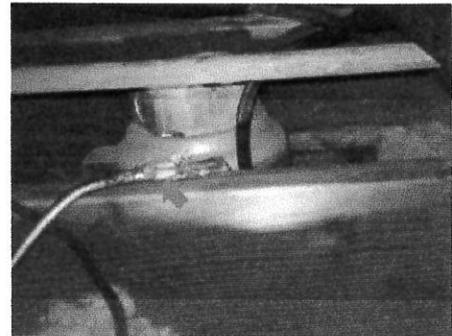
**Photo #21** WORN CLOTH WIRING INSULATION.

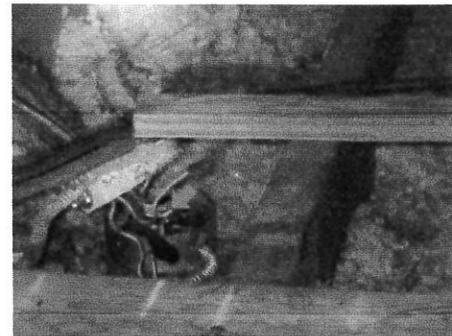
**Photo #22** SPLICES IN ATTIC.
