Structural Report for 2001 Hollywood Blvd.

December 09, 2019

Subject: Sun Trust Office Building
2001 Hollywood Blvd,
Hollywood, FL 33020

Structural Report

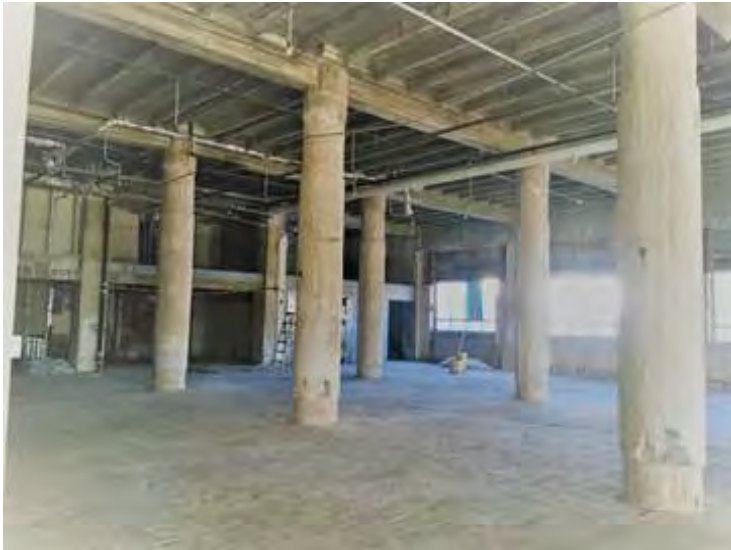
Photo #: 1

Ground floor columns at bank area.

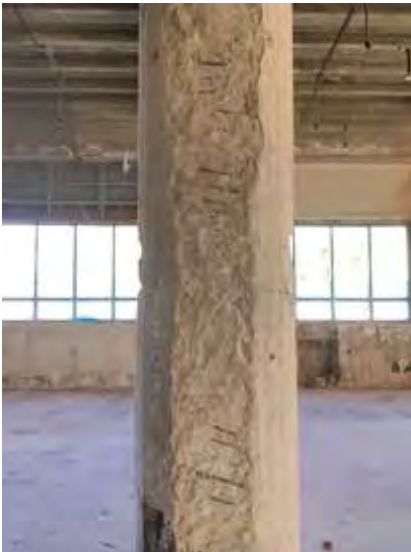
Photo #: 2

Ground floor columns at bank area:

Exposed column spiral reinforcing / loop ties.

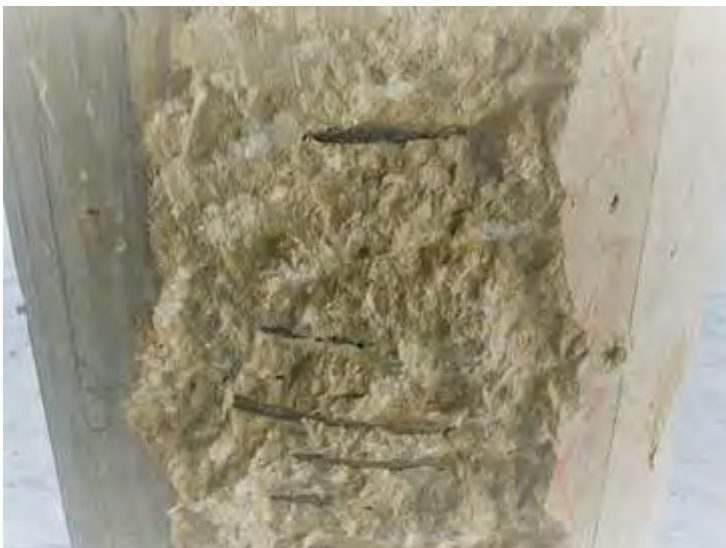
Photo #: 3

Ground floor columns at bank area:

Exposed column spiral reinforcing / loop ties.

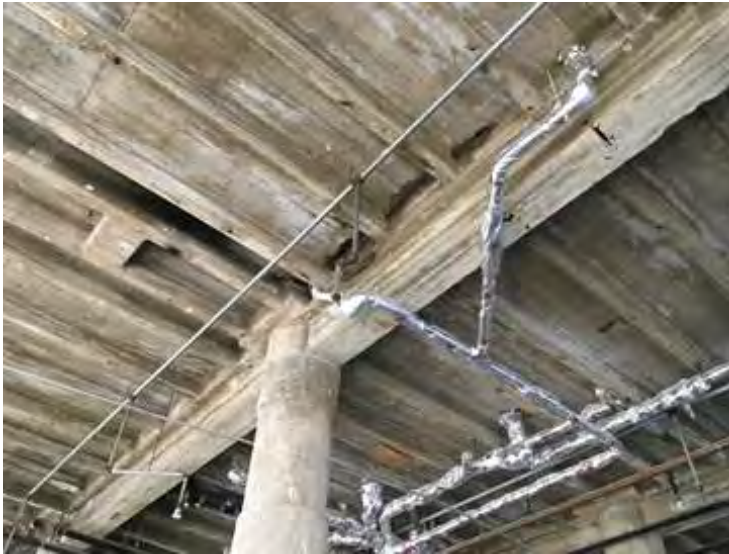
Photo #: 4

Second floor slab underside.
(viewed from ground floor bank area):

Deteriorated concrete slab shows signs of leakage, chipped concrete, voids in concrete, unsealed penetrations.

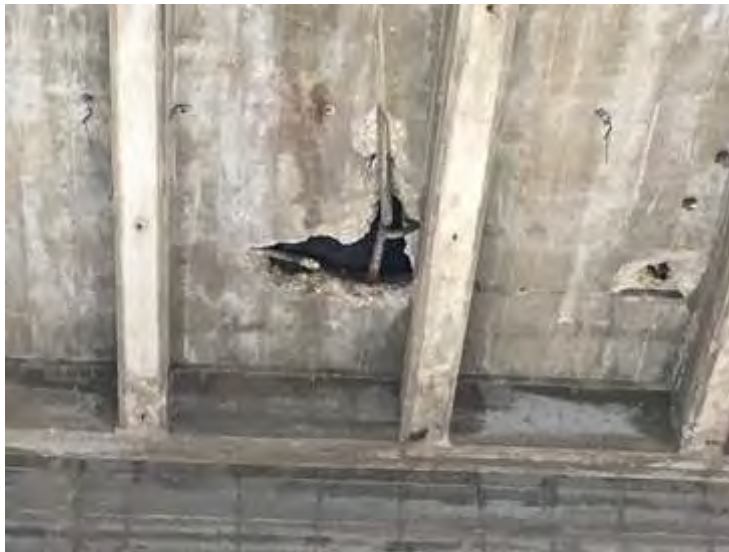
Photo #: 5

Second floor slab underside.
(viewed from ground floor bank area):

Deteriorated concrete slab shows signs of leakage, chipped concrete, voids in concrete, unsealed penetrations.

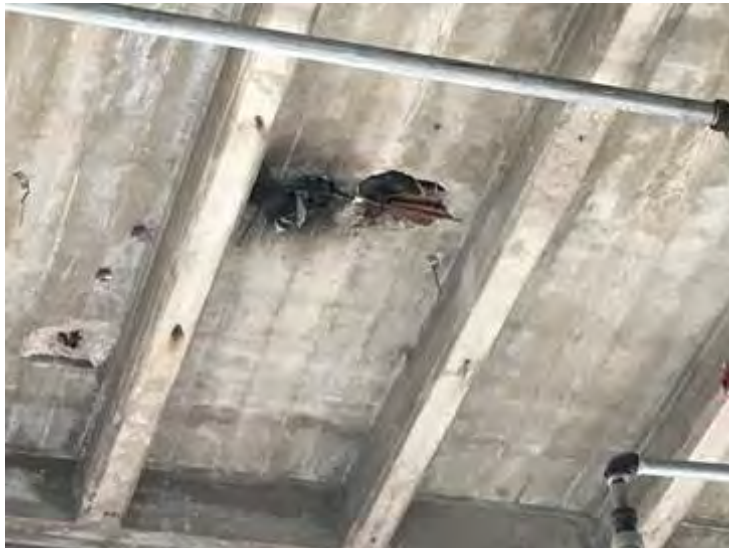
Photo #: 6

Second floor slab underside.
(viewed from ground floor bank area):

Deteriorated concrete slab shows signs of leakage, chipped concrete, voids in concrete, unsealed penetrations.

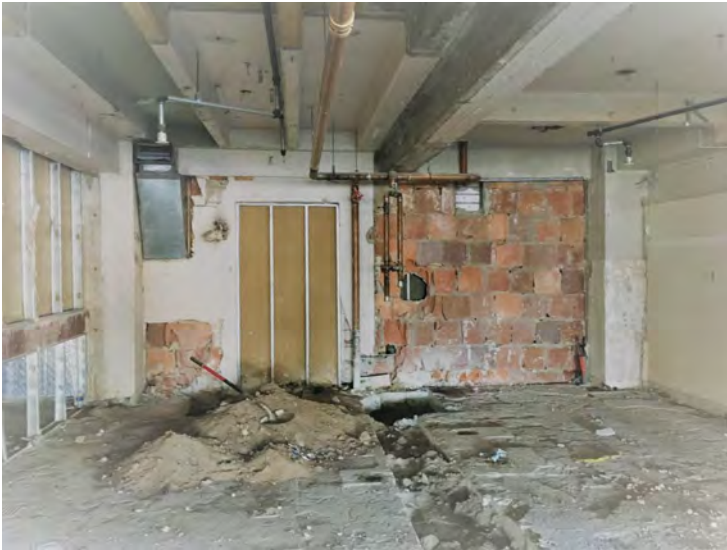
Photo #: 7

Ground exterior walls at bank area:

Exterior walls are made of framed wall with stucco at the exterior and hollow clay bricks. From the interior, the clay bricks show voids and deterioration.

The exterior walls are not structurally adequate to withstand hurricane design forces.

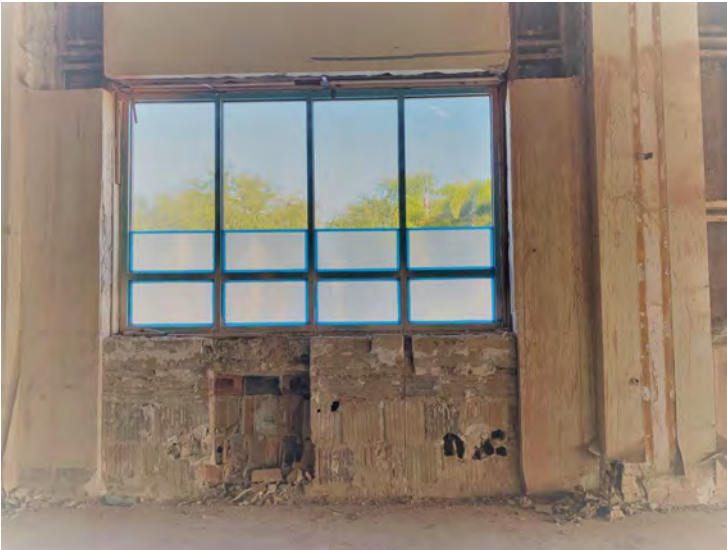
Photo #: 8

Ground exterior walls at bank area:

Exterior walls are made of framed wall with stucco at the exterior and hollow clay bricks. From the interior, the clay bricks show voids and deterioration.

Glazing Systems are not impact resistant and are not safely anchored to the structure.

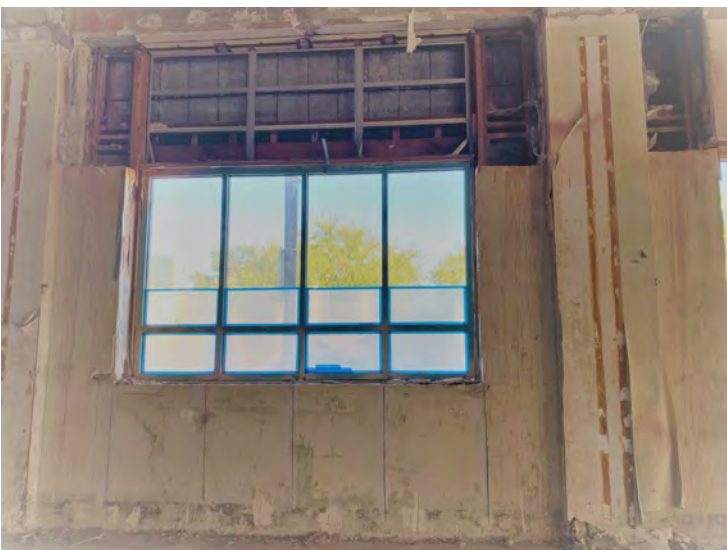
Photo #: 9

Ground exterior walls at bank area:

Exterior walls are made of framed wall with stucco at the exterior and hollow clay bricks. From the interior, the clay bricks show voids and deterioration.

Glazing Systems are not impact resistant and are not safely anchored to the structure.

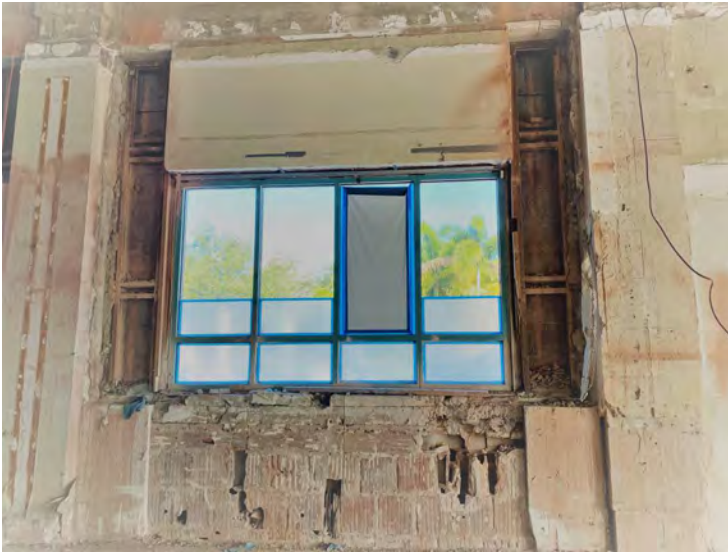
Photo #: 10

Ground exterior walls at bank area:

Exterior walls are made of framed wall with stucco at the exterior and hollow clay bricks. From the interior, the clay bricks show voids and deterioration. Some termite damaged wood was observed at window jambs.

Glazing Systems are not impact resistant and are not safely anchored to the structure. The exterior wall also is not structurally adequate to withstand loads imposed by the glazing systems.

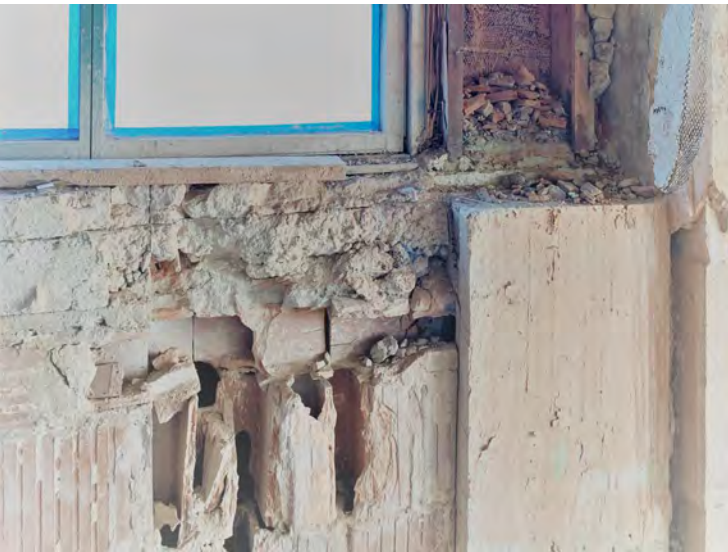
Photo #: 11

Ground exterior walls at bank area:

Enlarged photo showing exterior wall deterioration.

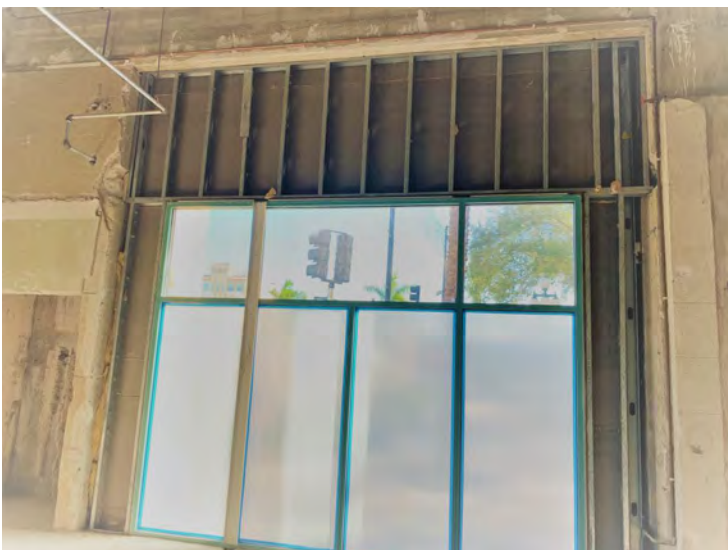
Photo #: 12

Ground exterior walls at bank area:

Framed exterior wall is not structurally sound to withstand wind loads imposed by the glazing systems.

Exterior wall would likely fail if subjected to hurricane forces expected for this building location.

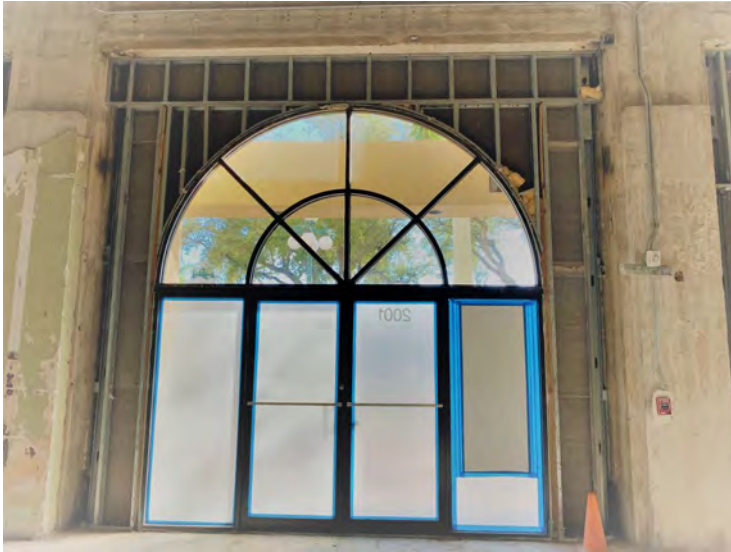
Photo #: 13

Ground exterior walls at bank area:

Entrance door and storefront anchored to framed exterior wall.

Observed framed exterior wall is not structurally sound to withstand wind loads imposed by the glazing systems.

Exterior wall would likely fail if subjected to hurricane forces expected for this building location.

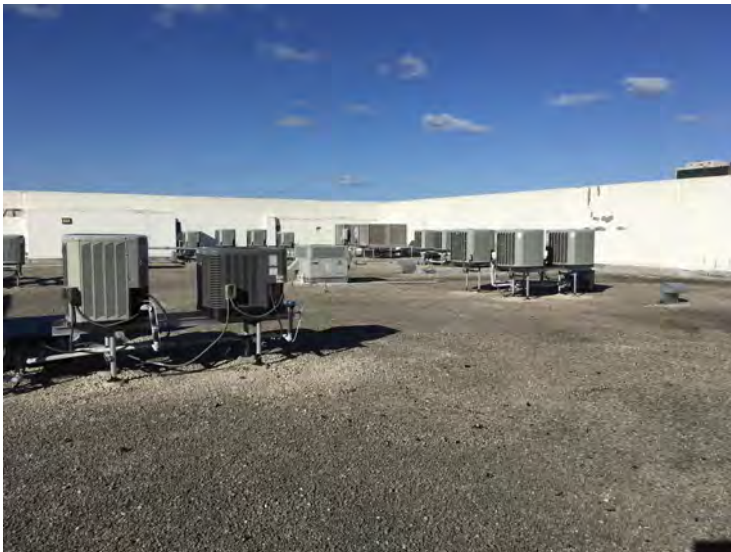
Photo #: 14

Roof:

Existing Ballast Roofing System is not compliant with current Florida Building Code.

Existing Roof drainage and scuppers are insufficient per current Florida Building Code requirements.

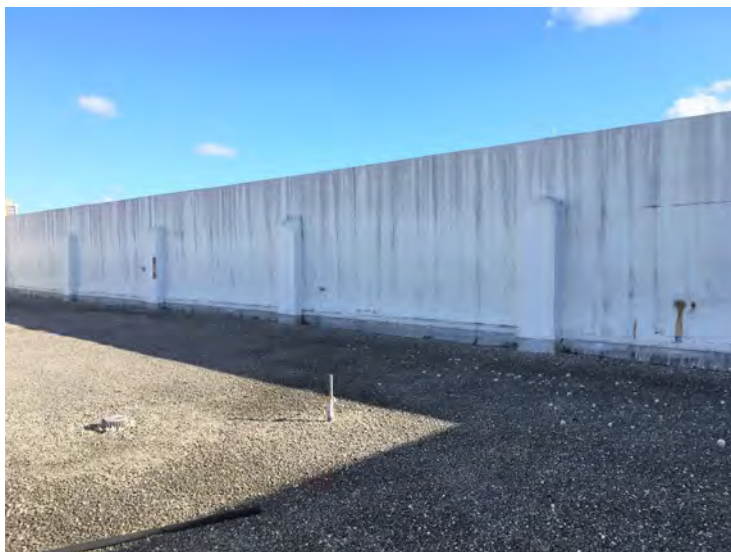
Photo #: 15

Roof Parapet Walls:

The parapet wall have been extended utilizing framed wall over CMU / concrete wall.

Horizontal cracks are noted at the transition of these materials and steel straps (that attached the frame wall extension) were noted corroded with missing fasteners.

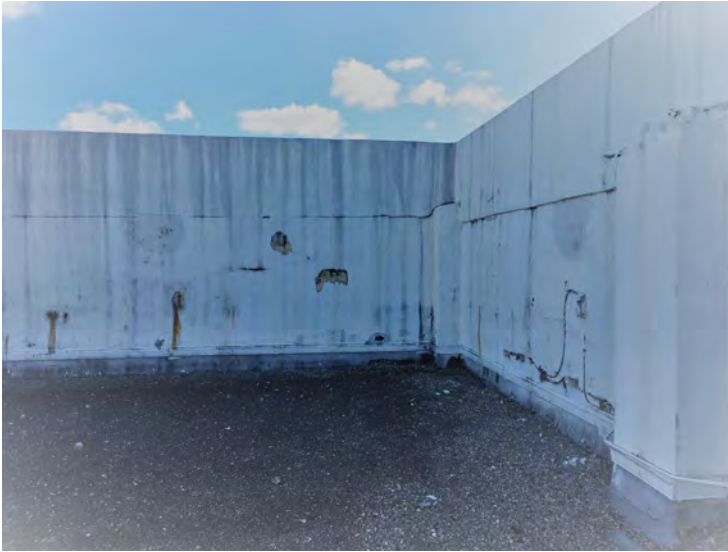
Photo #: 16

Roof Parapet Walls:

The parapet wall have been extended utilizing framed wall over CMU / concrete wall.

Horizontal cracks are noted at the transition of these materials and steel straps (that attached the frame wall extension) were noted corroded with missing fasteners.

Top of parapet wall extension is not structurally sound.

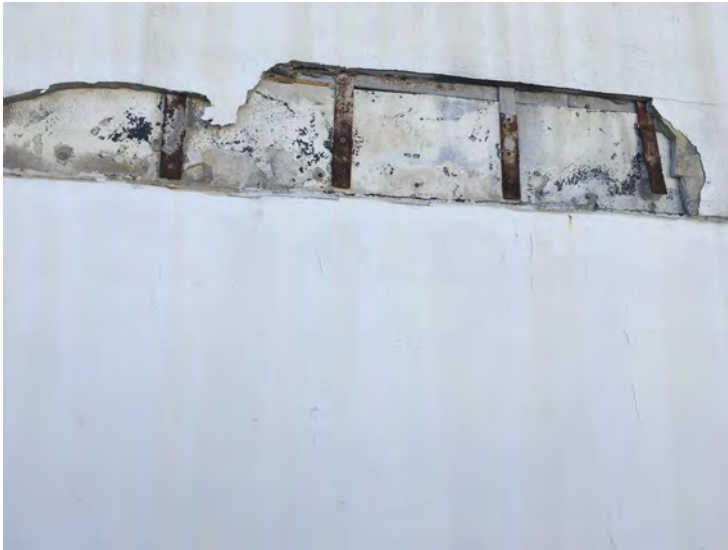
Photo #: 17

Roof Parapet Walls:

Refer to comments above (photo 16).

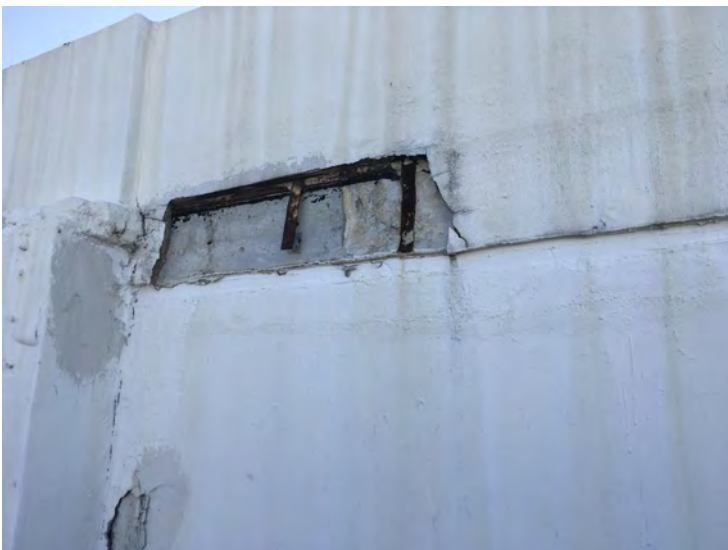
Photo #: 18

Refer to comments above (photo 16).
