# Structural and Feasibility Reports

Re: **Structural Evaluation Report for:**  
**Mr. & Mrs. John Goymer**  
**1049 Tyler Street • Hollywood, Florida**  
**Folio 5142 140 18 – 760**

Page 1 (Pictures)  
May 6, 2021

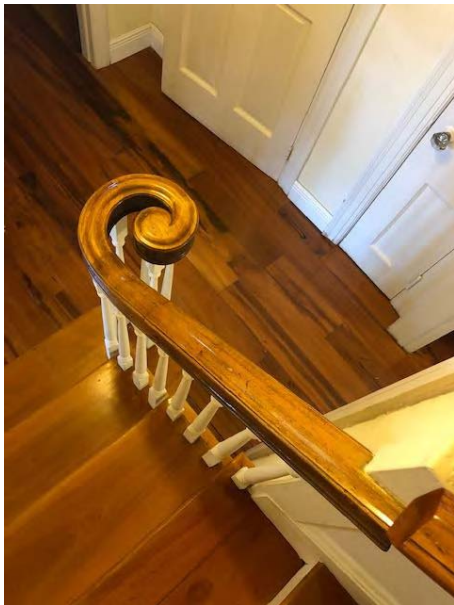
Newel post to be incorporated at new stairwell.

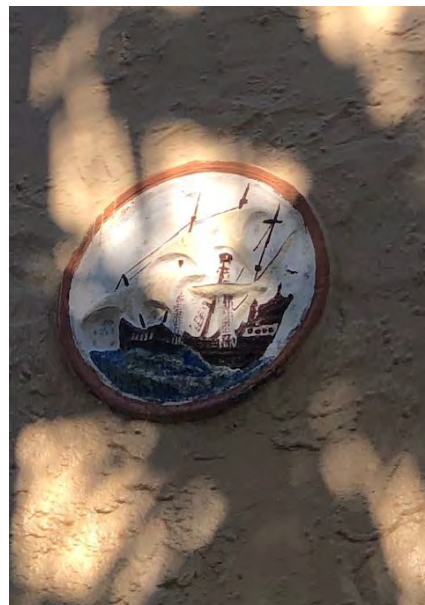
Medallion to be relocated to new chimney.

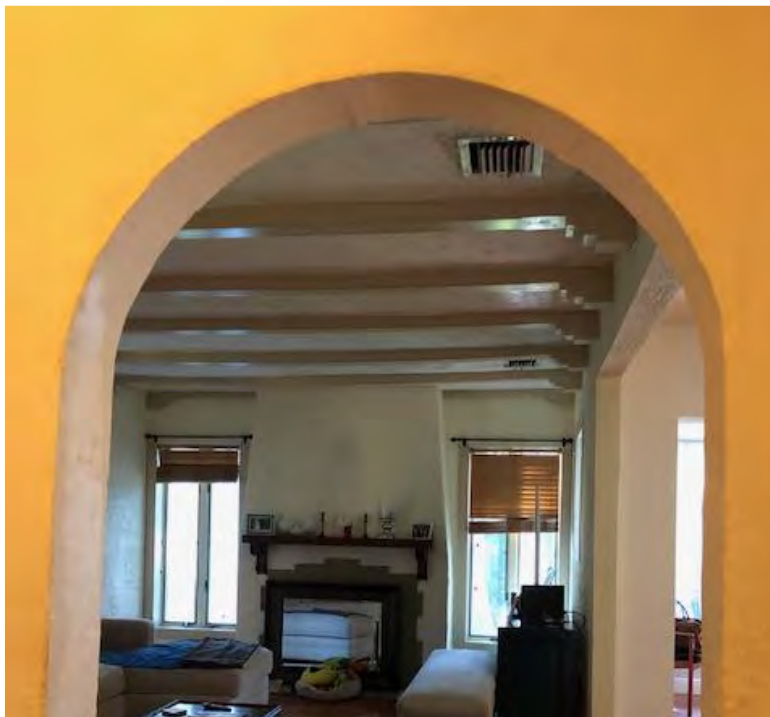
Exposed Wood Beams in Living Room

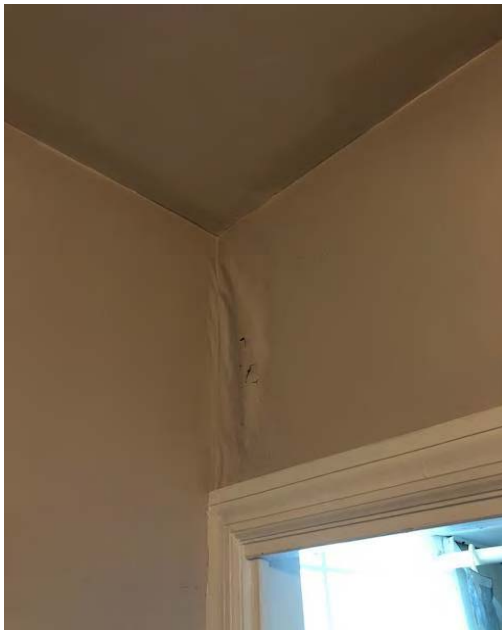
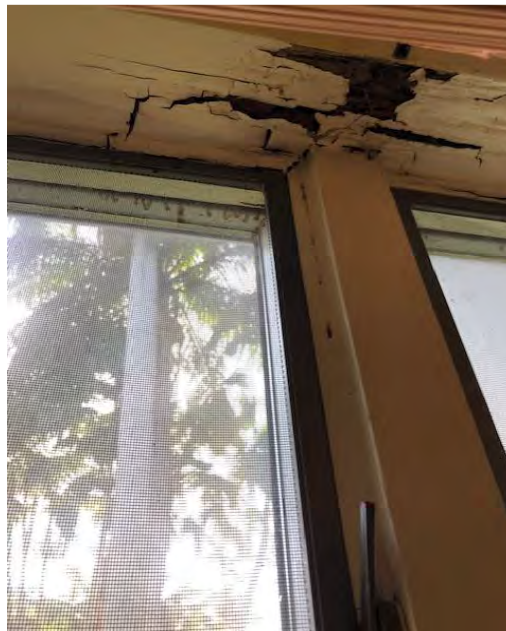
- There are damaged wall and ceiling areas due to moisture and termite infestation.
- Much of the original electrical system is still in place which presents a potential fire hazard due to the use of outdated cloth wiring.

Main Residence – Water Intrusion – Termite Infestation – Wood Rot

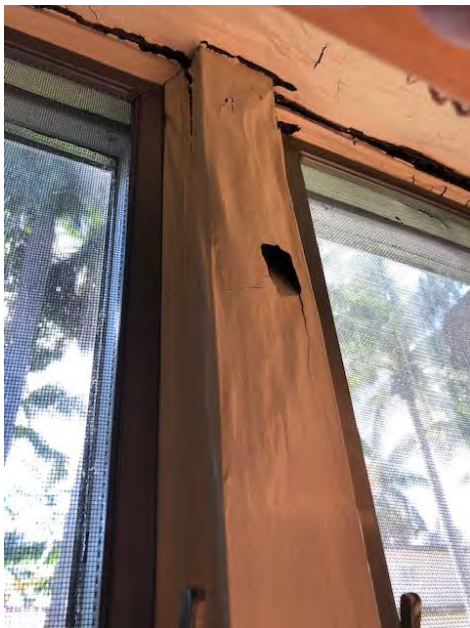
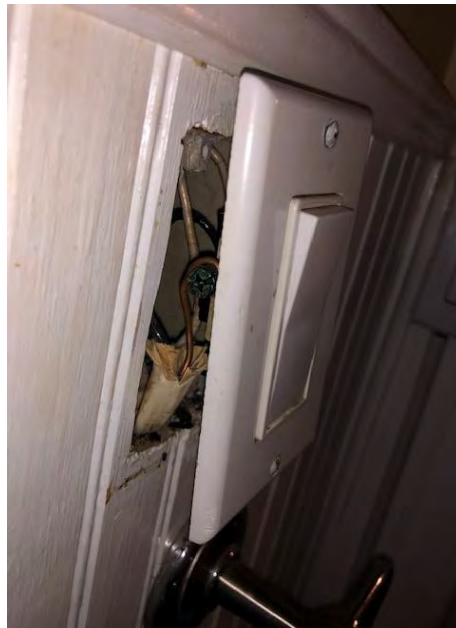
Main Residence – Water Intrusion – Termite Infestation – Wood Rot – Cloth Wiring – Water Intrusion

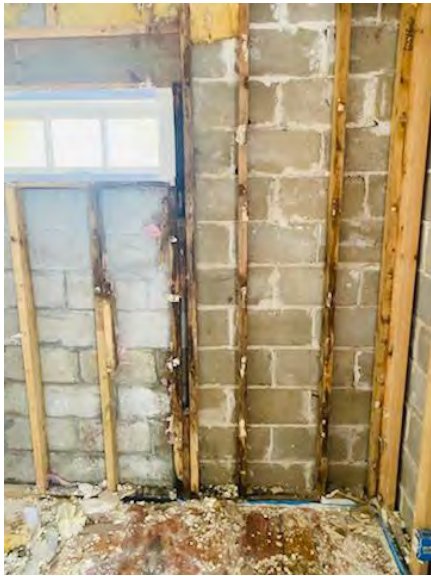
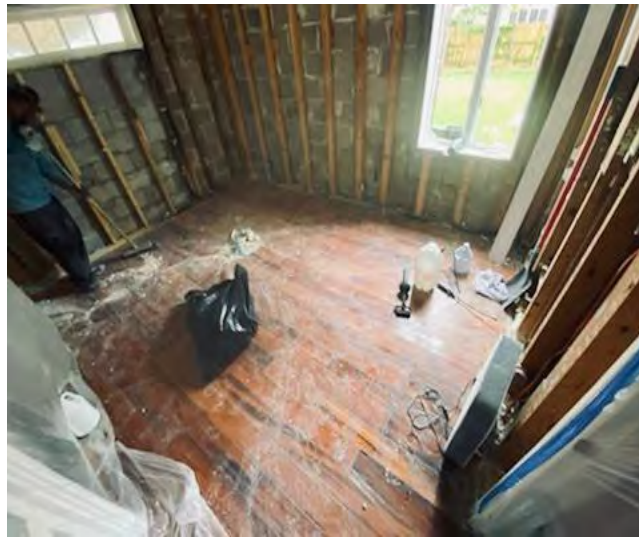
Main Residence – Water Intrusion – Termite Infestation – Wood Rot – Cloth Wiring – Water Intrusion

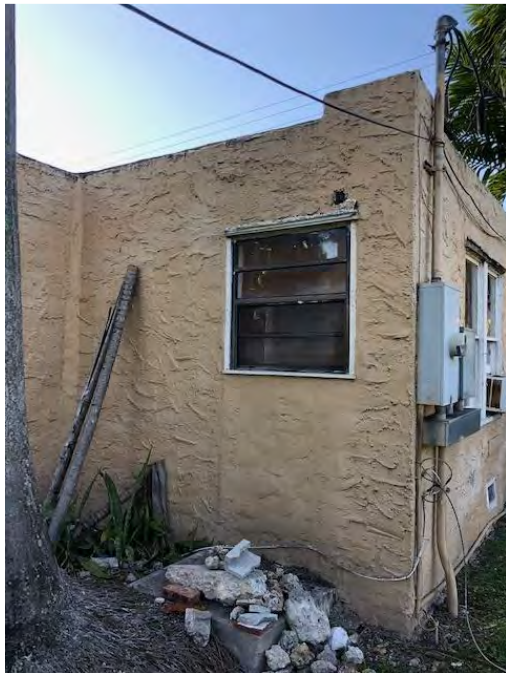
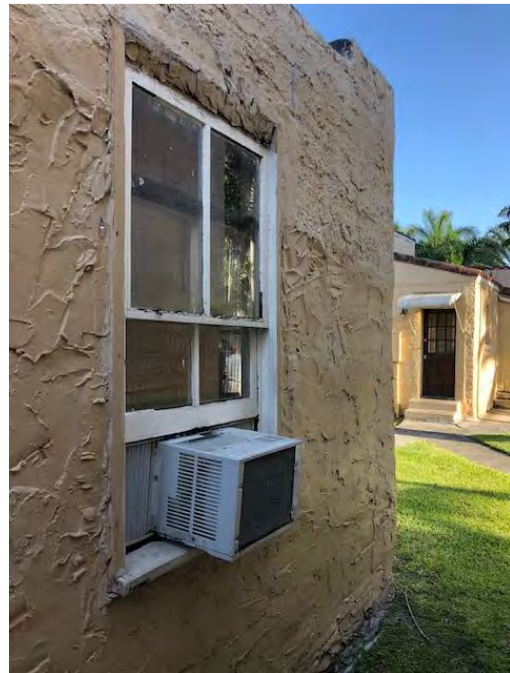
Cottage Building – Foliage impacting foundation – Non-Impact Windows & Doors – Inefficient Mechanical System

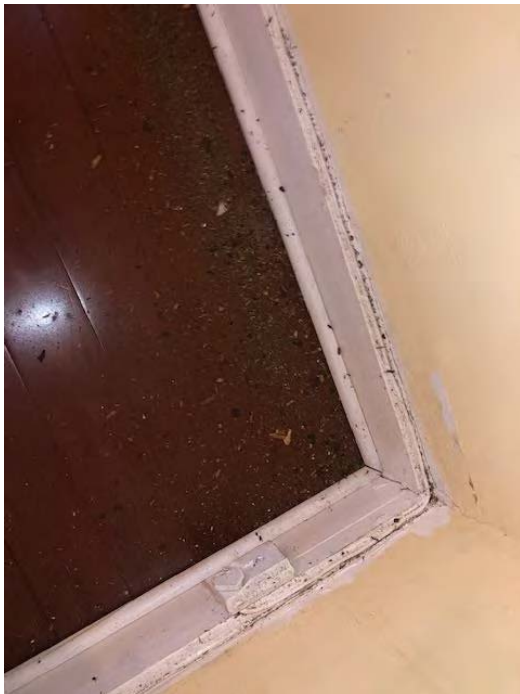
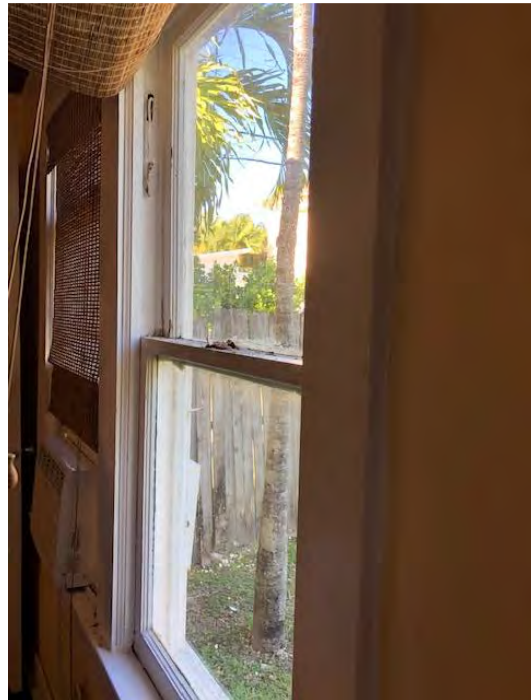
- The exterior doors and windows are rotted due to moisture and termite infestation.
- There are damaged wall and ceiling areas due to moisture and termite infestation.

Cottage Building – Termite Infestation – Non-impact Windows

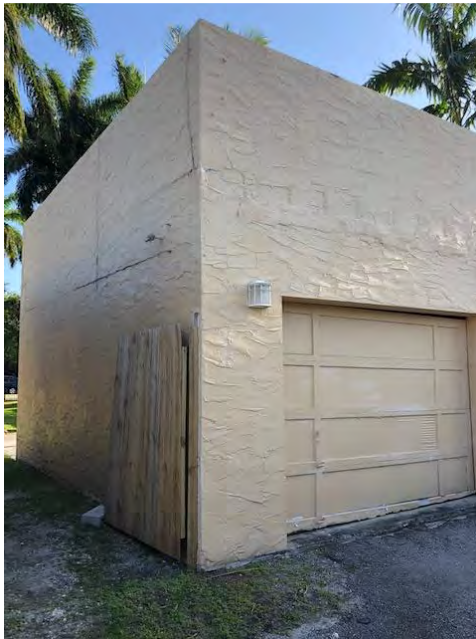
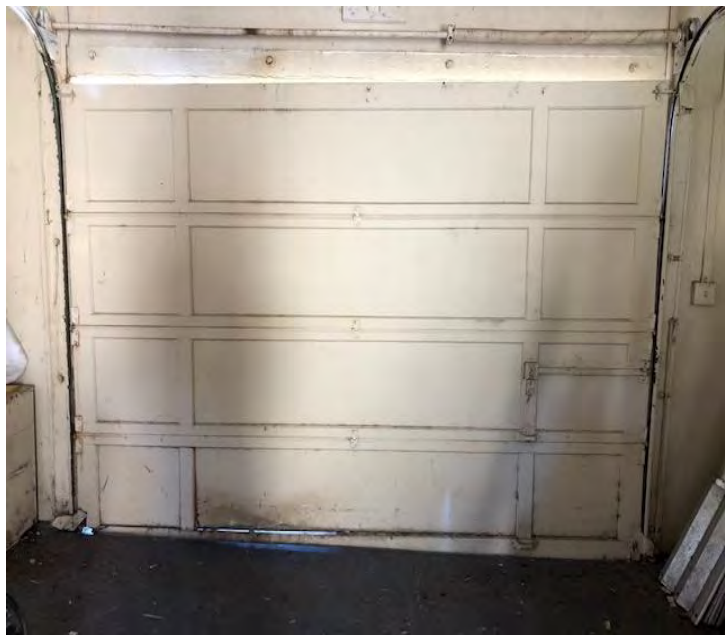
Garage Building – Structural Cracks at Parapet – Wood Rot – Water Intrusion

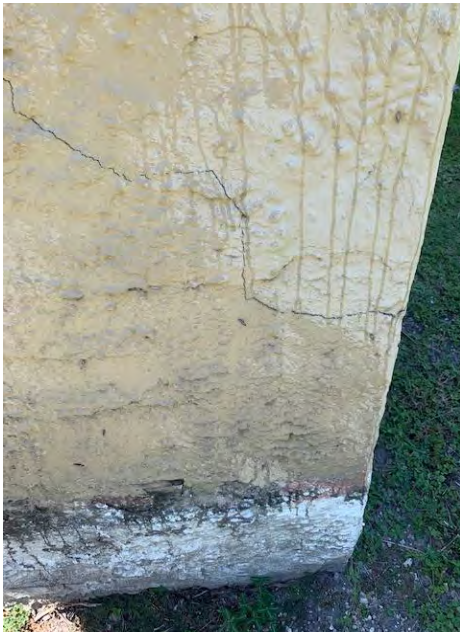
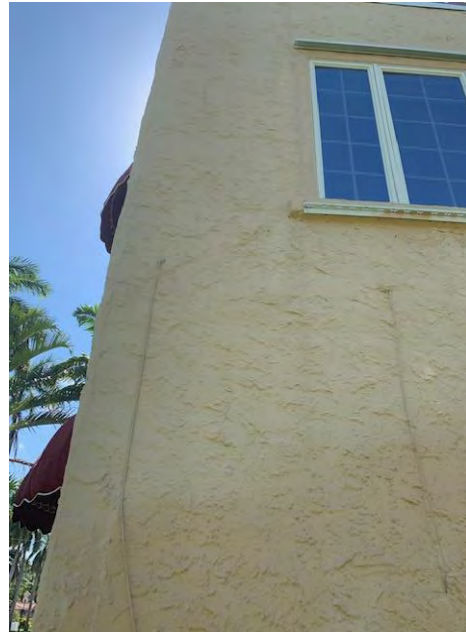
Wall crack

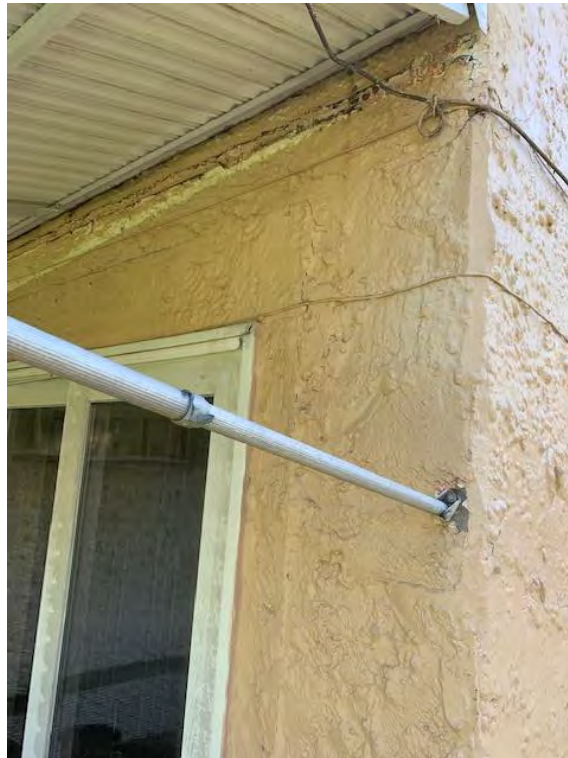
Wall crack

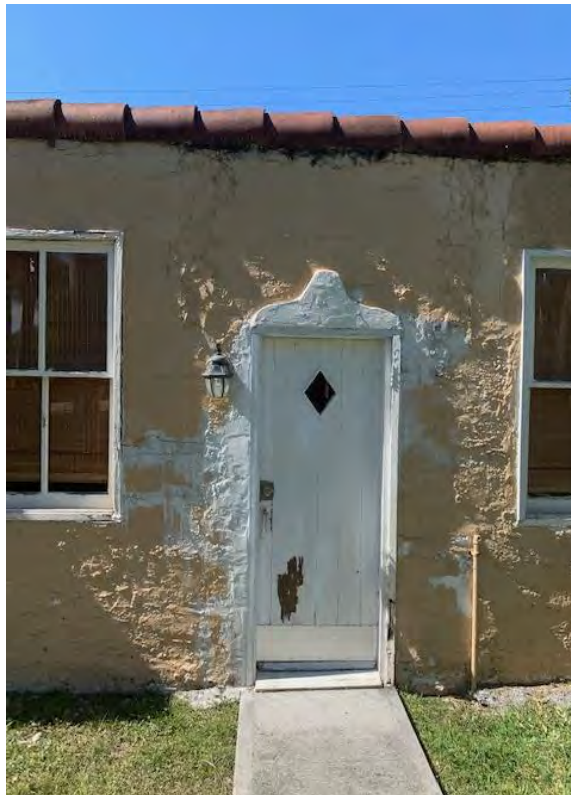
Deterioration of exterior wall

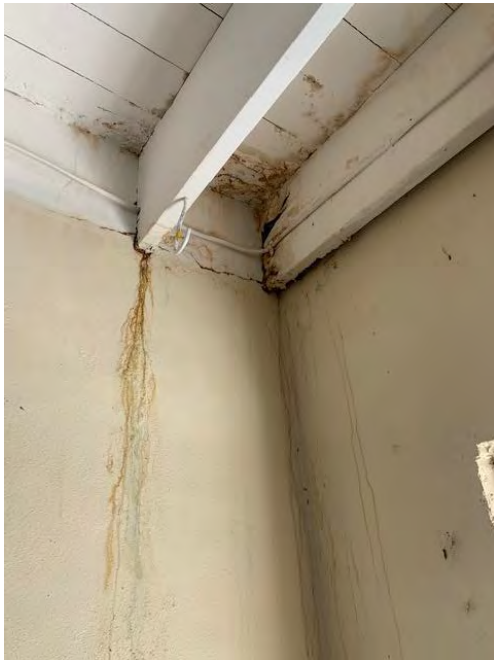
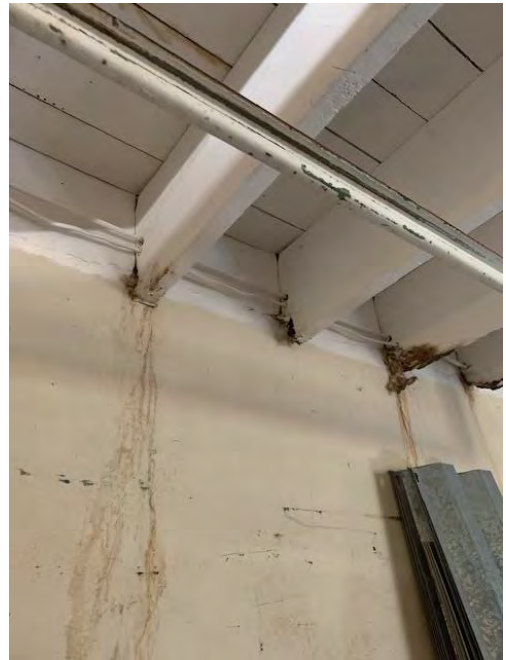
Moisture penetration and deterioration of wood joist

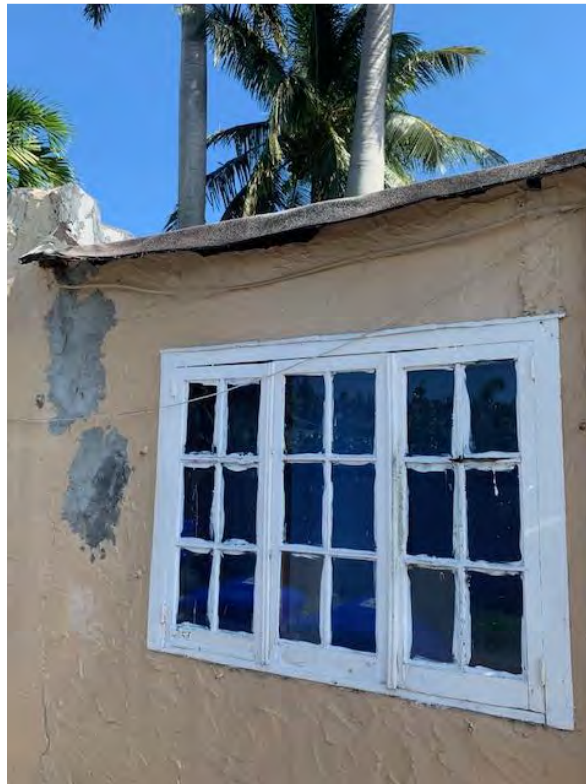
Exterior wall with horizontal and vertical cracks and window in poor condition

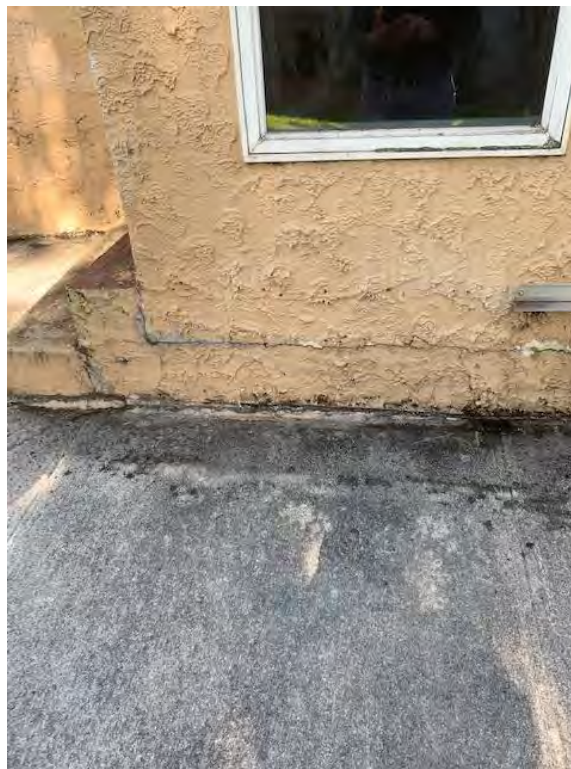
Damaged exterior wall at base.

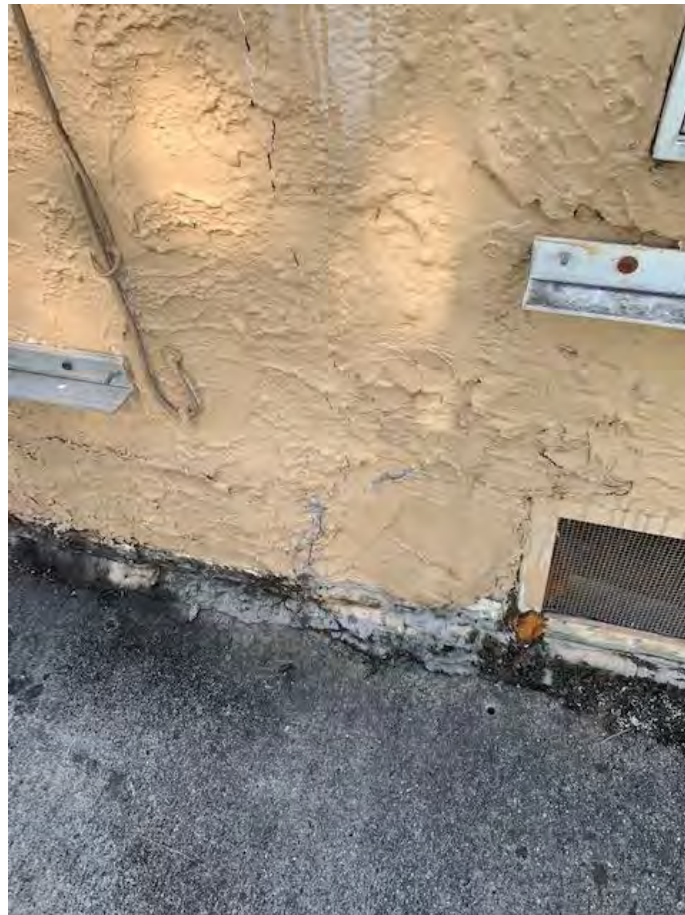
Erosion adjacent to footing

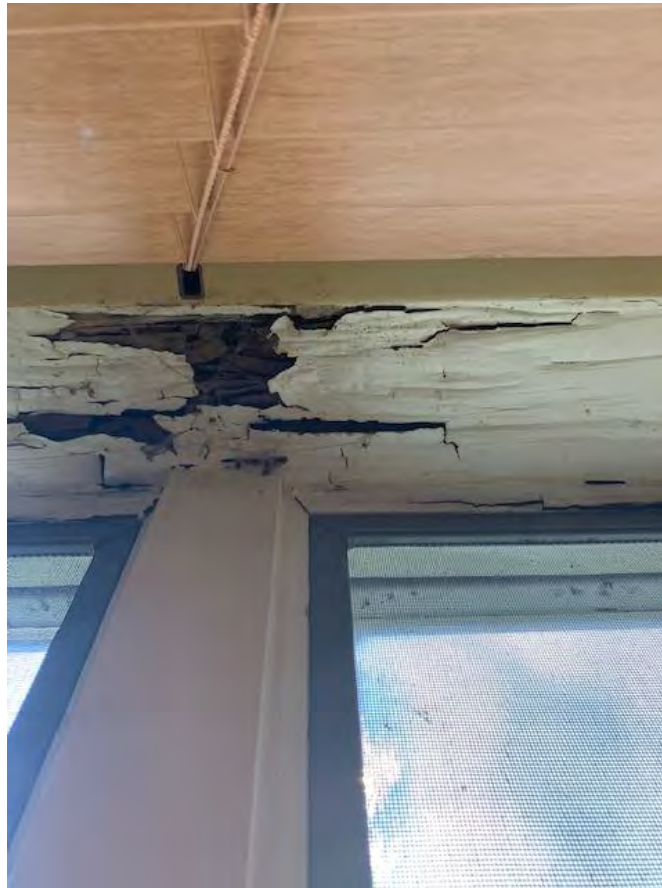
Deteriorated wood members
