ATTACHMENT B

Additional Documents

Hollywood Houses – The Work of Architect Charles Reed, Jr.

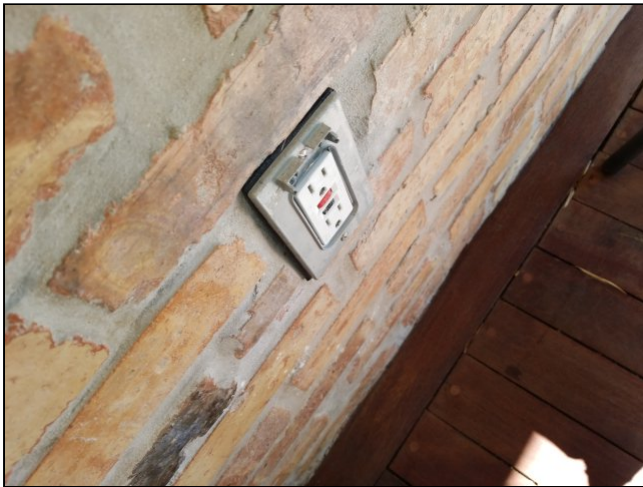
(32) Outlet missing cover.

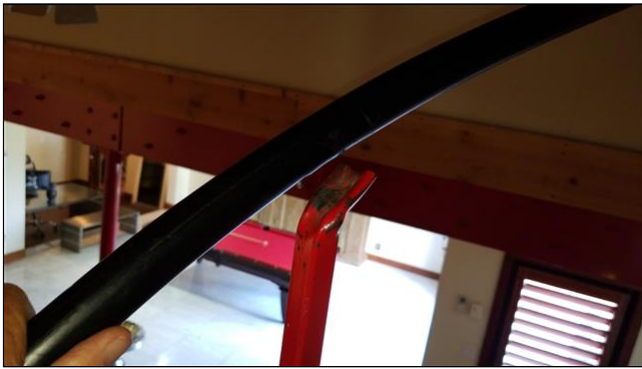
(3) Stairwell railing detached. \$100

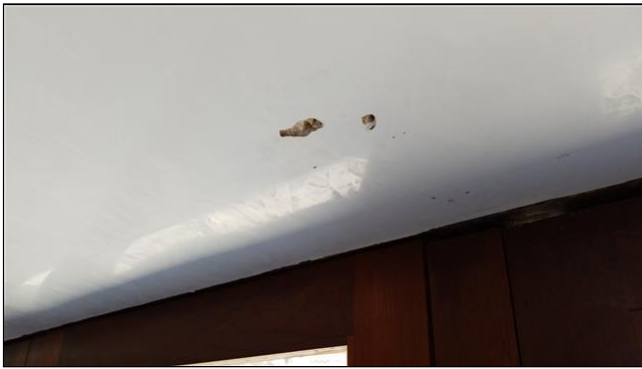
(5) Termite damage to ceiling finish & ceiling truss. \$ unknown. Recommend further evaluation.

Ceiling damage due to termite

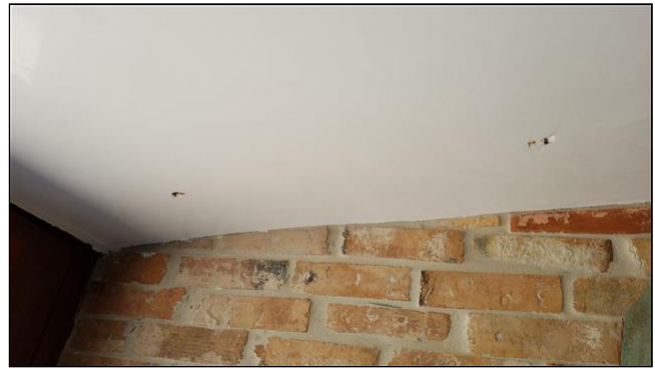
Ceiling damage due to termite

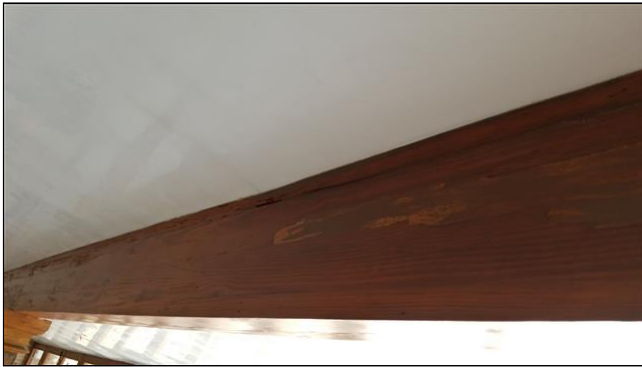
Termite damage to ceiling truss
