## Park Road – Community Meeting – Dec. 11, 2024

PARK ROAD DEVELOPMENT PD Master Plan, Residential and Commercial Site Plan Community Meeting December 11, 2024 at 6:00 p.m.

#### ISA Certified Arborist Report

The following is an arborist report for the customer defined scope area on the west side of South Park Road between Hillcrest Drive and Pembroke Road in Hollywood, FL. The purpose of this report is to inventory and evaluate the condition of the trees. This report is not a risk assessment on a Level 2 or 3 as described by the Levels and Scope of Tree Risk Assessment from the ANSI A300 Part 9: Tree, shrub, and Other Woody Plant Management – Standard Practices. The Santiago Group LLC cannot be held liable for damage to the tree or damage caused by the tree.

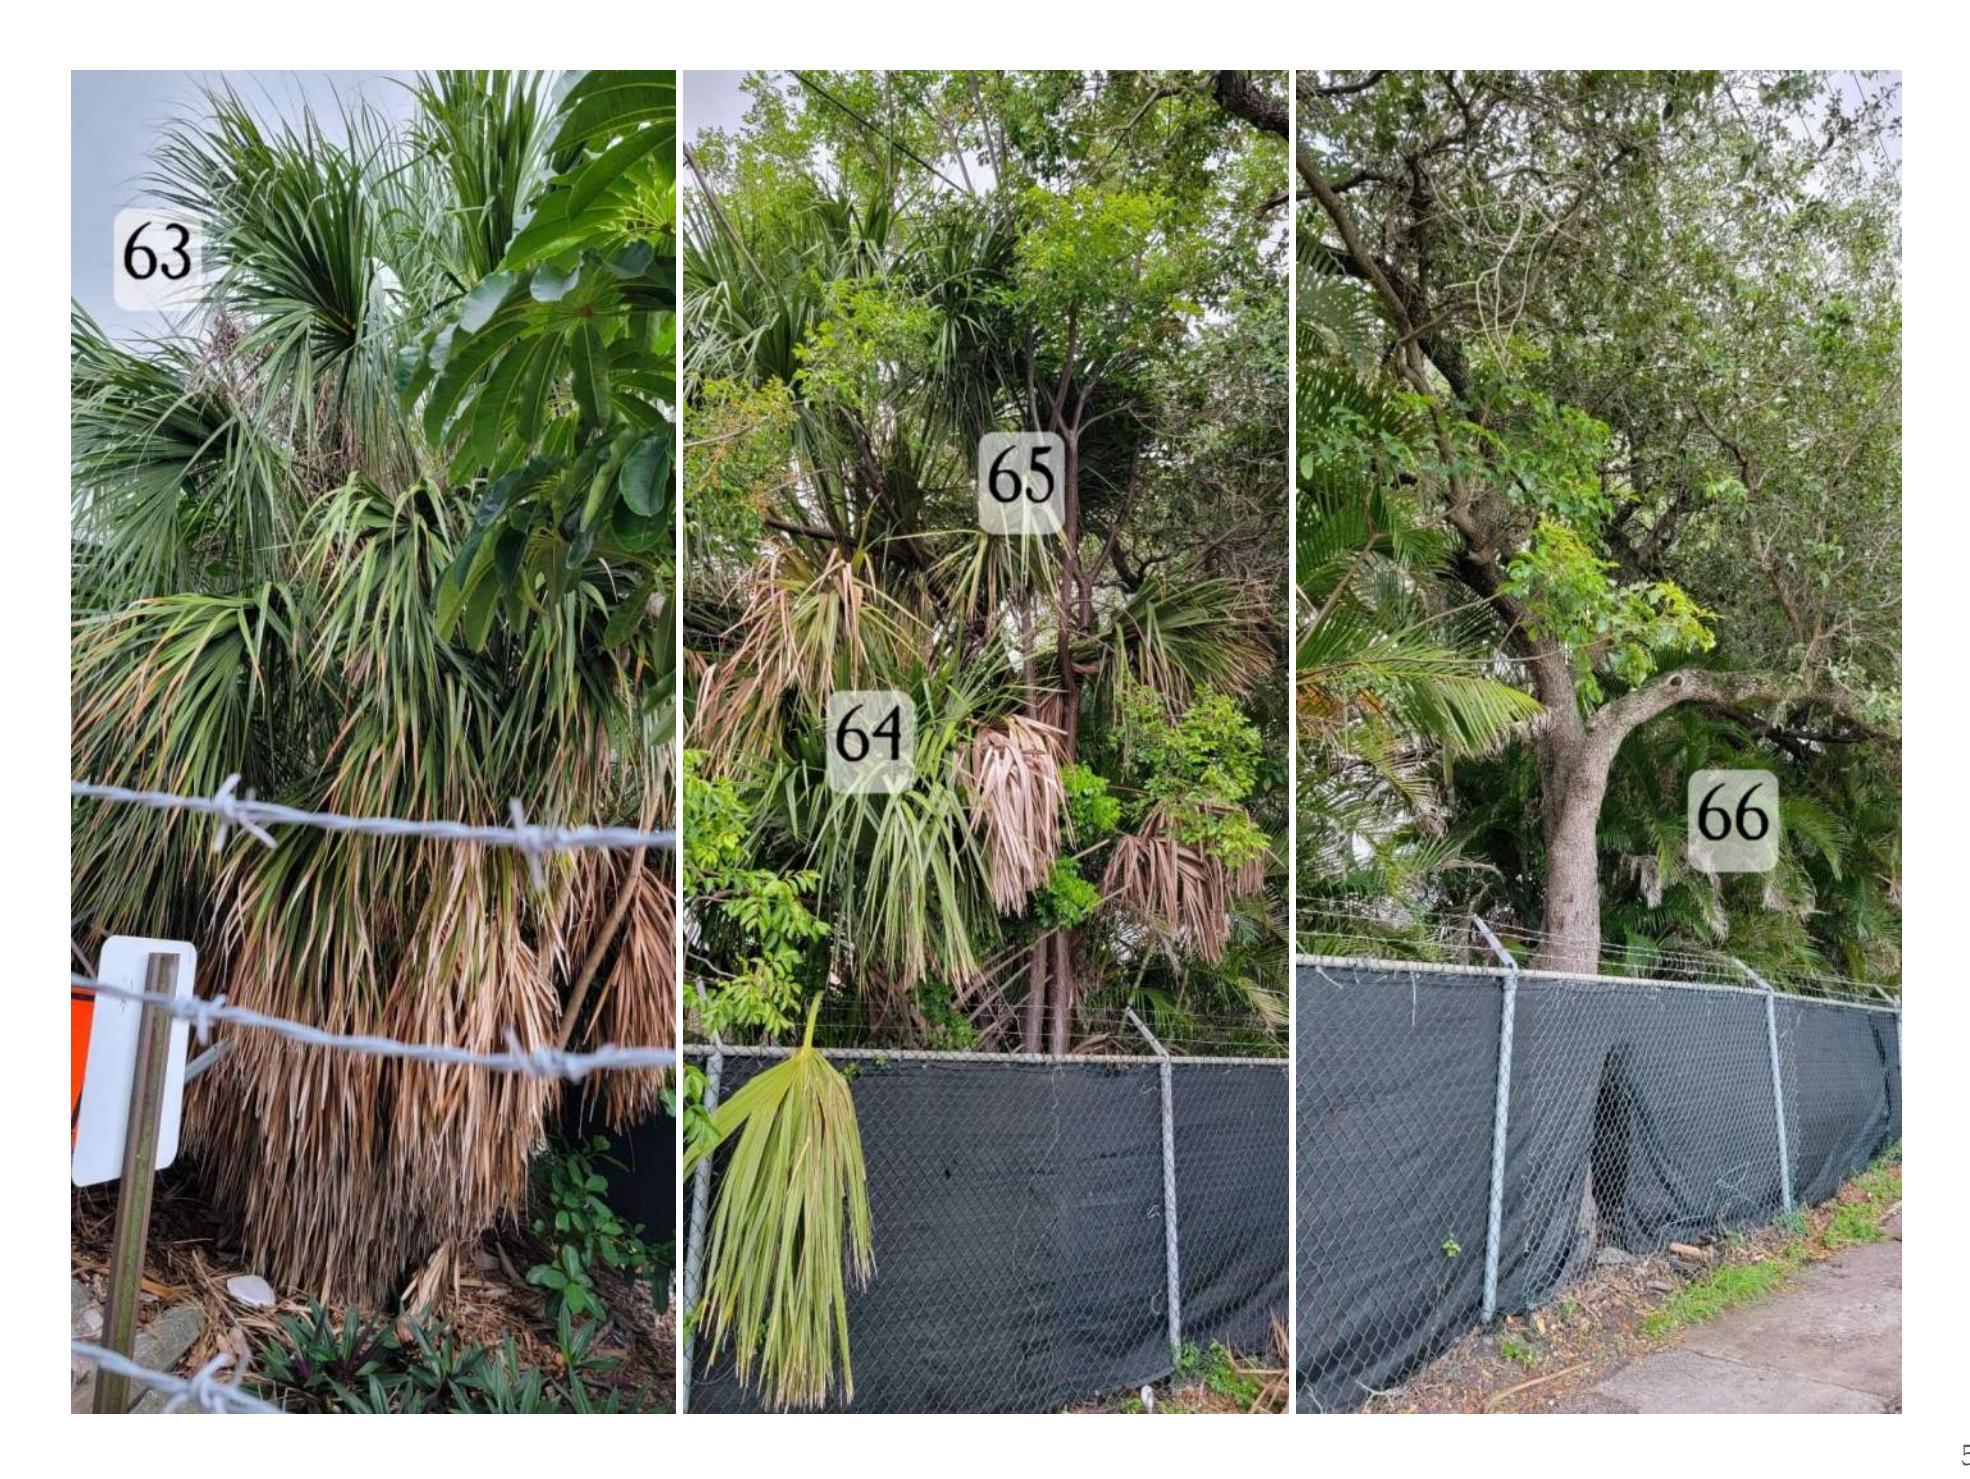
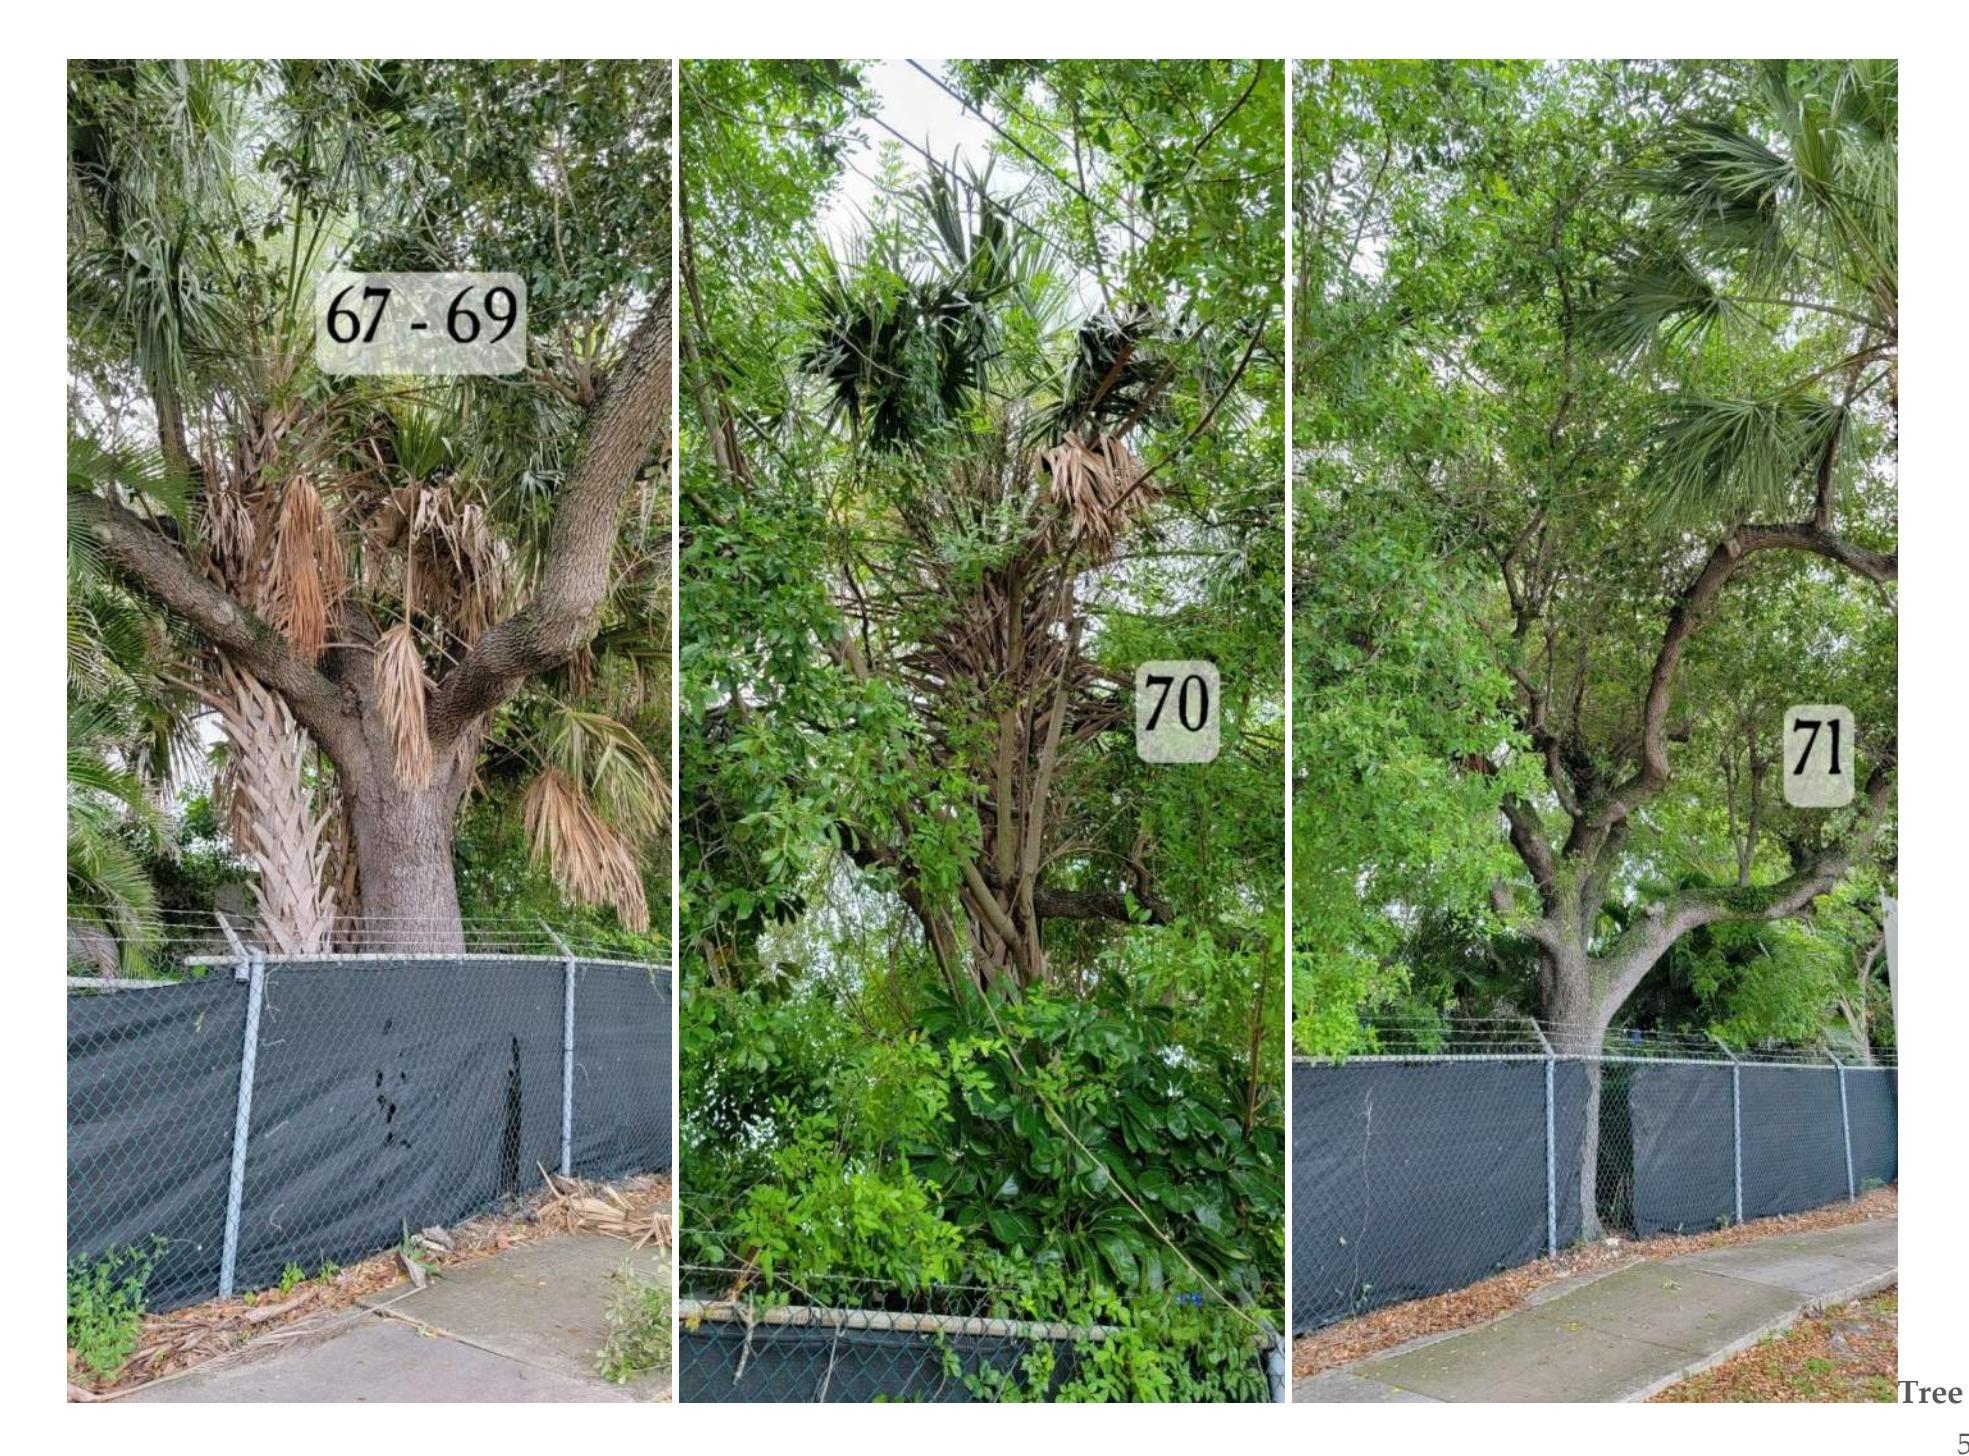
Tree 71 has a ample surface roots located beyond the sidewalk in the ROW. The sidewalk appears to have been laid atop these mature roots. The roots have been mechanically injured, likely from lawn mowers. The sidewalk also appears to be lifting.
