ATTACHMENT B

Additional Documents

Hollywood Houses – The Work of Architect Charles Reed, Jr.

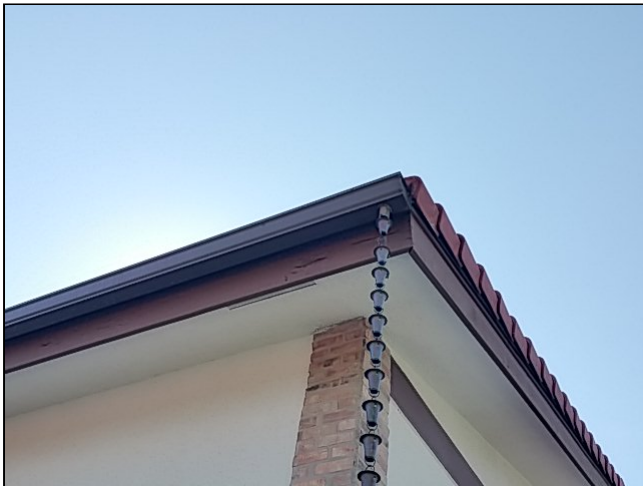
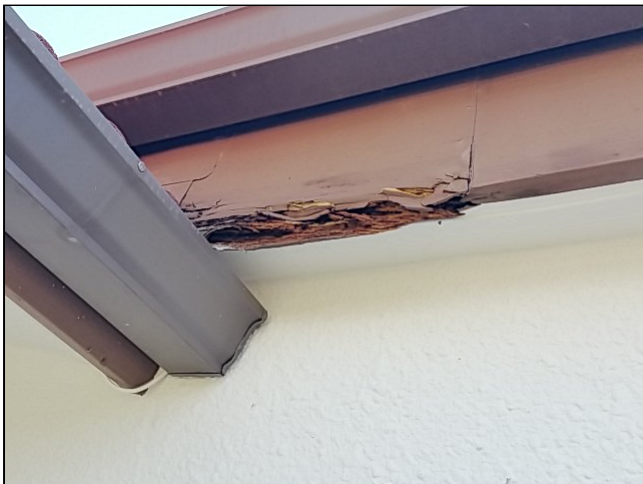
(1) Fascia has termite and wood rot damage in various areas.

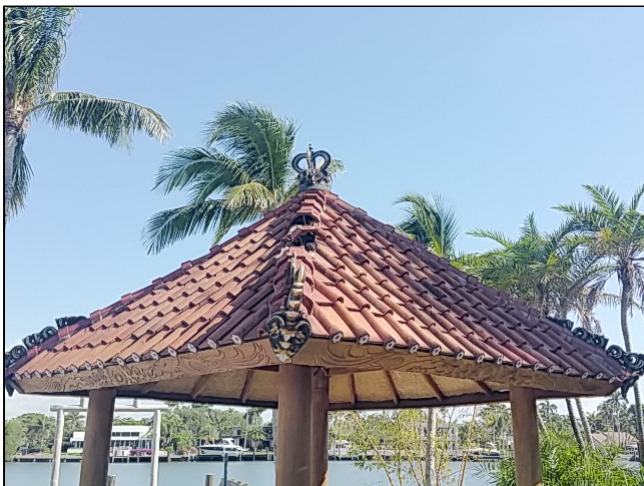
(5) East cabana roof is missing roof tile and a few are loose. \$500

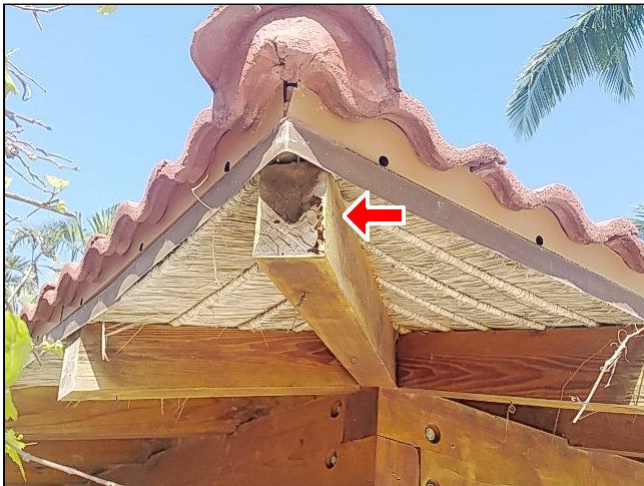
(8) West cabana roof is tilted down, possible subterranean damage. \$Unknown

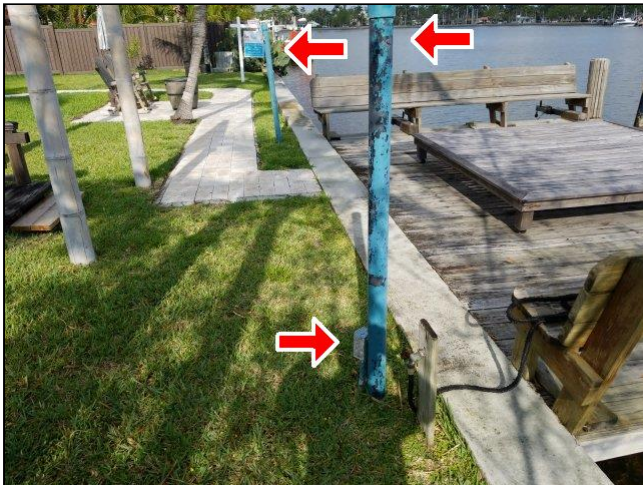
(10) Lamp posts by boat dock is inoperative and electrical outlet by post test it with no power. Recommend a licensed electrician inspect for the repair. \$Unknown

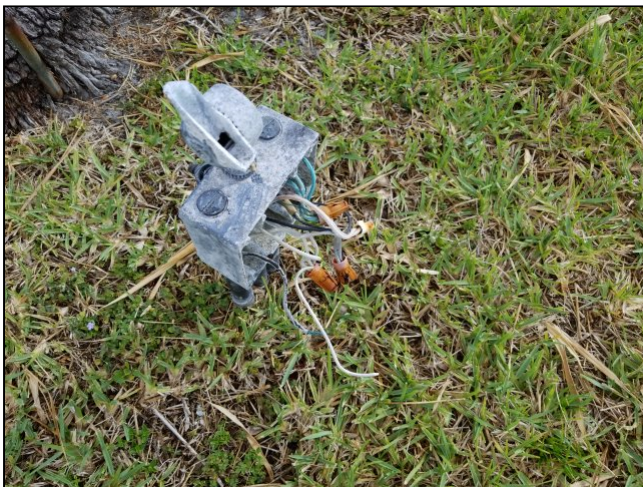
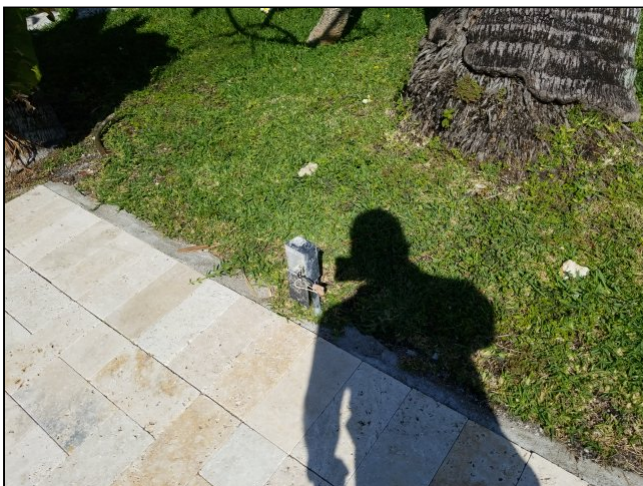
(11) Various electrical junction box throughout property are open with exposed wiring. Recommend a licensed electrician inspect further and repair. \$Unknown

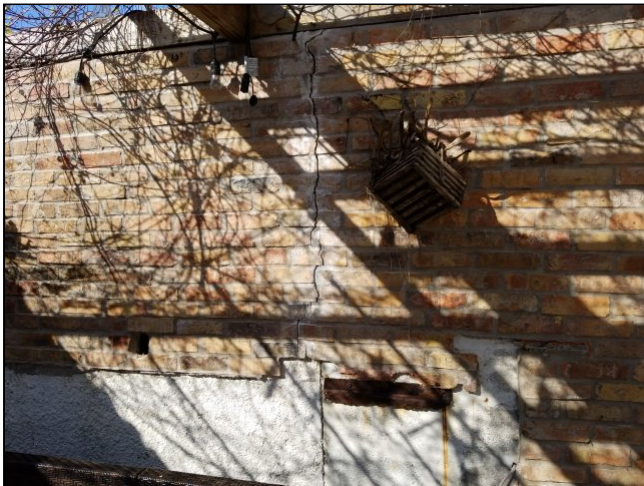
(17) Parapet wall has a settlement crack. Recommended license contractor inspect further. \$Unknown

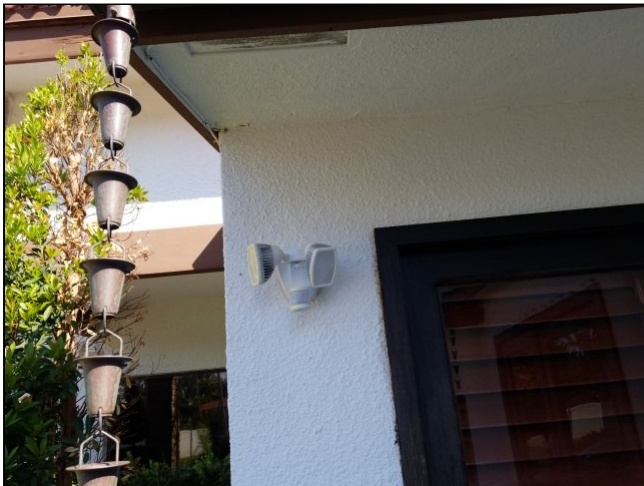
(25) Flood light fixtures are inoperative at time of inspection. Fixtures are on motion/light sensors.

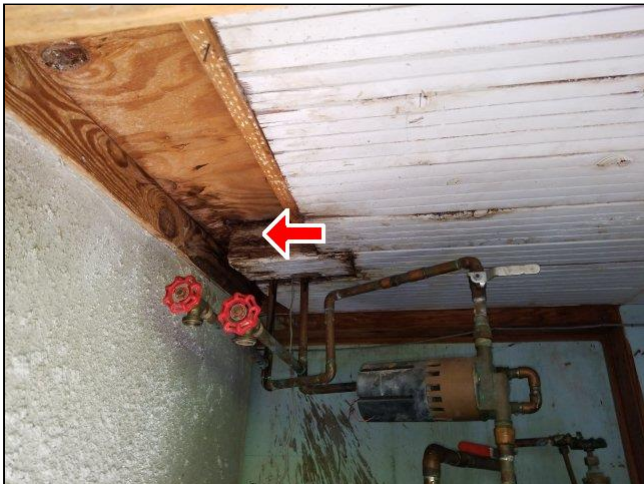
(28) Water closet ceiling sheathing has water stains from a roof leak.

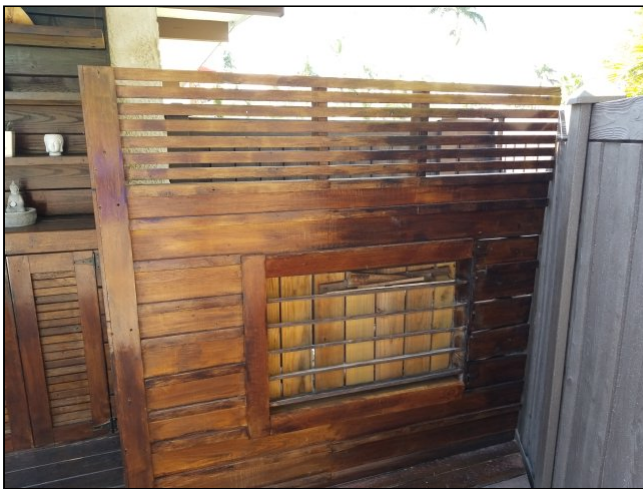
(33) No access to spa pool pump.

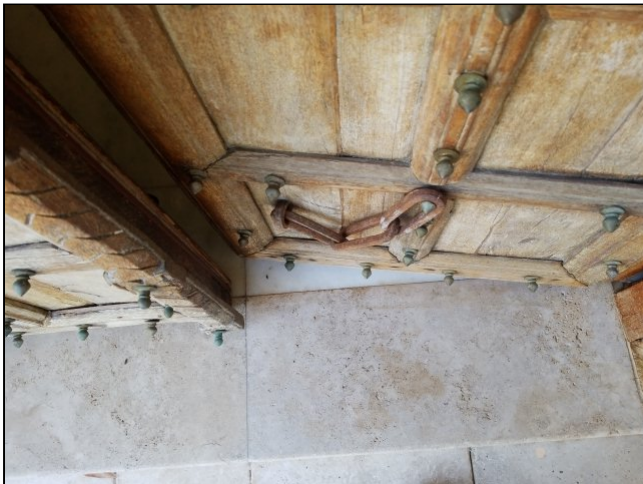
(34) Front door rubs against tile flooring and door does not remain open.

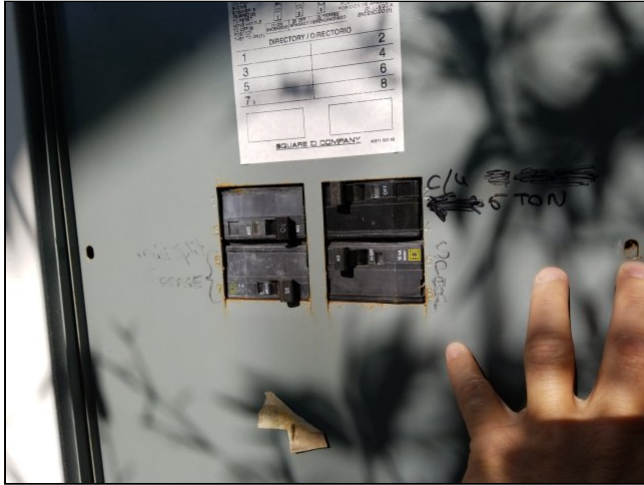
Service panel is missing inner cover fasteners. Recommend adding fasteners.

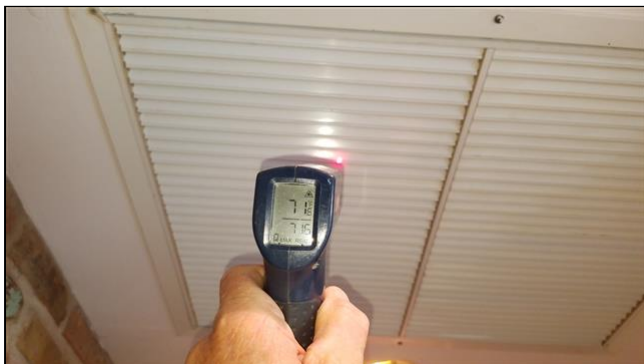
71 degrees at return

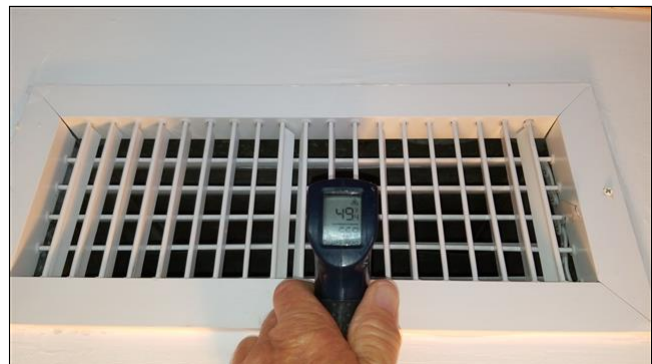
49 degrees at supply

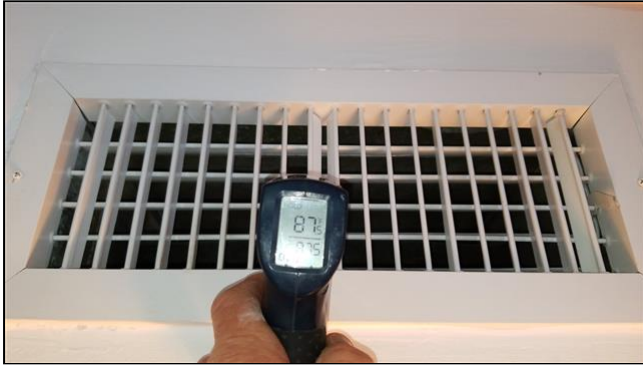
87 degrees at supply

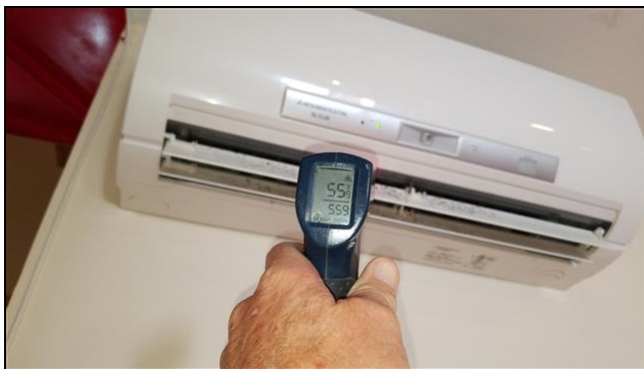
Heat did not turn on. Recommend further evaluation.

Cooling 55 degrees

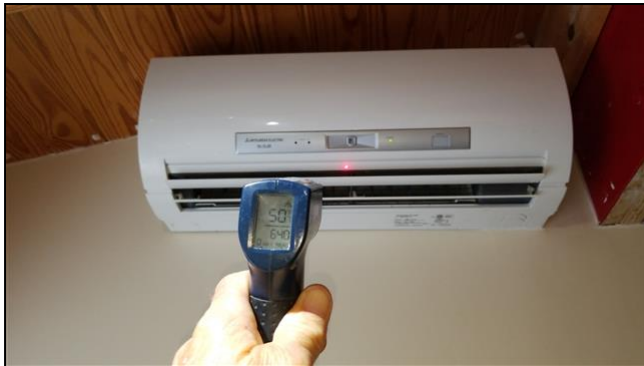
Heat did not turn on. Recommend further evaluation.

Cooling 50 degrees

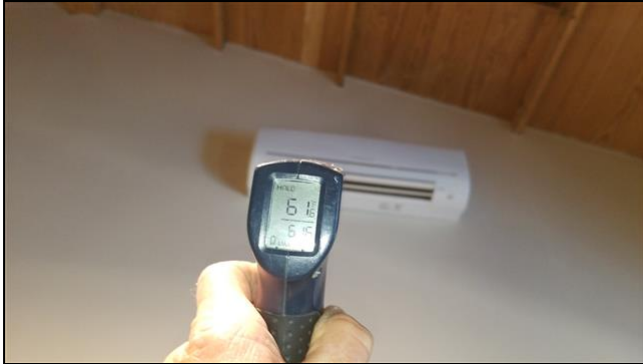
Heat did not turn on. Recommend further evaluation.

Cooling 61 degrees

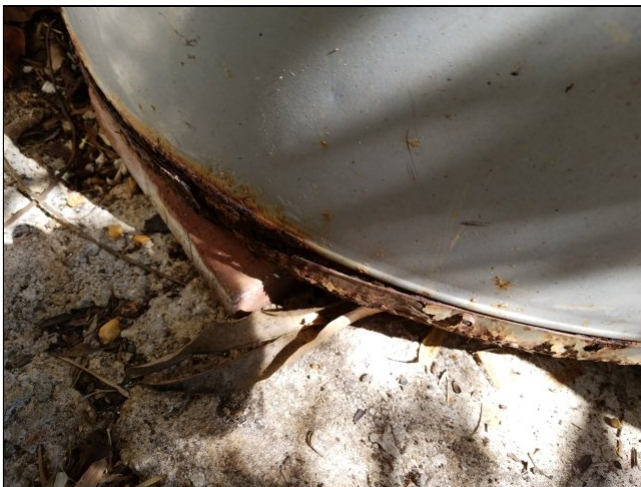
Water heater housing is rusted. No evidence of moisture at time of inspection.

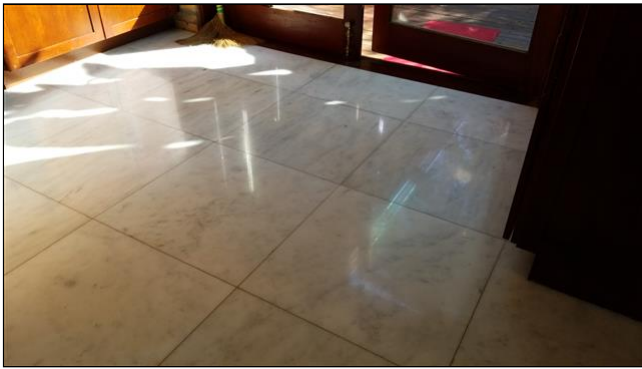
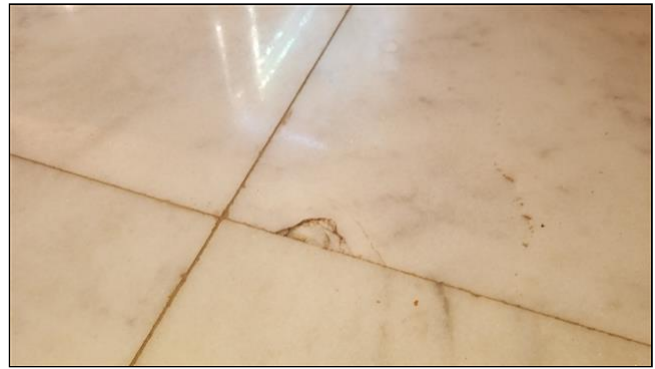
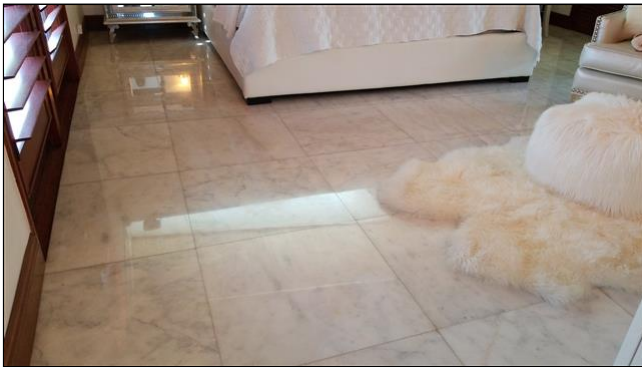
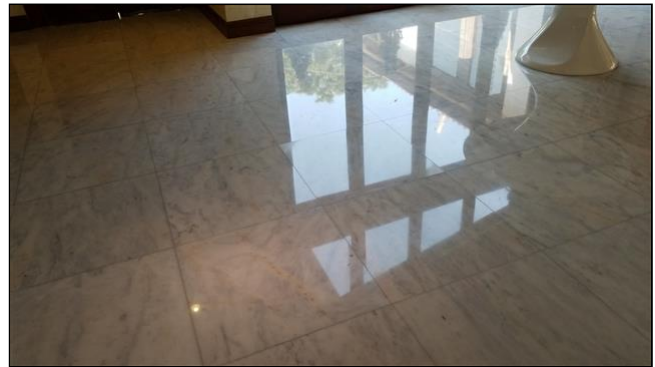
(1) Various hollow spots observed at tile flooring. Recommend further evaluation from licensed flooring contractor.

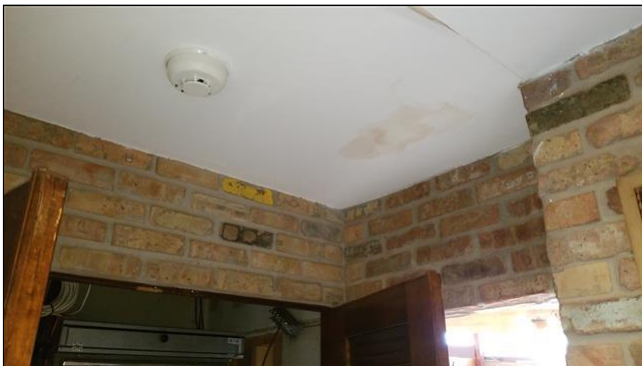
(2) Evidence of water intrusion at hallway ceiling, area tested negative for moisture. Recommend further evaluation.

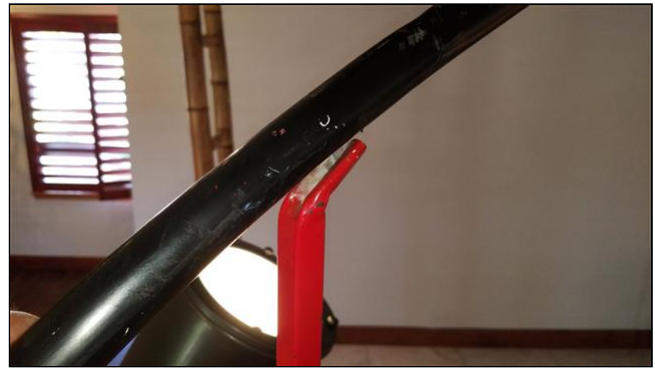
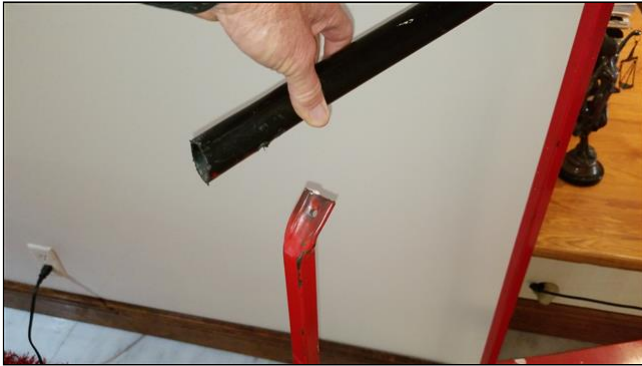
(3) Stairwell railing detached. \$100

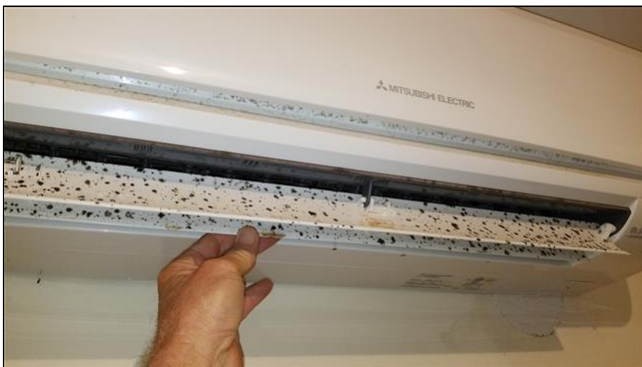
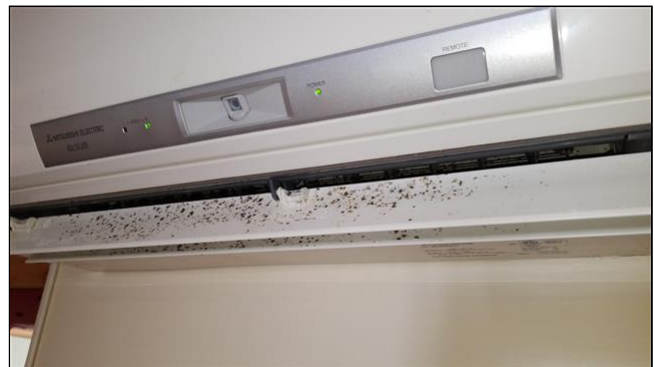
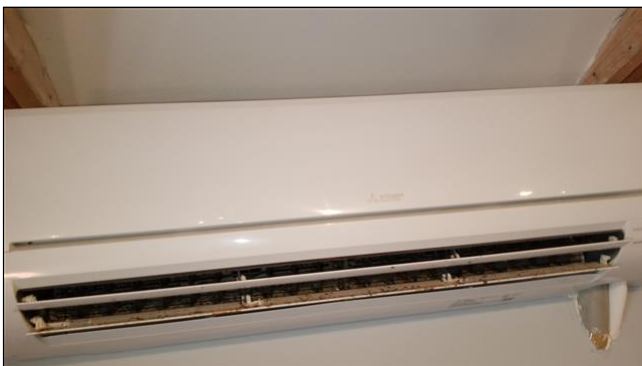
(4) Evidence of mold at interior air handlers. Recommend further evaluation.

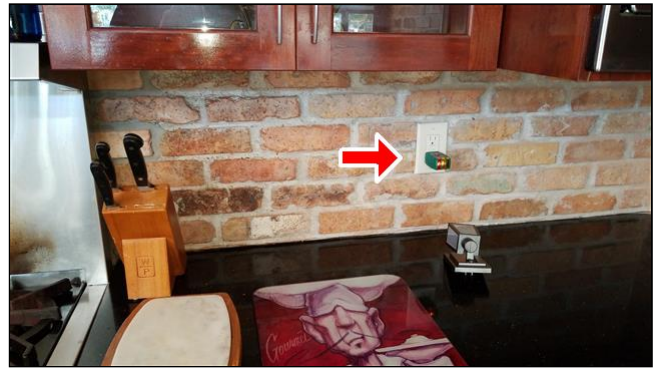
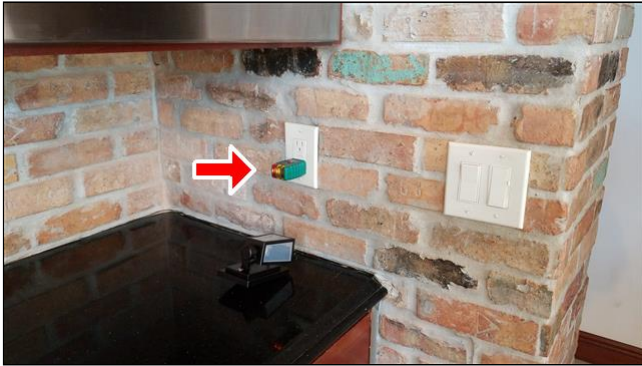
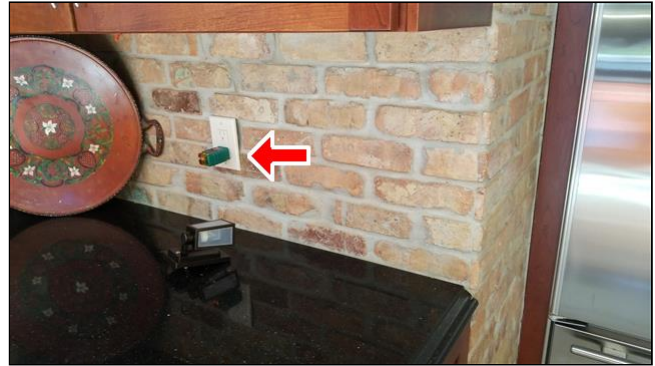
(1) 4 GFCI outlets have hot neutral reversed and are not tripping. \$150 - unknown

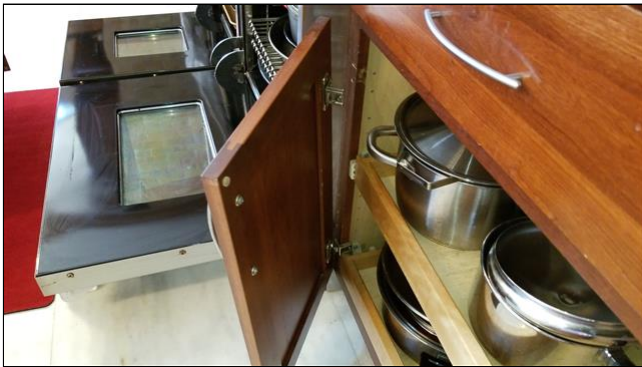
(2) Cabinet hinge detached. \$25

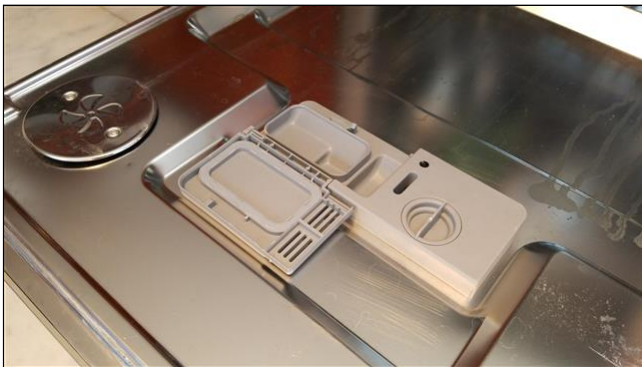
(3) Dishwasher dispenser not closing. \$50 - unknown

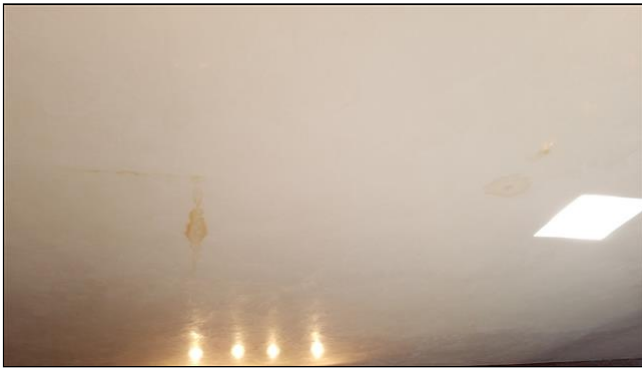
(4) Evidence of water intrusion at ceiling, areas tested negative for moisture. Recommend further evaluation.

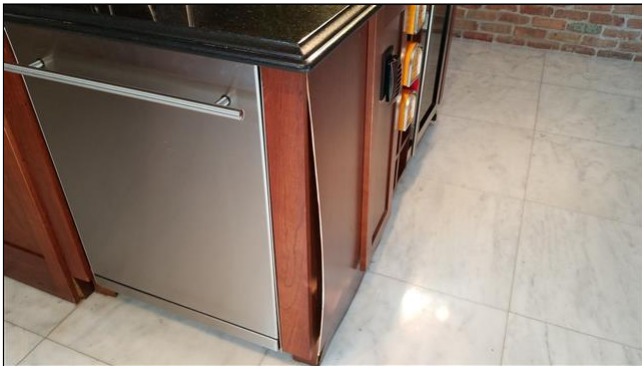
(5) Cabinet cover panel detached. \$25

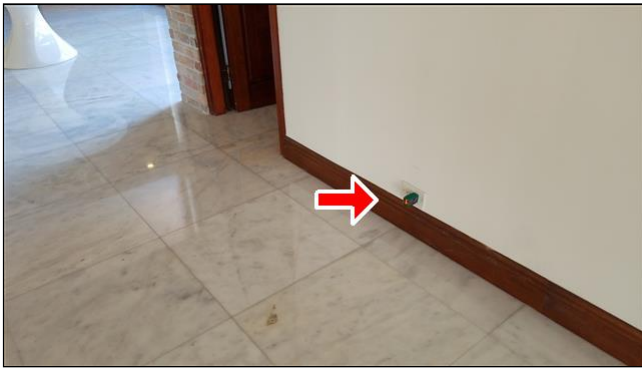
(1) Outlet has hot neutral reversed. \$100

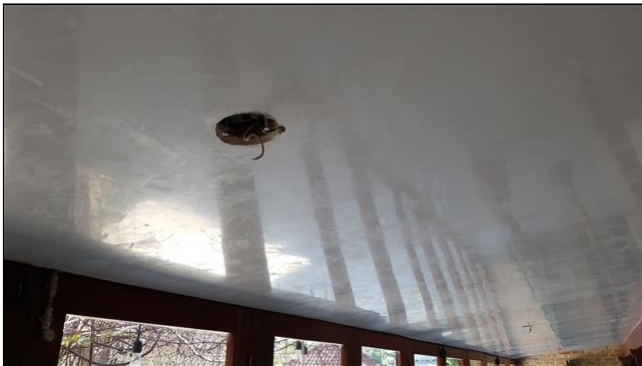
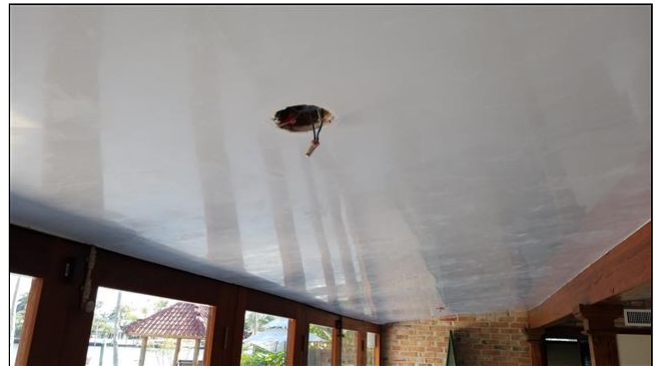
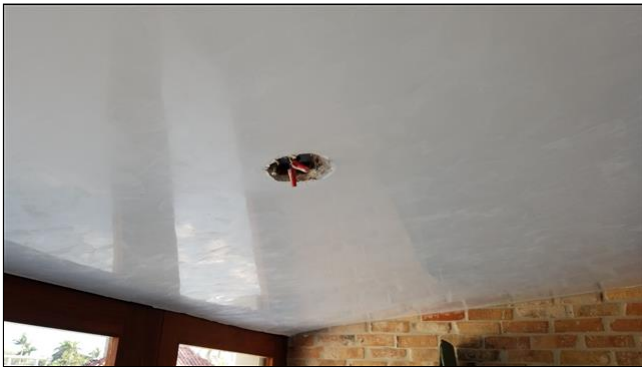
(2) Missing ceiling lights. \$ unknown

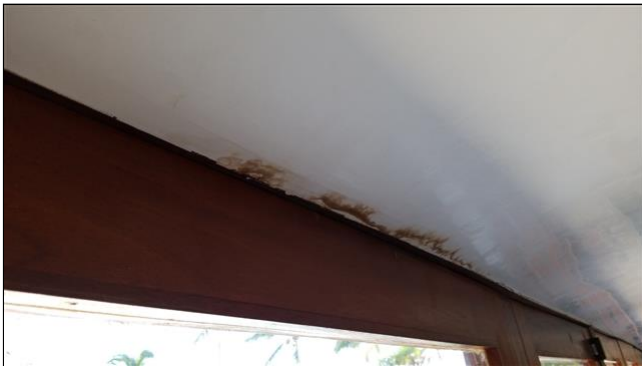
(3) Evidence of water intrusion at ceiling above door. Area tested negative for moisture. Recommend further evaluation.

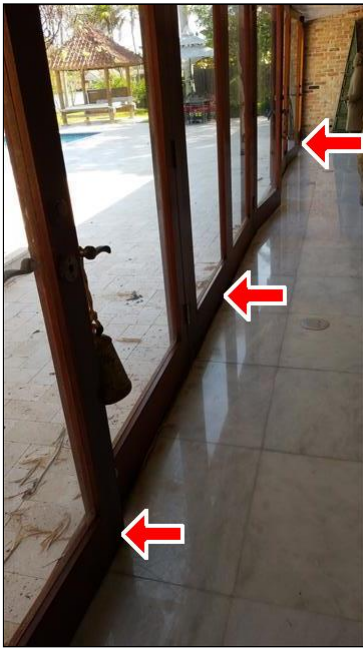
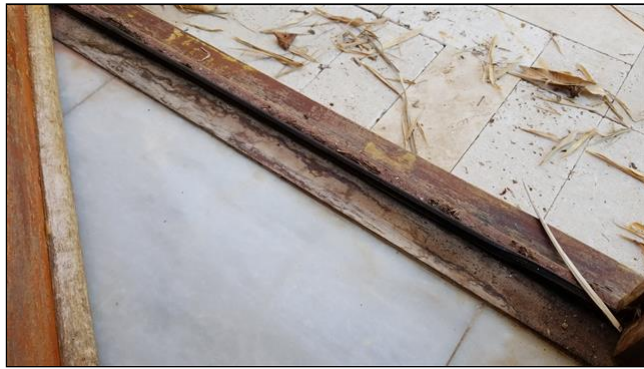
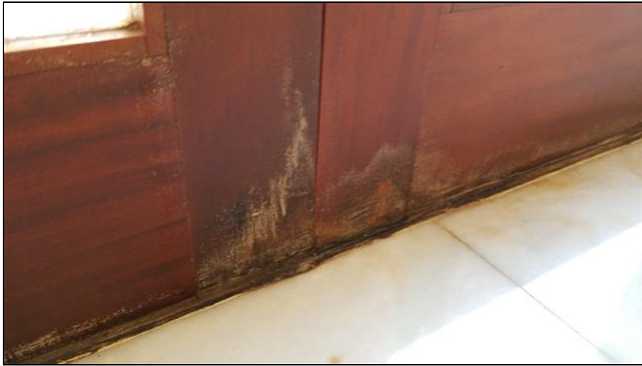
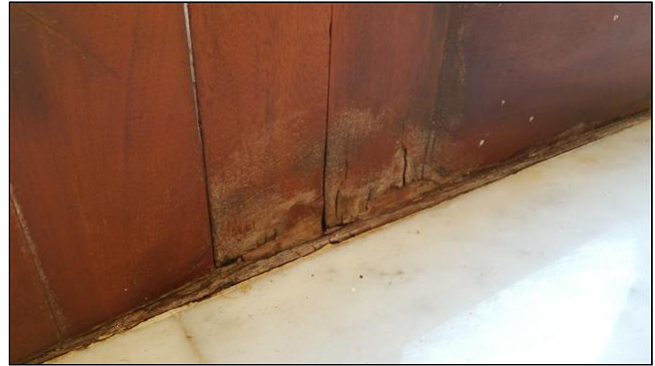
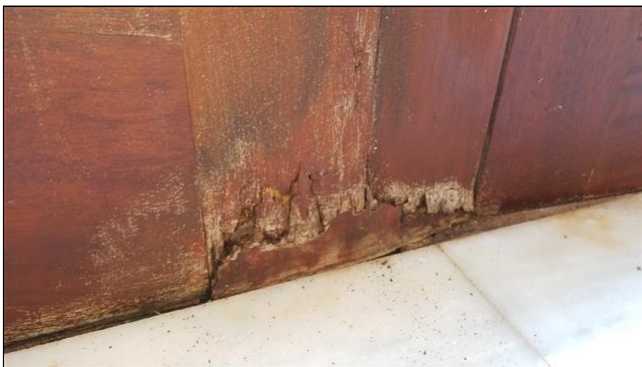
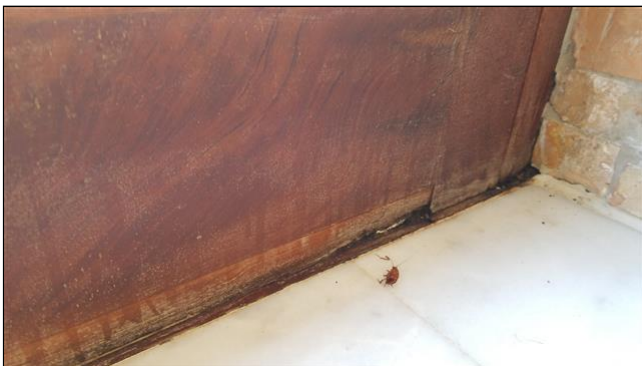
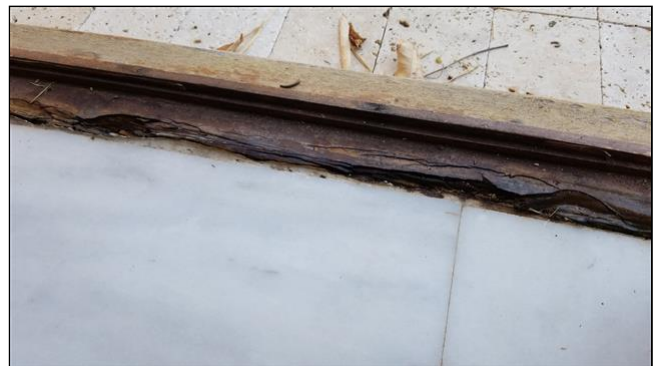
(4) Water intrusion and damage to door/window framing at various areas. \$ unknown. Recommend further evaluation.

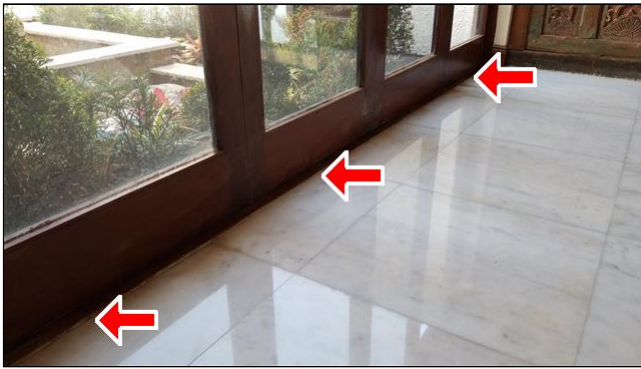
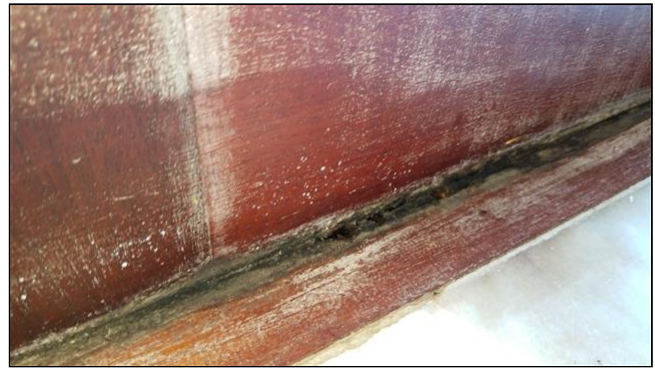
(1) Evidence of water intrusion / dry rot at window base. \$ unknown. Recommend further evaluation.

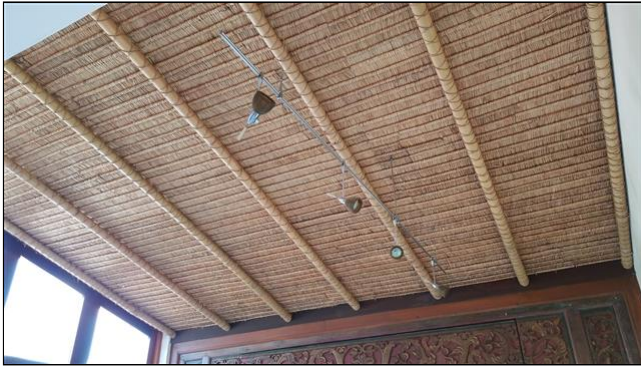
(2) Ceiling lights not turning on. \$50 (if bulbs) - unknown

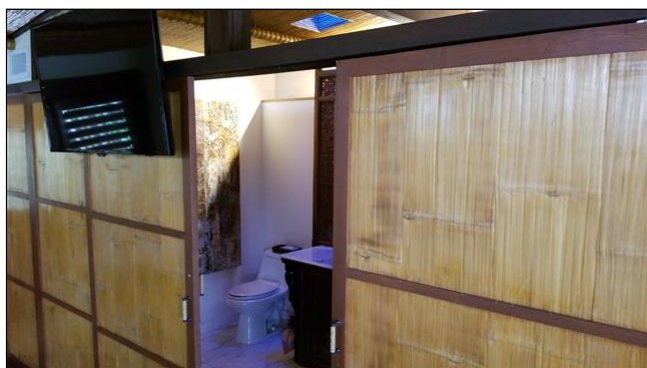
Sliding doors not rolling along tracks smoothly. \$50 - \$100

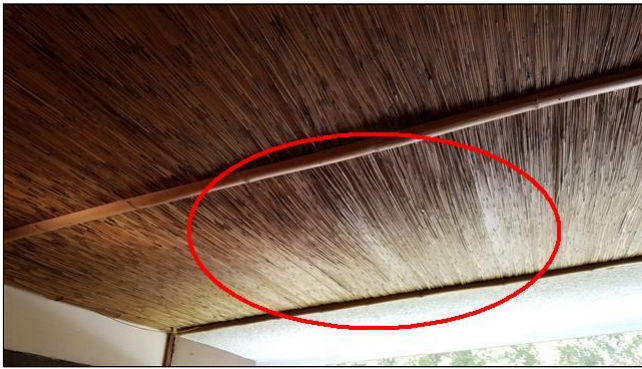
Ceiling deflection. \$ unknown

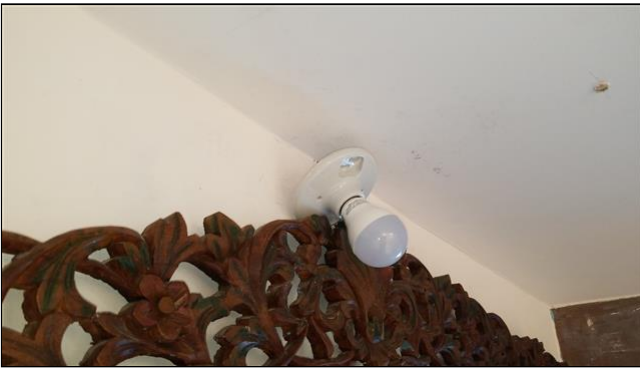
(1) Light not secured. \$50

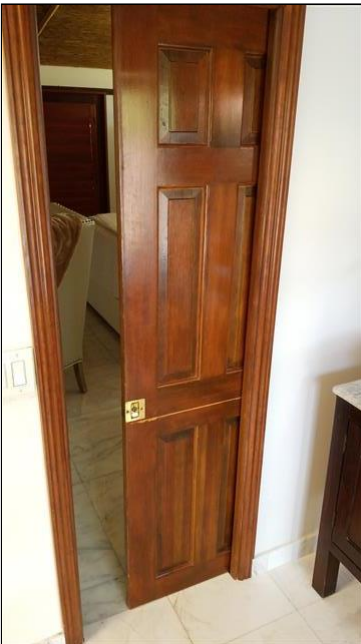
(2) Pocket door hitting frame. \$100 - \$400

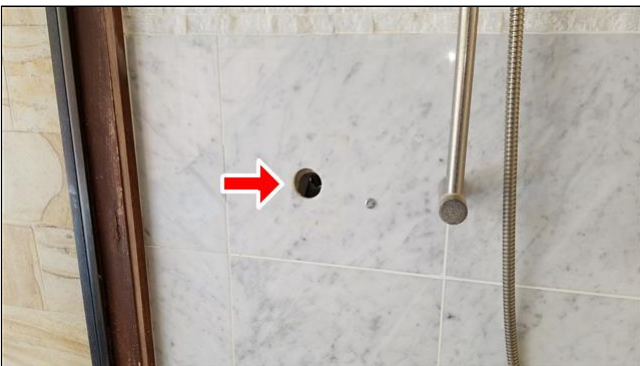
(3) Unknown opening at shower wall. \$ unknown

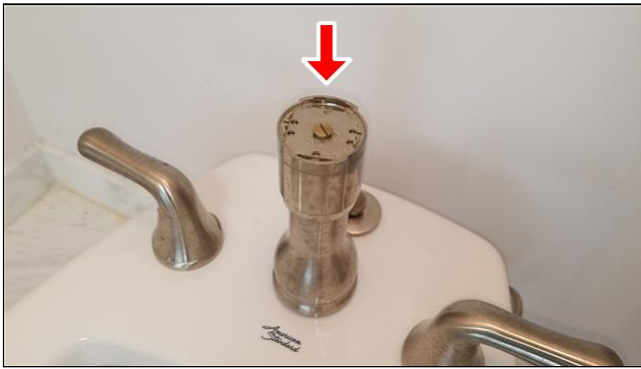
(4) Bidet diverter handle missing cap. \$50

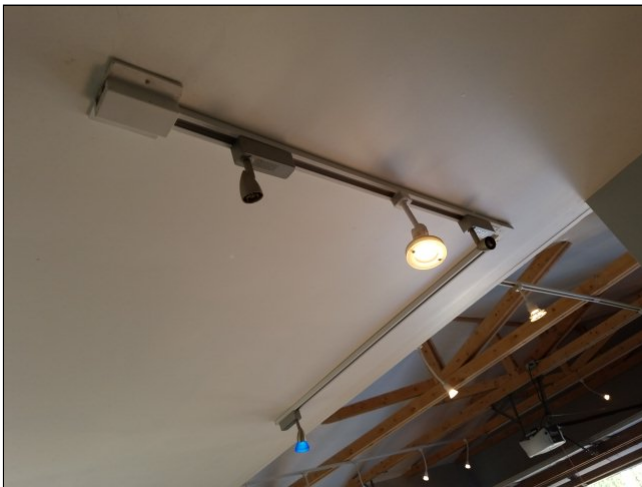
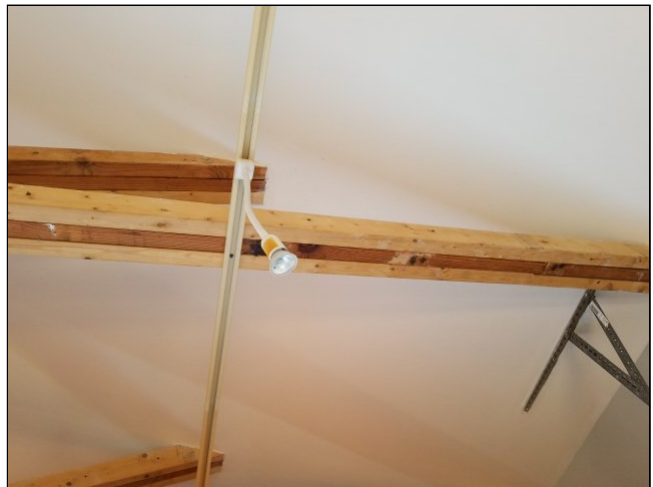
(2) Various ceiling light fixtures are inoperative.

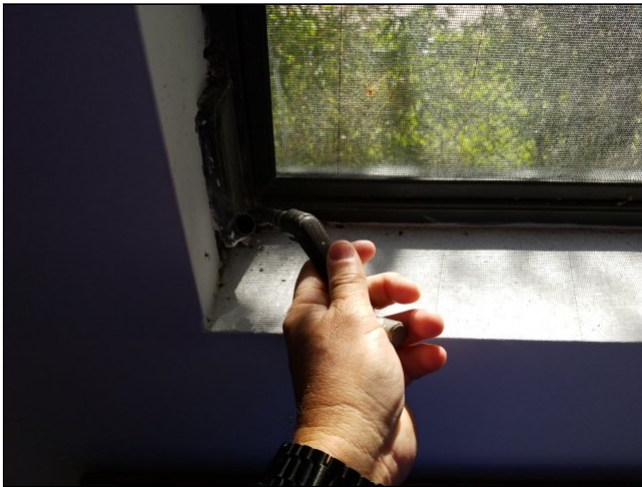
(3) Awning window does not open.
